NTUC INCOME INSURANCE CO-OPERATIVE LTD Ref: NS/INC19007198/K1sd3n2	
73 BRAS BASAH ROAD #05-01 NTUC TRADE UNION HOUSESINGAPORE 189556	Date: 06-05-2019
	Code: INC4

1. Policy Particulars :- THIRD PARTY CLAIM

THE VEHICLE SUSTAINED DAMAGES AT THE N/S WING MIRROR.
DAMAGES SEE DETAILS.

ADJUSTMENT ON REPAIR COST FOR VEHICLE NO. SHB 4033Z

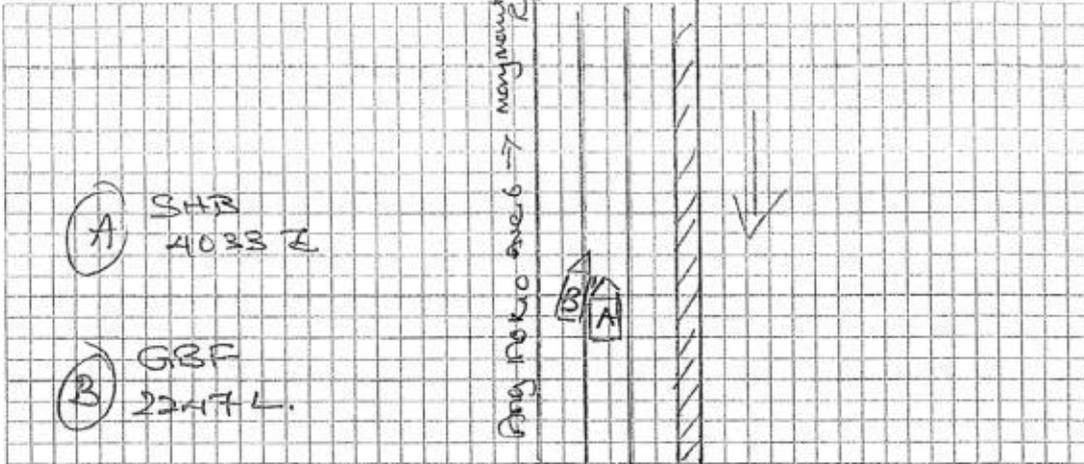
SKETCH PLAN

ON: 17 April 2019 @ 14:10hr. I VEH
 A was driving along straight on the
 above location. Suddenly VEH B from
 grt lane dash into 2nd lane and hit
 left wing mirror. at the point of
 accident VEH A ferry para not injured.

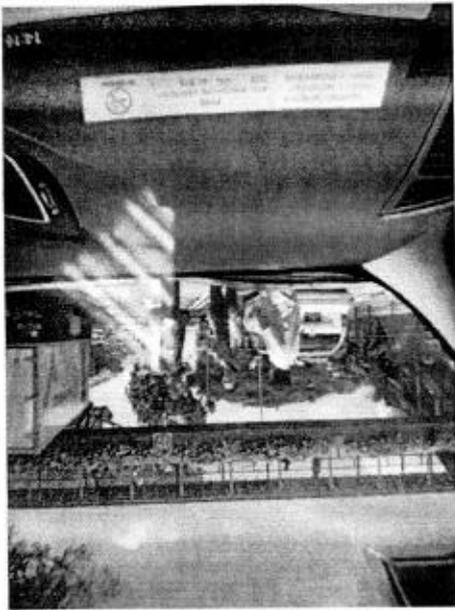
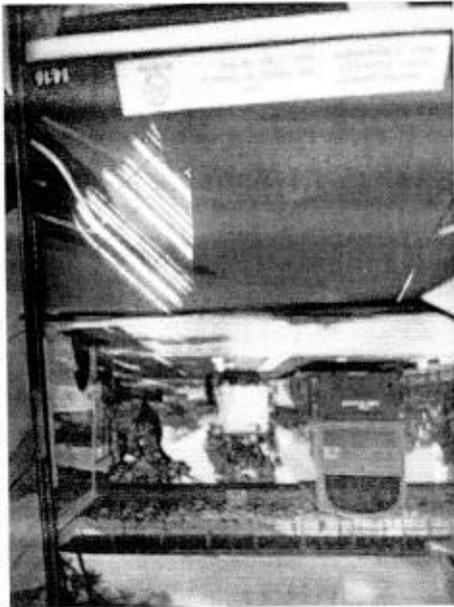
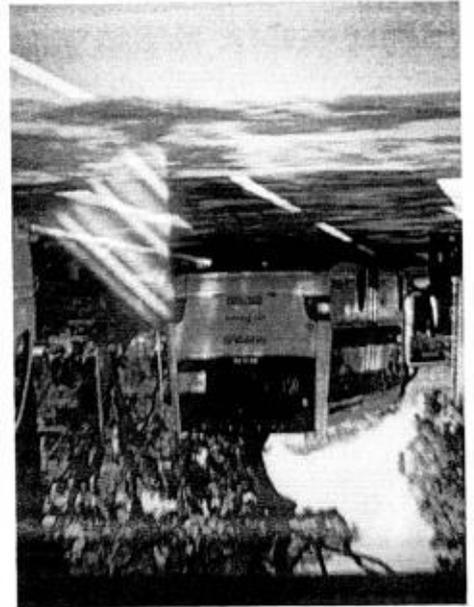
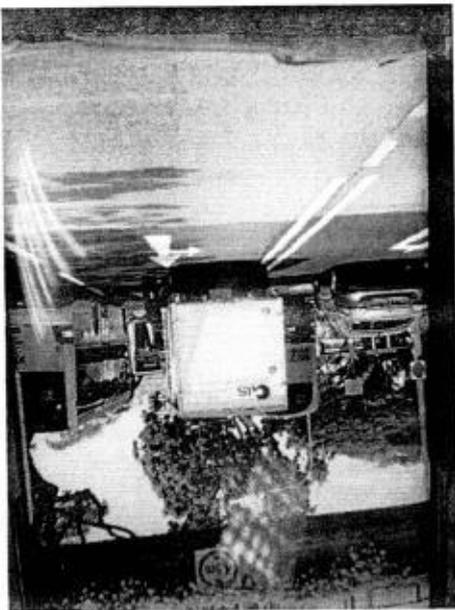
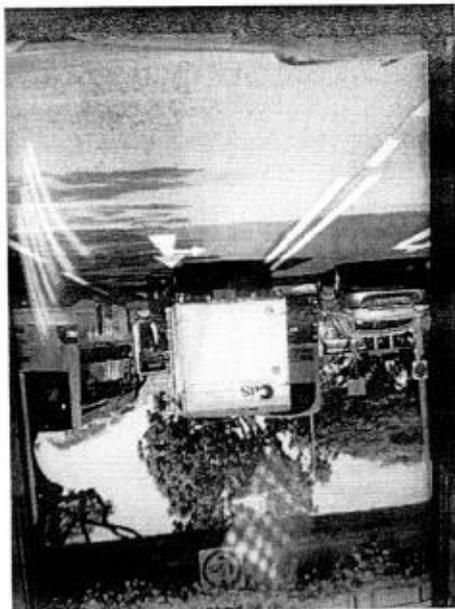
n/s wing mirror

Qty	Description of Parts	Condition	Estimate By Workshop (\$)	Our Adjusted (\$)
	REPLACEMENT OF PARTS			
1	FRONT DOOR MIRROR ASSY (LH)	BROKEN	670.00	670.00
	LESS 20% DISCOUNT		-134.00	-134.00
			536.00	536.00
	LABOUR			
	PANEL BEATING.		100.00	50.00
	SPRAY PAINTING CHARGE.		100.00	50.00
	WIRING CHARGE.	NOT NECESSARY	50.00	-
			250.00	100.00
	GRAND TOTAL		786.00	636.00
	RECOMMENDED COST OF LUMP SUM REPAIRS (TO ITS PRE-ACCIDENT CONDITION) (CONFIRMED)			500.00
