NTUC INCOME INSURANCE CO-OPERATIVE LTD Ref: NS/INC19007201/K1vd3e2				
73 BRAS BASAH ROAD #05-01 NTUC TRADE UNION HOUSESINGAPORE 189556			Date: 03-05-2019	 
Code: INC4

1. Policy Particulars :- THIRD PARTY CLAIM				
Insured Veh.	PC 1403J	Veh. Inspected	SHA 7719P	
Policy No.	5095391839-01	Coverage (\$)	0.00	
Claim No.	MT/1041000-002	Excess (\$)	0.00	
Assign From		Assign Date	18/04/2019

ADJUSTMENT ON REPAIR COST FOR VEHICLE NO. SHA 7719P

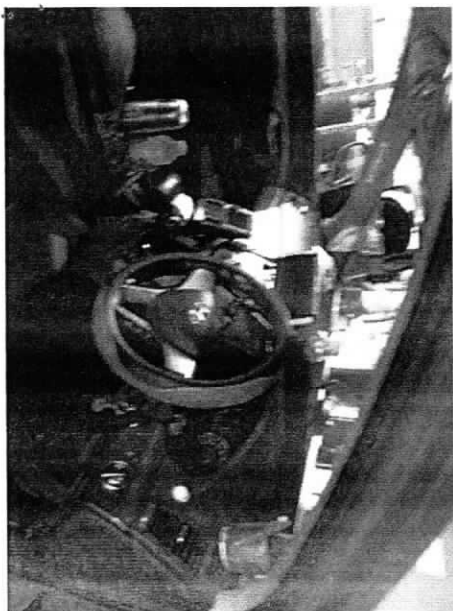
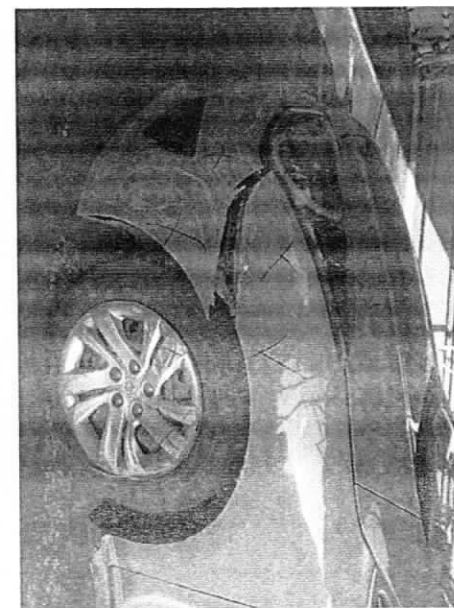
4. Description of Damages				
THE VEHICLE SUSTAINED DAMAGES AT THE WHOLE N/S PORTION. DAMAGES SEE DETAILS.				
5. General Information				
Accident Date	18/04/2019	Inspection Date	18/04/2019	
Survey held at	COMFORTDELGRO ENGINEERING PTE LTD 59 LOYANG DRIVE SINGAPORE 508969			
5a. Remarks				
A)THE INSPECTION WAS CONDUCTED ON A"WITHOUT PREJUDICE" BASIS. B)IN ACCORDANCE TO YOUR INSTRUCTIONS, WE HAVE NOT AUTHORISED REPAIRS.				
5b. Estimate Days of Repair				
ESTIMATED NORMAL PERIOD FOR REPAIR:		3 Working Days

Qty	Description of Parts	Condition	Estimate By Workshop (\$)	Our Adjusted (\$)
<u>REPLACEMENT OF PARTS</u>				
1	FRONT BUMPER COVER	CRACKED	1,052.20	1,052.20
1	FRONT BUMPER GRILLE AIRDUCT (LH)	SERVICEABLE	26.20	-
1	FRONT BUMPER BRACKET TOP (LH)	CRACKED	22.40	22.40
1	FRONT BUMPER RETAINER MOUNTING	SERVICEABLE	9.20	-
1	HEADLAMP (LH)	GRAZED	1,388.00	1,388.00
1	FRONT FENDER (LH)	BUCKLED	663.00	663.00
1	FRONT FENDER SHIELD (LH)	TORN	174.90	174.90
1	FRONT FENDER RETAINER	SERVICEABLE	24.60	-
1	FRONT DOOR MIRROR ASSY (LH)	TO REPAIR SEE LABOUR	670.00	-
1	FRONT WHEEL HUB CAP (LH)	GRAZED	107.10	107.10
	LESS 20% DISCOUNT		-827.52	-681.52
			3,310.08	2,726.08
<u>NETT ITEMS</u>				
1	DOOR LOGO FRT (N)	NECESSARY	75.00	75.00
1	DOOR LOGO REAR (N)	NECESSARY	80.00	80.00
	LESS 10% DISCOUNT		-	-15.50

400.00	400.00
<u>LABOUR</u>				
	PANEL BEATING.INCLUSIVE OF THE REPAIR OF FRONT DOOR MIRROR ASSY (LH) .		600.00	400.00
	SPRAY PAINTING CHARGE.		1,200.00	1,000.00
	WIRING CHARGE.		30.00	20.00

Qty	Description of Parts	Condition	Estimate By Workshop (\$)	Our Adjusted (\$)
	TUFF KOTE.		50.00	20.00
			1,880.00	1,440.00
GRAND TOTAL			5,745.08	4,705.58
RECOMMENDED COST OF LUMP SUM REPAIRS (TO ITS PRE-ACCIDENT CONDITION) (CONFIRMED)				3,750.00
