REF: NS/INC 19007232/Klvd302

NTUC INCOME INSURANCE CO-OPERATIVE LTD		Ref: NS/INC19007232/K1vd3e2	
73 BRAS BASAH ROAD #05-01 NTUC TRADE UNION HOUSESINGAPORE 189556		Date: 03-05-2019	 
		Code: INC4

4. Description of Damages			
THE VEHICLE SUSTAINED DAMAGES AT THE REAR O/S PORTION. DAMAGES SEE DETAILS.			
5. General Information			
Accident Date	18/04/2019	Inspection Date	18/04/2019
Survey held at	COMFORTDELGRO ENGINEERING PTE LTD 59 LOYANG DRIVE SINGAPORE 508969		
5a. Remarks			
A)THE INSPECTION WAS CONDUCTED ON A"WITHOUT PREJUDICE" BASIS. B)IN ACCORDANCE TO YOUR INSTRUCTIONS, WE HAVE NOT AUTHORISED REPAIRS.			
5b. Estimate Days of Repair			
ESTIMATED NORMAL PERIOD FOR REPAIR:		4 Working Days

ADJUSTMENT ON REPAIR COST FOR VEHICLE NO. SHA 2877Z

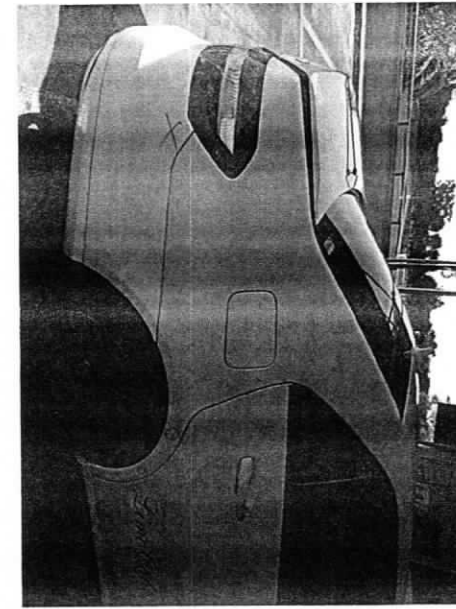
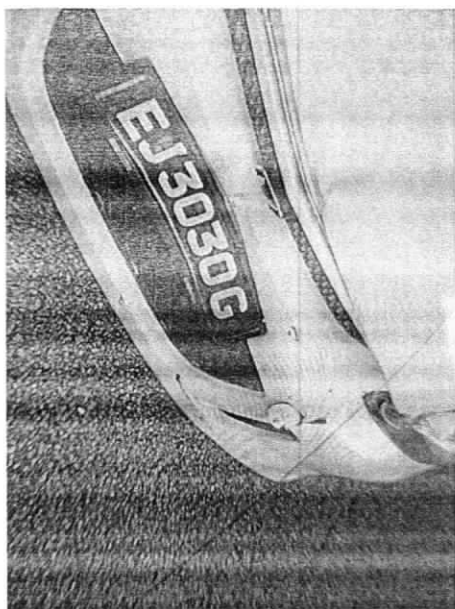
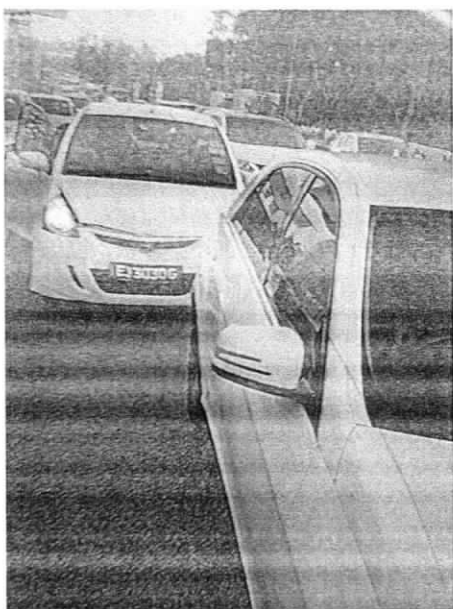
The U/C / Chassis frame / Body Structure affected due to collision.

Qty	Description of Parts	Condition	Estimate By Workshop (\$)	Our Adjusted (\$)
<u>REPLACEMENT OF PARTS</u>				
1	BOOT LID	BENT	2,470.00	2,470.00
1	BOOT LID MOULDING	SERVICEABLE	110.00	-
1	BOOT LID LOCK	SERVICEABLE	275.00	-
1	BOOT LID 'E220' EMBLEM	NECESSARY	54.30	54.30
1	BOOT LID STAR LOGO	NECESSARY	45.00	45.00
1	BOOT LID - EMBLEM	NECESSARY	54.30	54.30
1	REAR BUMPER	DEFORMED	1,510.00	1,510.00
1	REAR BUMPER REINFORCEMENT	BENT	1,150.00	1,150.00
1	REAR BUMPER BRACKET LOWER (RH)	SERVICEABLE	135.00	-
1	REAR BUMPER ABSORBER (RH)	SERVICEABLE	196.45	-
1	REAR BUMPER CENTRE FRAME	SERVICEABLE	177.55	-
1	REAR BUMPER TOWING COVER	MISSING	175.00	175.00
1	REAR BUMPER UNDER SIDE COVER	SERVICEABLE	245.30	-
1	TAILLAMP (RH)	BENT	1,280.00	1,280.00
1	REAR PANEL END	BUCKLED	1,380.00	1,380.00
1	REAR PANEL INNER GARNISH	CRACKED	240.00	240.00
10	REAR PANEL INNER GARNISH CLIP	NECESSARY	40.00	40.00
	LESS 20% DISCOUNT		-1,907.58	-1,679.72

RECOMMENDED COST OF LUMP SUM REPAIRS (TO ITS PRE-ACCIDENT CONDITION) (CONFIRMED)				6,700.00
---	--	--	--	----------
