REF: NS/INC 19007262/K19d3m2

TP Claims against NTUC Income: Follow-Through Survey

1. Policy Particulars :- THIRD PARTY CLAIM				
Insured Veh.	SMG 3579L	Veh. Inspected	SHC 3227H	
Policy No.	5105166822	Coverage (\$)	0.00	
Claim No.	MT/1041317-002	Excess (\$)	0.00	
Assign From		Assign Date	22/04/2019

ADJUSTMENT ON REPAIR COST FOR VEHICLE NO. SHC 3227H

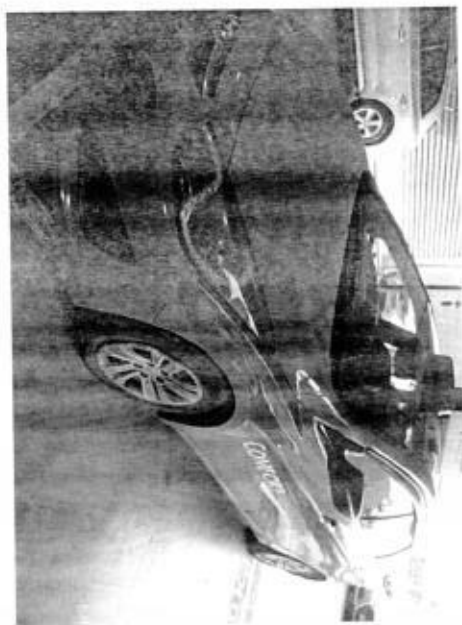
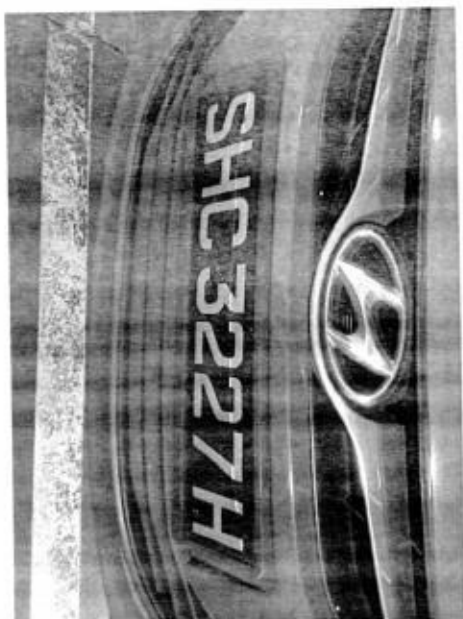
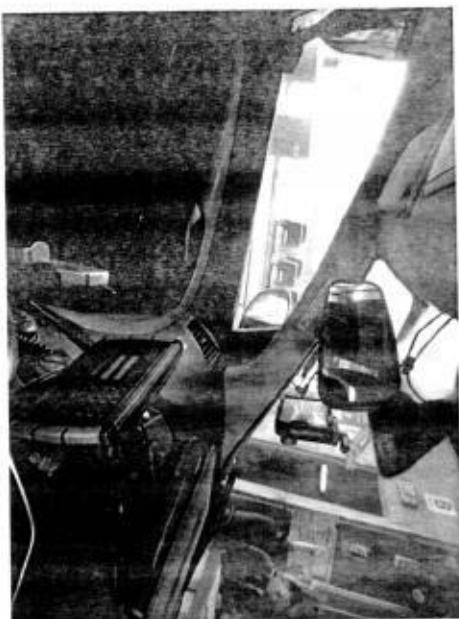
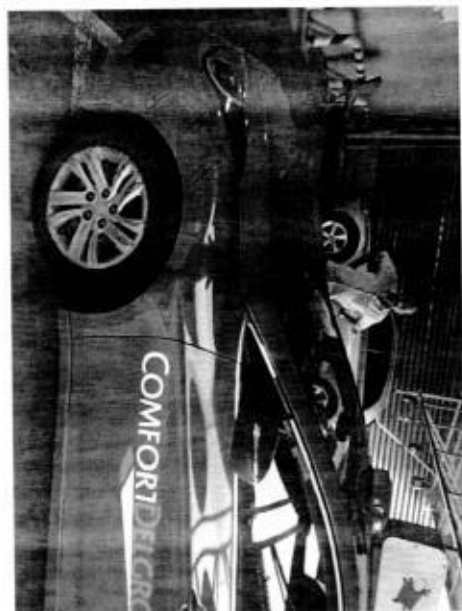
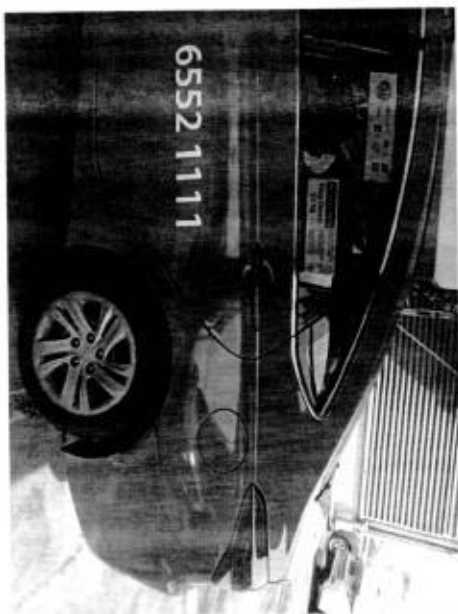
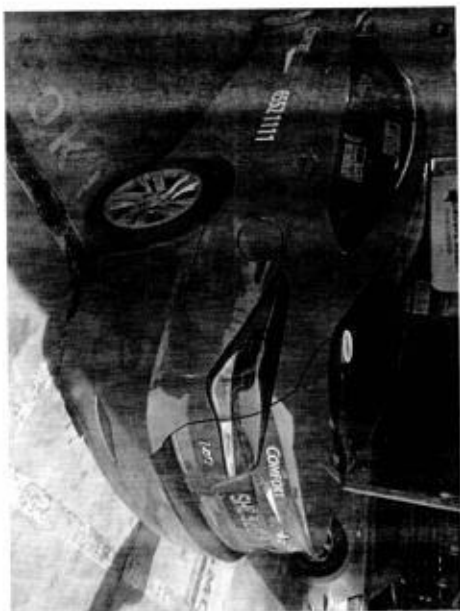
4. Description of Damages				
THE VEHICLE SUSTAINED DAMAGES AT THE N/S FRONT PORTION. DAMAGES SEE DETAILS.				
5. General Information				
Accident Date	21/04/2019	Inspection Date	22/04/2019	
Survey held at	COMFORTDELGRO ENGINEERING PTE LTD 59 LOYANG DRIVE SINGAPORE 508969			
5a. Remarks				
A)THE INSPECTION WAS CONDUCTED ON A"WITHOUT PREJUDICE" BASIS. B)IN ACCORDANCE TO YOUR INSTRUCTIONS, WE HAVE NOT AUTHORISED REPAIRS.				
5b. Estimate Days of Repair				
ESTIMATED NORMAL PERIOD FOR REPAIR:		2 Working Days

Qty	Description of Parts	Condition	Estimate By Workshop (\$)	Our Adjusted (\$)
<u>REPLACEMENT OF PARTS</u>				
1	FRT BUMPER	TO REPAIR SEE LABOUR	544.50	-
1	FRT FENDER LH	BUCKLED	566.30	566.30
1	FRT WHEEL CAP LH	GRAZED	107.10	107.10
	LESS 20% DISCOUNT		-243.58	-134.68
			974.32	538.72
<u>LABOUR</u>				
	PANEL BEATING.INCLUSIVE OF THE REPAIR OF FRT BUMPER.		500.00	300.00
	SPRAYPAINT CHARGE.		500.00	400.00
	TUFF COAT ON AFFECTED PARTS.		40.00	20.00
	WHEEL ALIGNMENT.	NOT NECESSARY	120.00	-
			1,160.00	720.00
GRAND TOTAL			2,134.32	1,258.72
RECOMMENDED COST OF LUMP SUM REPAIRS (TO ITS PRE-ACCIDENT CONDITION) (CONFIRMED)				1,000.00
