REF: NS/INC 19007309 / KIVD3N2

Code: INC4				
<b>1. Policy Particulars :- THIRD PARTY CLAIM</b>				
Insured Veh.	PA 786X	Veh. Inspected	SHC 3387D	
Policy No.	5107199794	Coverage (\$)	0.00	
Claim No.	MT/1041502-002	Excess (\$)	0.00	
Assign From		Assign Date	24/04/2019	
<b>2. Vehicle Particulars &amp; Condition</b>				
Make & Model	HYUNDAI I40	c.c	1685	
Engine No.	HIDDEN	Year of Reg.	2014	
Chassis No.	KMHLB41UMDU043509	Colour	BLUE	
Odometer	902485	Steering	IN ORDER	
Brakes	IN ORDER	Modification	STANDARD ALLOY RIM	
General	FAIR			
<b>3. Conditions of Tyres</b>				
	Size	Make	Balance	
R/H Front Tyre	205/60 R16	HANKOOK	7 mm	
L/H Front Tyre	205/60 R16	HANKOOK	7 mm	
R/H Rear Tyre	205/60 R16	HANKOOK	7 mm	
L/H Rear Tyre	205/60 R16	HANKOOK	7 mm	
<b>4. Description of Damages</b>				
THE VEHICLE SUSTAINED DAMAGES AT THE N/S REAR PORTION. DAMAGES SEE DETAILS.

## ADJUSTMENT ON REPAIR COST FOR VEHICLE NO. SHC 3387D

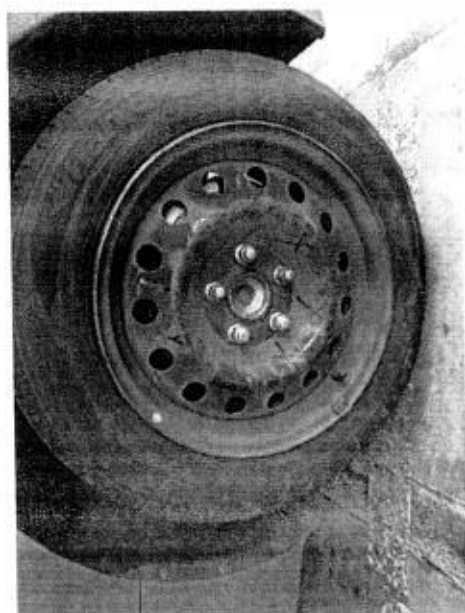
Remark: The veh had commenced its repair at the time of inspection.

Qty	Description of Parts	Condition	Estimate By Workshop (\$)	Our Adjusted (\$)
<b>REPLACEMENT OF PARTS</b>				
1	REAR BUMPER	DEFORMED	553.00	553.00
10	REAR BUMPER CLIP	NECESSARY	22.00	22.00
1	REAR DOOR (LH)	TO REPAIR SEE LABOUR	2,201.10	-
1	REAR WHEEL HUB CAP, LH	MISSING	107.10	107.10
1	REAR LH FENDER (NPA)	TO REPAIR SEE LABOUR	-	-
	LESS 20% DISCOUNT		-576.64	-136.42
			2,306.56	545.68
<b>SPECIAL NETT ITEMS</b>				
1	REAR BUMPER RUBBER MAT (SN)	NECESSARY	50.00	50.00
1	REAR DOOR COMFORTDELGRO & APPS STICKER (LH) (SN)	NECESSARY	80.00	80.00

130.00	130.00
<b>LABOUR</b>				
	PANEL BEATING. INCLUSIVE OF THE REPAIR OF REAR DOOR (LH) AND REAR LH FENDER.		400.00	300.00
	SPRAY PAINTING CHARGE-FENDER/BUMPER/DOOR.		900.00	600.00
	TUFF KOTE.	NOT NECESSARY	50.00	-
	REMOVE/REFIX REVERSE SENSOR.		80.00	30.00
	TRANSFER OF DOOR.	NOT NECESSARY	80.00	-
	REAR WHEEL ALIGNMENT.	NOT NECESSARY	80.00	-
			1,590.00	930.00
<b>GRAND TOTAL</b>			<b>4,026.56</b>	<b>1,605.68</b>
<b>RECOMMENDED COST OF LUMP SUM REPAIRS (TO ITS PRE-ACCIDENT CONDITION) (CONFIRMED)</b>				<b>1,300.00</b>
