Insured: XE 499JPolicy No. 5088412823-02 (09/05/2018)Claims No. MT/1041766-002

Veh No: SH 9151X Yr Regn: 14 May 2018

NTUC INCOME INSURANCE CO-OPERATIVE LTD		Ref: NS/INC19007320/K1td3e2	
73 BRAS BASAH ROAD #05-01 NTUC TRADE UNION HOUSESINGAPORE 189556		Date: 06-05-2019	 
Code: INC4			
<b>1. Policy Particulars :- THIRD PARTY CLAIM</b>			
Insured Veh.	XE 499J	Veh. Inspected	SH 9151X
Policy No.	5088412823-02	Coverage (\$)	0.00
Claim No.	MT/1041766-002	Excess (\$)	0.00
Assign From		Assign Date	24/04/2019
<b>2. Vehicle Particulars &amp; Condition</b>			
Make & Model	HYUNDAI I40	c.c	1685
Engine No.	HIDDEN	Year of Reg.	2014
Chassis No.	KMHLB41UMEU053855	Colour	BLUE
Odometer	836132	Steering	IN ORDER
Brakes	IN ORDER	Modification	STANDARD ALLOY RIM
General	FAIR		
<b>3. Conditions of Tyres</b>			
	Size	Make	Balance
R/H Front Tyre	205/60 R16	WEST LAKE	7 mm
L/H Front Tyre	205/60 R16	WEST LAKE	7 mm
R/H Rear Tyre	205/60 R16	WEST LAKE	7 mm
L/H Rear Tyre	205/60 R16	WEST LAKE	7 mm
<b>4. Description of Damages</b>			
THE VEHICLE SUSTAINED DAMAGES AT THE O/S FRONT PORTION. DAMAGES SEE DETAILS.

**ADJUSTMENT ON REPAIR COST FOR VEHICLE NO. SH 9151X**

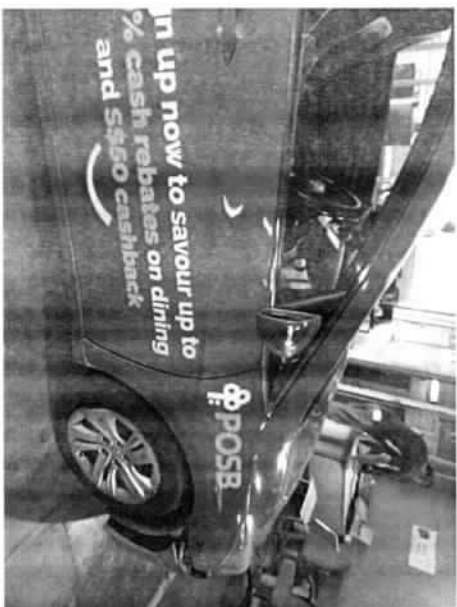
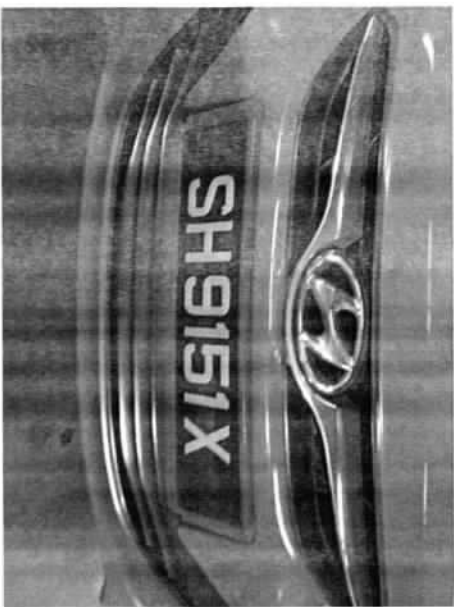
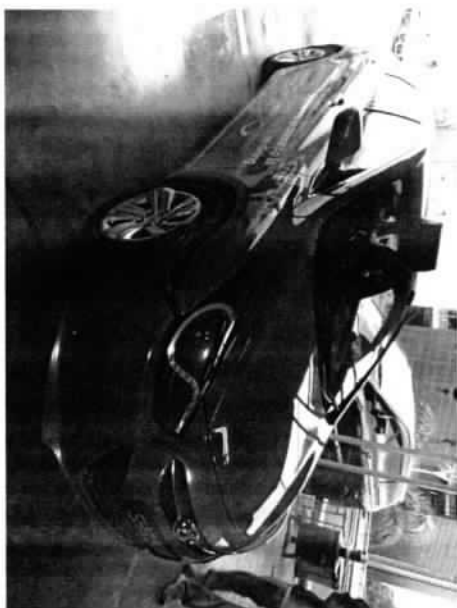
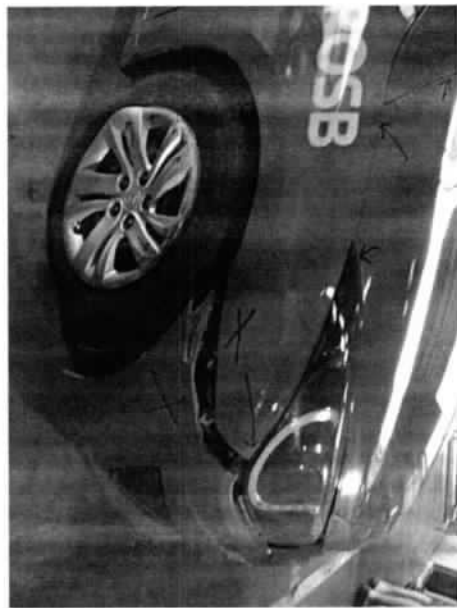
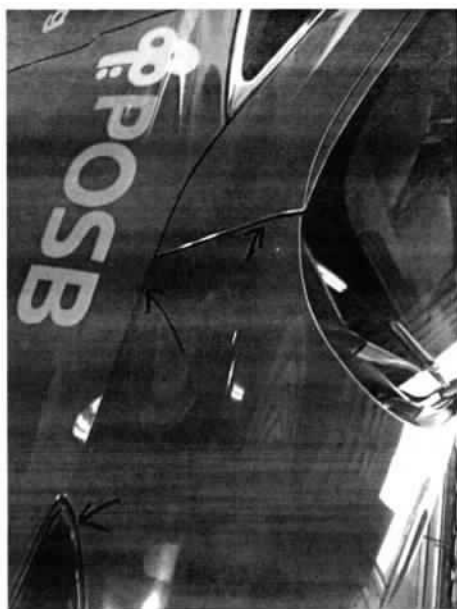
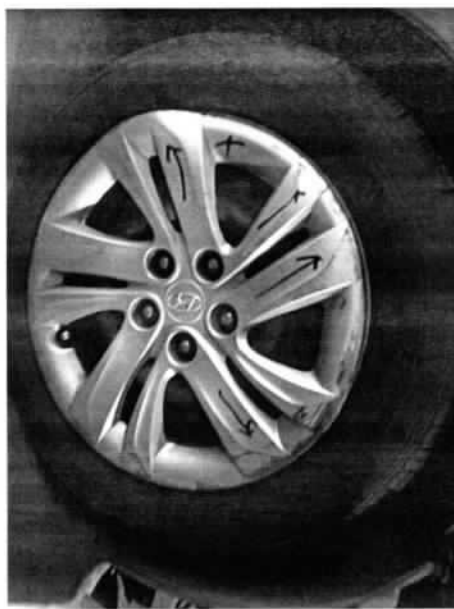
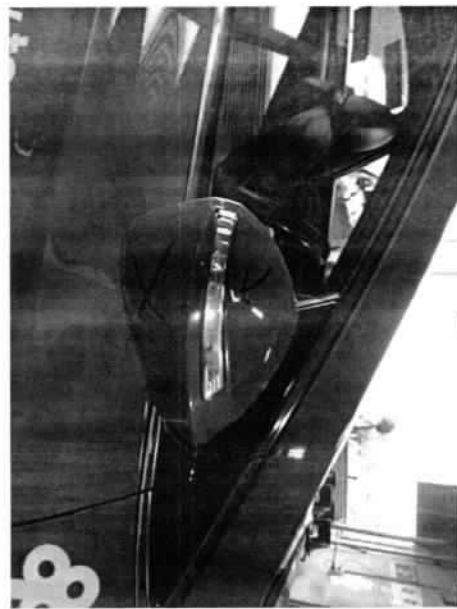
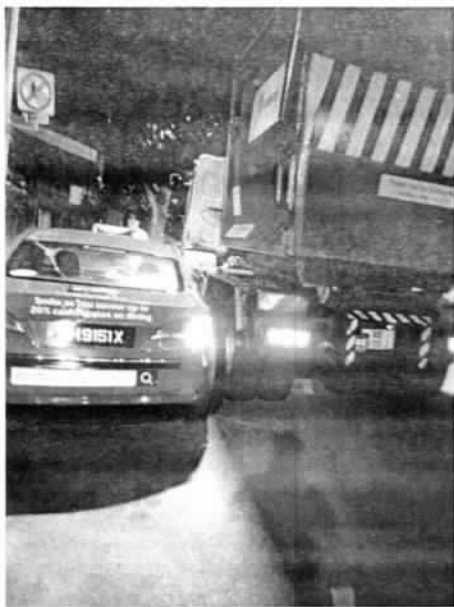
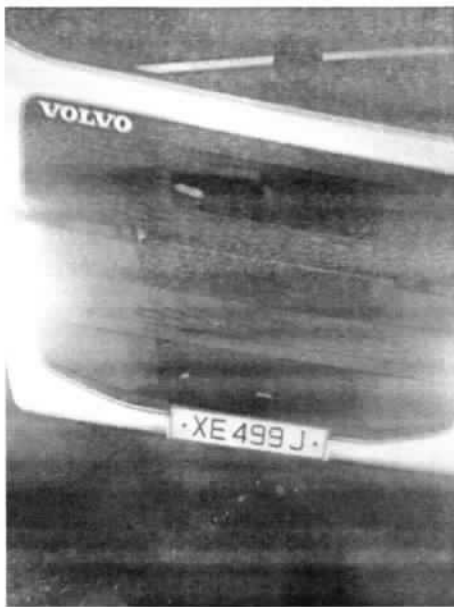
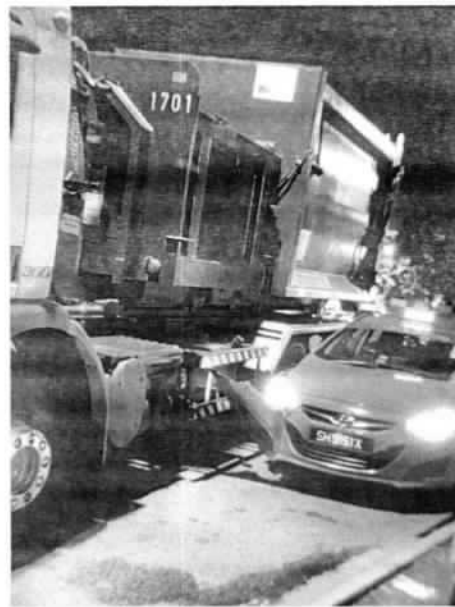
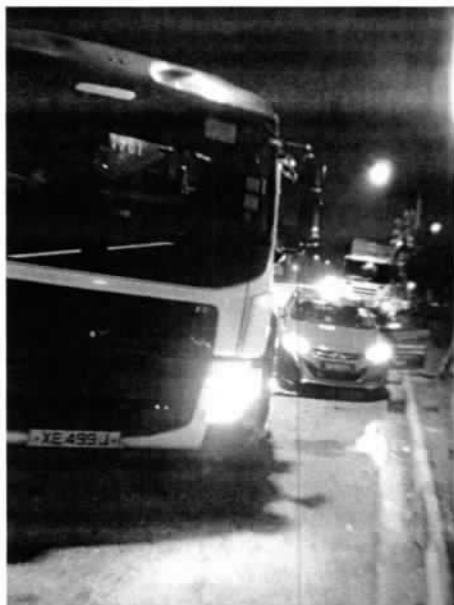
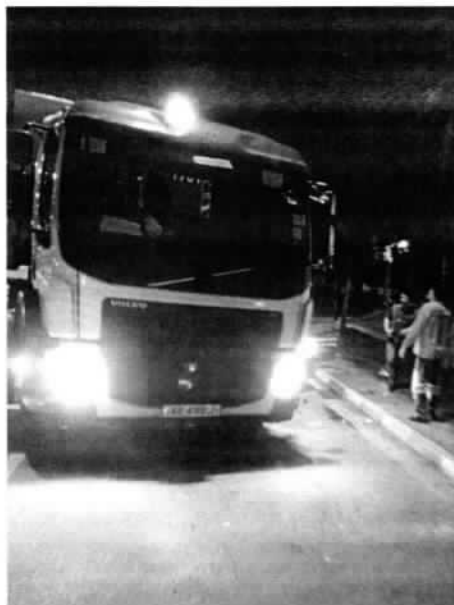
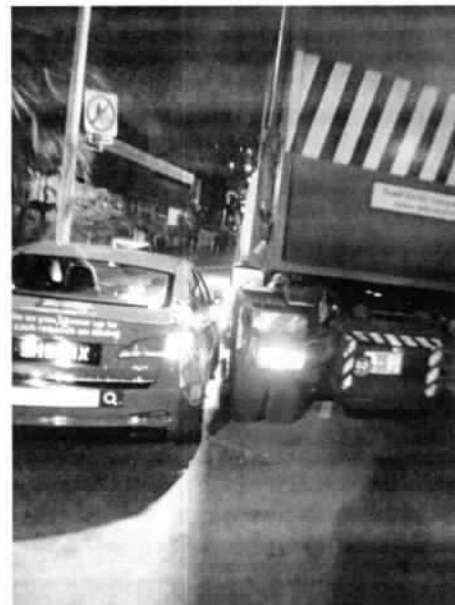
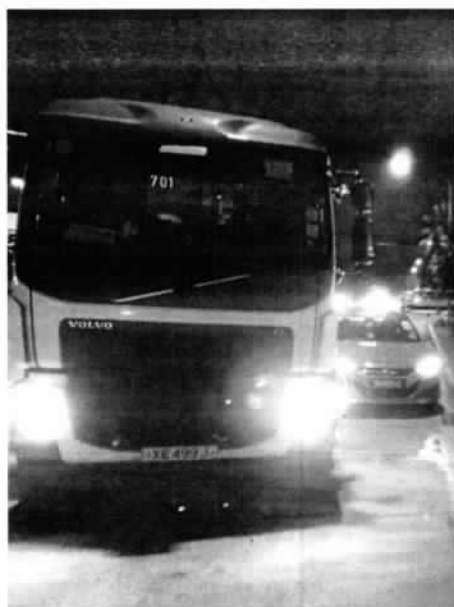
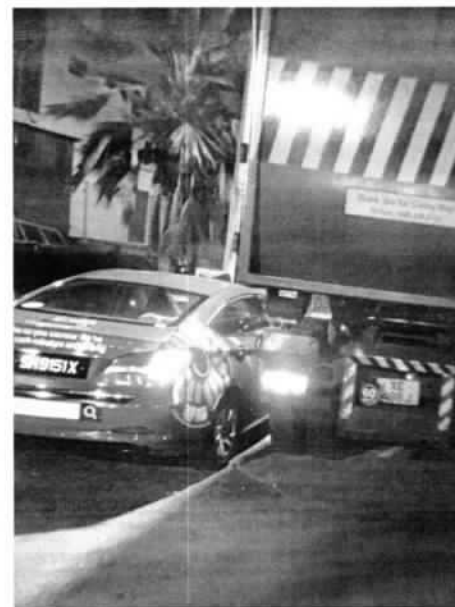
Qty	Description of Parts	Condition	Estimate By Workshop (\$)	Our Adjusted (\$)
<b><u>REPLACEMENT OF PARTS</u></b>				
1	FRONT BUMPER COVER	CRACKED	544.50	544.50
1	FRONT BUMPER GRILLE (RH)	SERVICEABLE	41.60	-
1	FRONT BUMPER BRACKET (RH)	CRACKED	24.60	24.60
1	HEADLAMP (RH)	CRACKED	1,388.00	1,388.00
1	FRT WHEEL HUB CAP, RH	GRAZED	107.10	107.10
1	FRONT RH FENDER LINER	TORN	174.90	174.90
1	FRONT RH FENDER (NPA)	TO REPAIR SEE LABOUR	-	-
1	RH WING MIRROR (NPA)	TO REPAIR SEE LABOUR	-	-
	LESS 20% DISCOUNT		-456.14	-447.82
			1,824.56	1,791.28
<b><u>SPECIAL NETT ITEMS</u></b>				
1	FRONT FENDER ADVERTISEMENT LOGO (RH) (SN)	NECESSARY	100.00	100.00

980.00	670.00
<b>GRAND TOTAL</b>			<b>2,904.56</b>	<b>2,561.28</b>
<b>RECOMMENDED COST OF LUMP SUM REPAIRS (TO ITS PRE-ACCIDENT CONDITION) (CONFIRMED)</b>				<b>2,050.00</b>
