Surveyor: KalvinREF: NS/INC19007373/Klsd3s2

1. Policy Particulars :- THIRD PARTY CLAIM

Insured Veh.	ES 5211R	Veh. Inspected	SHB 6685D
Policy No.	5081175836-02	Coverage (\$)	0.00
Claim No.	MT/1041686-002	Excess (\$)	0.00
Assign From		Assign Date	25/04/2019

ADJUSTMENT ON REPAIR COST FOR VEHICLE NO. SHB 6685D

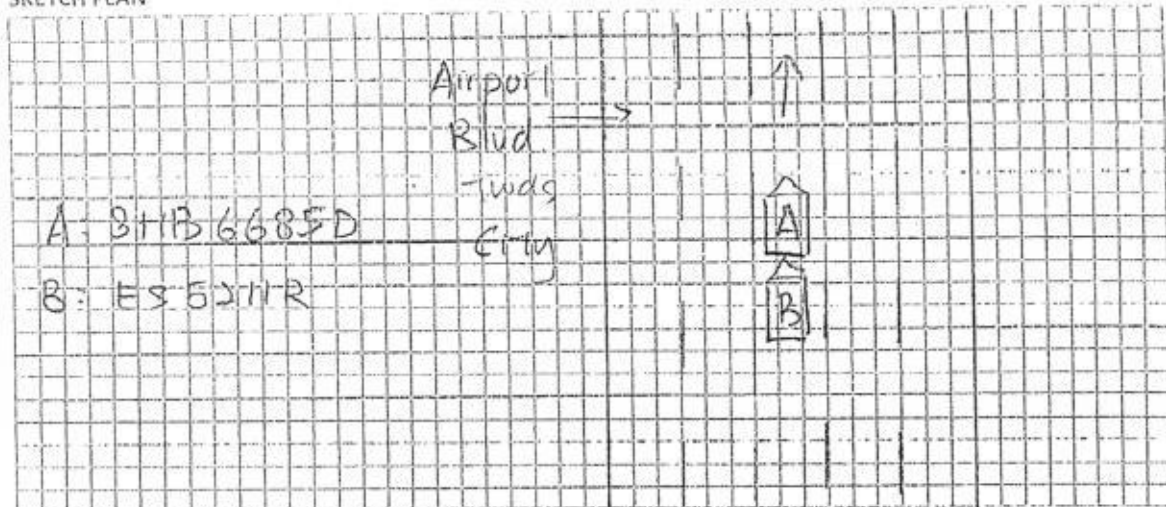
SKETCH PLAN

On 24/4/19 at about 23:10 hrs, I was driving at above said location with 7 passengers onboard. Shortly veh in front braked to stopped and I follow suit. A split second later, I felt an impact from behind followed by a jerk. Luckily I able to avoid collision with the veh in front, I stepped out and found veh B in front portion collided onto the rear portion of my stationary taxi. I felt pain on waist and shoulder, will consult doctor later on. All passengers was fine.

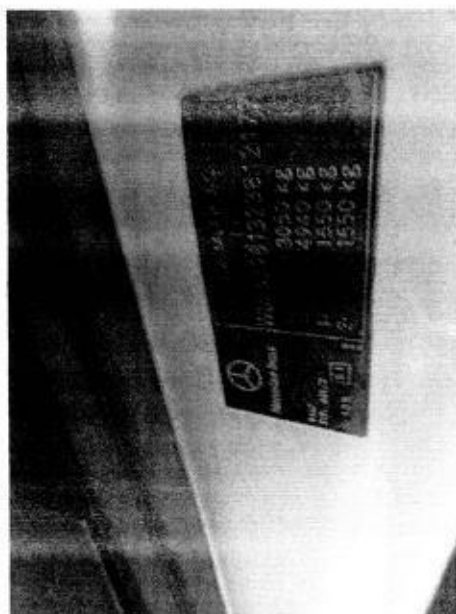
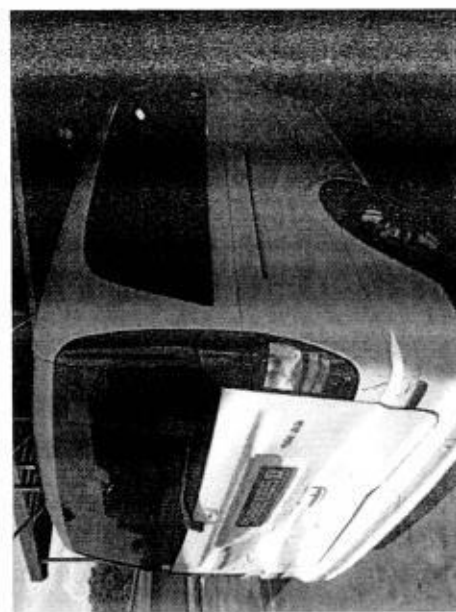
The U/C / Chassis frame / Body Structure affected due to collision.

THE VEHICLE SUSTAINED DAMAGES AT THE REAR PORTION. DAMAGES SEE DETAILS.
--

Qty	Description of Parts	Condition	Estimate By Workshop (\$)	Our Adjusted (\$)
<u>REPLACEMENT OF PARTS</u>				
1	REAR BUMPER	DEFORMED	1,372.00	1,372.00
1	BUMPER L/H SIDE, RR	CRACKED	473.60	473.60
1	BUMPER R/H SIDE, RR	SERVICEABLE	473.60	-
1	TAIL GATE ASSY	DENTED	3,951.98	3,951.98
1	TAIL GATE MERCEDES STAR LOGO	NECESSARY	45.46	45.46
1	TAIL GATE "2.2" LOGO	NECESSARY	78.00	78.00
1	TAIL GATE VIA NO LOGO	NECESSARY	78.00	78.00
1	TAIL GATE LOCK	JAMMED	273.40	273.40
1	TAIL GATE LOCK OUTER HANDLE	CRACKED	175.54	175.54
1	TAIL GATE STEP GARNISH	SERVICEABLE	161.45	-
1	TAIL GATE BOTTOM HANDLE	SERVICEABLE	10.00	-
1	NUMBER PLATE GARNISH, RR	SERVICEABLE	166.78	-
1	TAIL LAMP ASSY LOWER, LH	CUT	750.00	750.00
1	TAIL LAMP ASSY LOWER, RH	SERVICEABLE	750.00	-
1	REAR WINDSCREEN GLASS	SERVICEABLE	1,273.98	-
	LESS 20% DISCOUNT		-2,006.76	-1,439.60
			8,027.03	5,758.38
<u>NETT ITEMS</u>				
1	REVERSE SENSOR (N)	SHORTED	288.00	288.00
1	REAR WINDSCREEN SEALANT (N)	NECESSARY	46.00	46.00

Qty	Description of Parts	Condition	Estimate By Workshop (\$)	Our Adjusted (\$)
	WIRING CHARGE.	NOT NECESSARY	30.00	20.00
	TOWING CHARGES.		150.00	-
	TUFF KOTE.		50.00	20.00
	REMOVE / REFIX CUSHION & UPHOLSTERY REAR.		150.00	-
	REMOVE / REFIX REAR WINDSCREEN GLASS (SEALANT)		150.00	100.00
			1,930.00	1,140.00
GRAND TOTAL			10,371.03	7,198.98
RECOMMENDED COST OF LUMP SUM REPAIRS (TO ITS PRE-ACCIDENT CONDITION) (CONFIRMED)				5,750.00
