NTUC INCOME INSURANCE CO-OPERATIVE LTD Ref: NS/INC19007556/K1td3n2

1. Policy Particulars :- THIRD PARTY CLAIM

THE VEHICLE SUSTAINED DAMAGES AT THE REAR PORTION. DAMAGES SEE DETAILS.
--

ADJUSTMENT ON REPAIR COST FOR VEHICLE NO. SHD 6530G

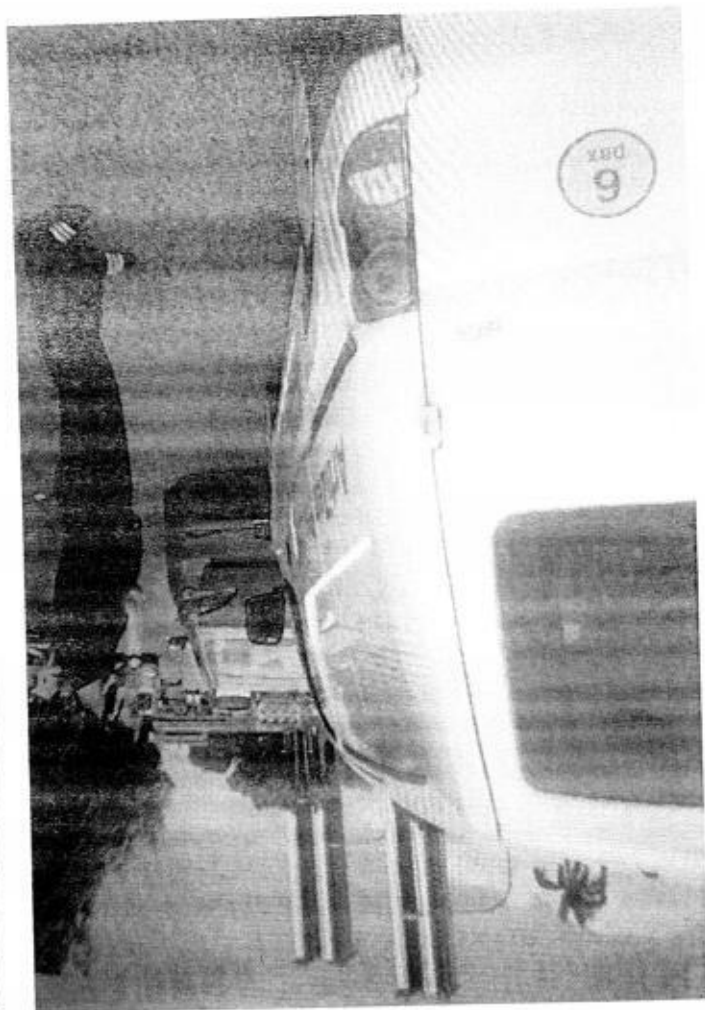
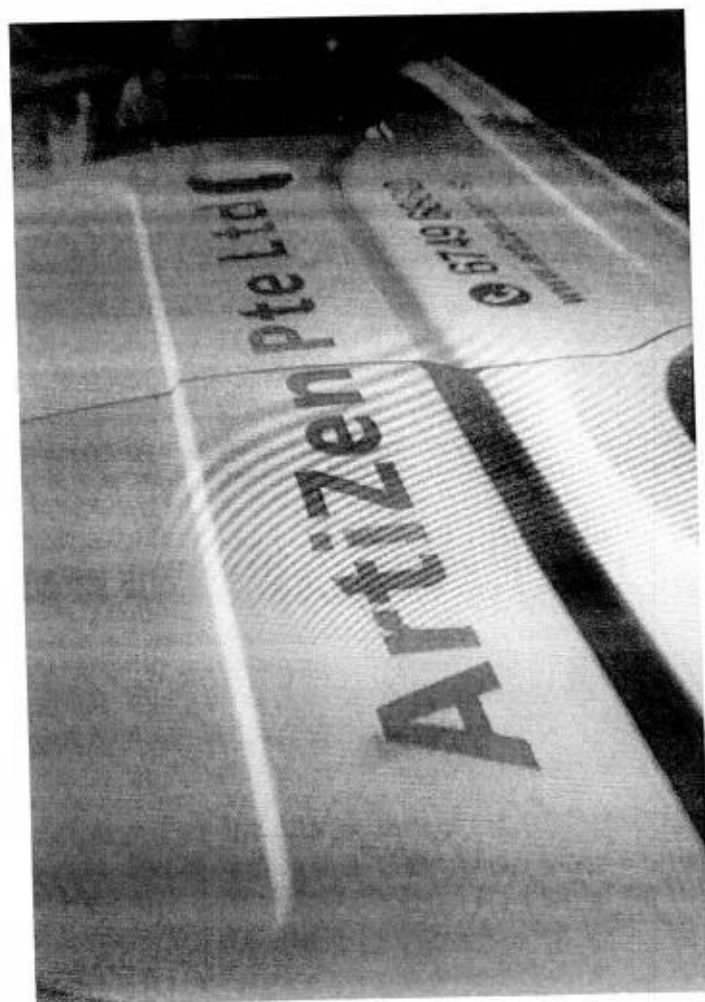
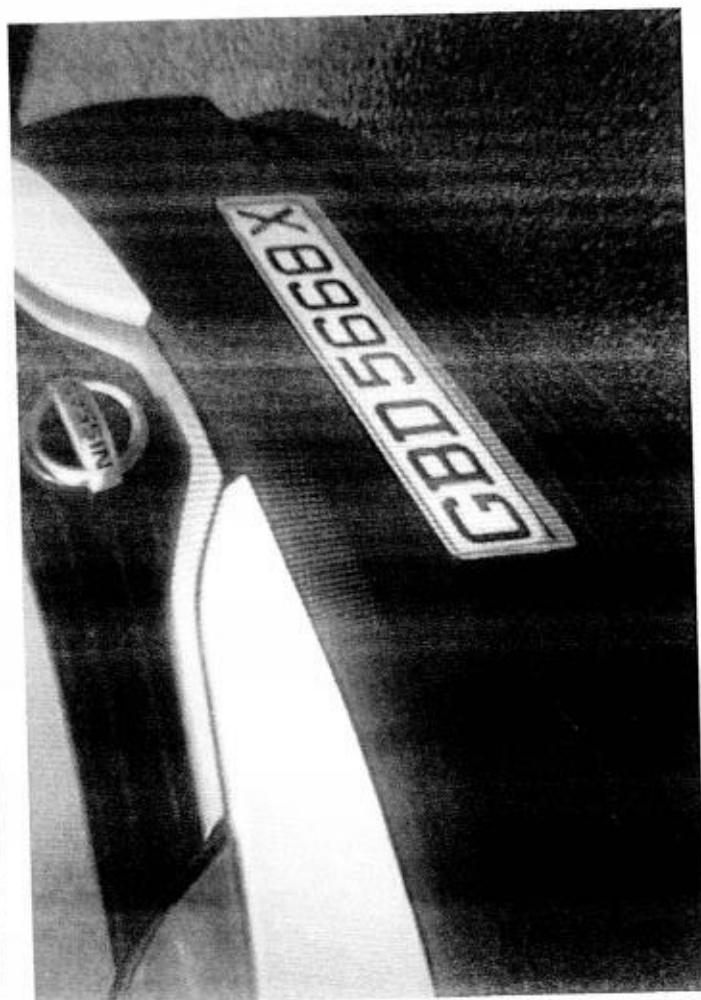
Remark: The veh had commenced its repair at the time of inspection.

Per
The U/C / Chassis frame / Body Structure affected due to collision.

Qty	Description of Parts	Condition	Estimate By Workshop (\$)	Our Adjusted (\$)
REPLACEMENT OF PARTS				
1	LICENCE LAMP GARNISH	CRACKED	100.00	100.00
1	REAR BUMPER	TO REPAIR SEE LABOUR	553.00	-
10	REAR BUMPER CLIP	NOT NECESSARY	22.00	-
	LESS 20% DISCOUNT		-135.00	-20.00
			540.00	80.00
NETT ITEMS				
1	REAR NO PLATE (N)	CRACKED	25.00	25.00
	LESS 10% DISCOUNT		-	-2.50
			25.00	22.50
SPECIAL NETT ITEMS				
1	REAR BUMPER RUBBER MAT (SN)	NOT NECESSARY	50.00	-
			50.00	-
LABOUR				
	PANEL BEATING.INCLUSIVE OF THE REPAIR OF REAR BUMPER.		400.00	200.00
	SPRAY PAINTING CHARGE.		300.00	200.00
	WIRING CHARGE.	NOT NECESSARY	50.00	-
	REMOVE/REFIX REVERSE SENSOR.	NOT NECESSARY	80.00	-
			830.00	400.00
GRAND TOTAL			1,445.00	502.50
RECOMMENDED COST OF LUMP SUM REPAIRS (TO ITS PRE-ACCIDENT CONDITION) (CONFIRMED)				400.00
