1. Policy Particulars :- THIRD PARTY CLAIM

Insured Veh.	SHB 8754A	Veh. Inspected	SHA 7643Z
Policy No.		Coverage (\$)	0.00
Claim No.	MT/1042124-002	Excess (\$)	0.00
Assign From		Assign Date	30/04/2019

ADJUSTMENT ON REPAIR COST FOR VEHICLE NO. SHA 7643Z

Report Ref No. NS/INC19007649/K1sd3n2

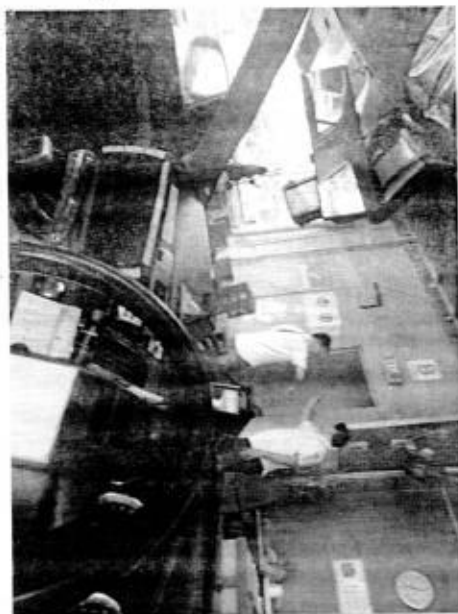
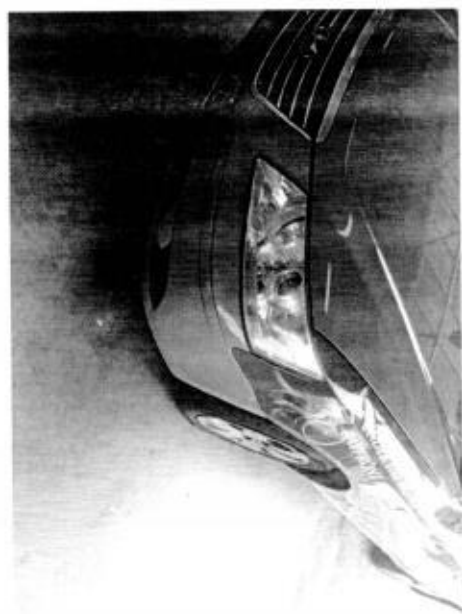
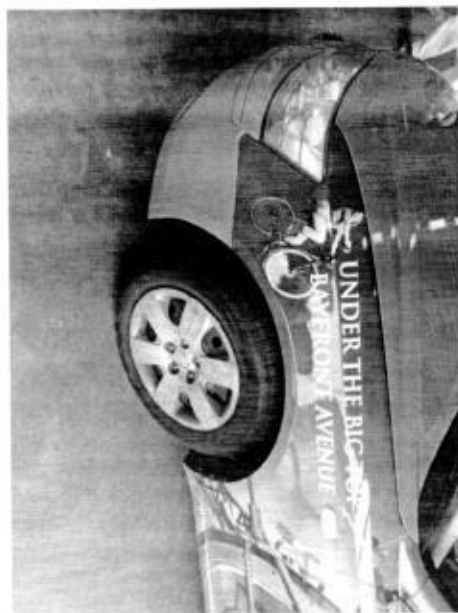
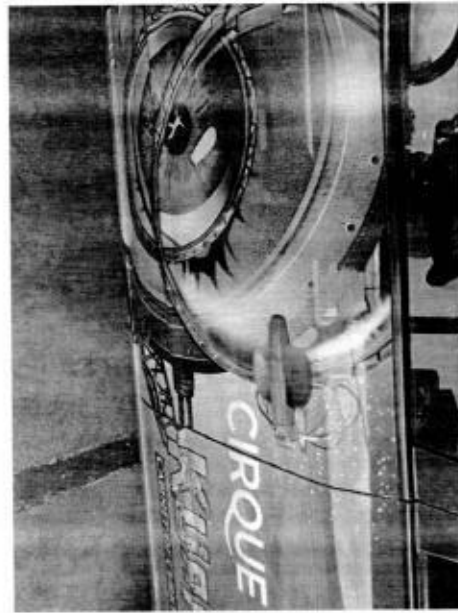
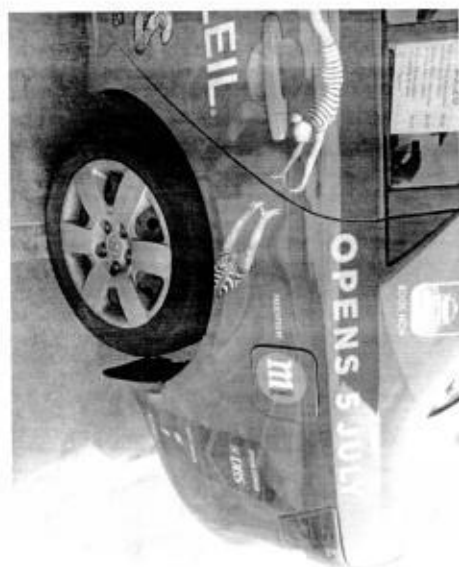
The U/C / Chassis frame / Body Structure affected due to collision.

THE VEHICLE SUSTAINED DAMAGES AT THE O/S FRONT PORTION.
DAMAGES SEE DETAILS.

Qty	Description of Parts	Condition	Estimate By Workshop (\$)	Our Adjusted (\$)
<u>REPLACEMENT OF PARTS</u>				
1	FRONT BUMPER COVER	DEFORMED	538.80	538.80
1	FRONT BUMPER BRACKET TOP (RH)	SERVICEABLE	22.40	-
1	FRONT BUMPER PROTECTOR (RH)	TO REPAIR SEE LABOUR	29.20	-
1	HEADLAMP (RH)	CRACKED	797.90	797.90
1	FRONT FENDER (RH)	BUCKLED	593.00	593.00
1	FRONT FENDER SHIELD (RH)	SERVICEABLE	86.00	-
1	FRONT FENDER RETAINER	SERVICEABLE	9.20	-
1	FRONT WHEEL HUB CAP (RH)	SERVICEABLE	145.00	-
	LESS 20% DISCOUNT		-444.30	-385.94
			1,777.20	1,543.76
<u>SPECIAL NETT ITEMS</u>				
1	FRONT FENDER ADVERTISEMENT LOGO (RH)(SN)	NECESSARY	100.00	100.00

100.00	100.00
<u>LABOUR</u>				
	PANEL BEATING.INCLUSIVE OF THE REPAIR OF FRONT BUMPER PROTECTOR (RH).		400.00	300.00
	SPRAY PAINTING CHARGE.		600.00	400.00
	TUFF KOTE.		50.00	30.00
	FRT WHEEL ALIGNMENT.	NOT NECESSARY	80.00	-
			1,130.00	730.00
GRAND TOTAL			3,007.20	2,373.76
RECOMMENDED COST OF LUMP SUM REPAIRS (TO ITS PRE-ACCIDENT CONDITION) (CONFIRMED)				1,900.00
