VEHICLE DAMAGE INSPECTION REPORT

Our File No: CS/TMI19007729/K1TD3Q2

Claimant Vehicle No : SHD6610J

Make & Model: HYUNDAI I40, 1.7 GDI (A)

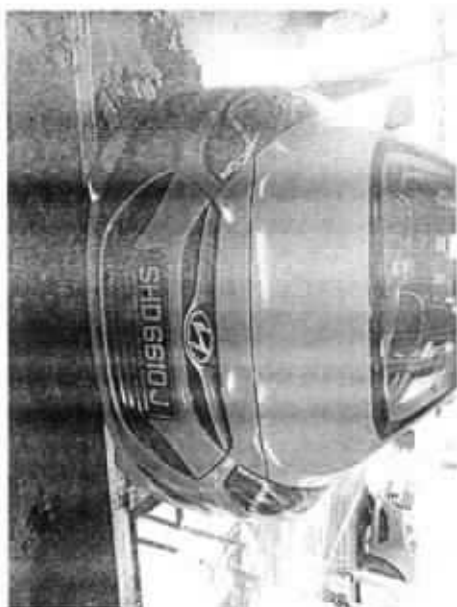
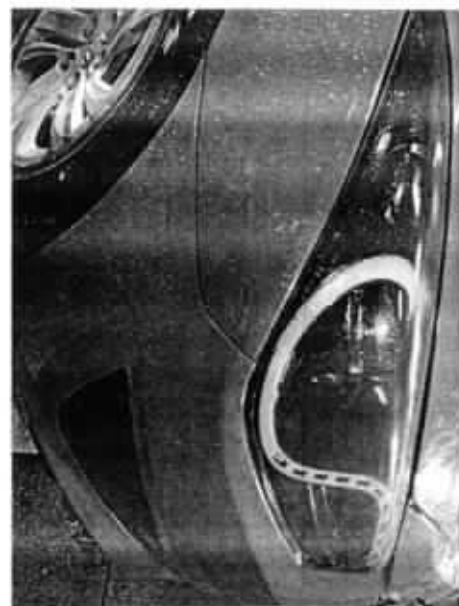
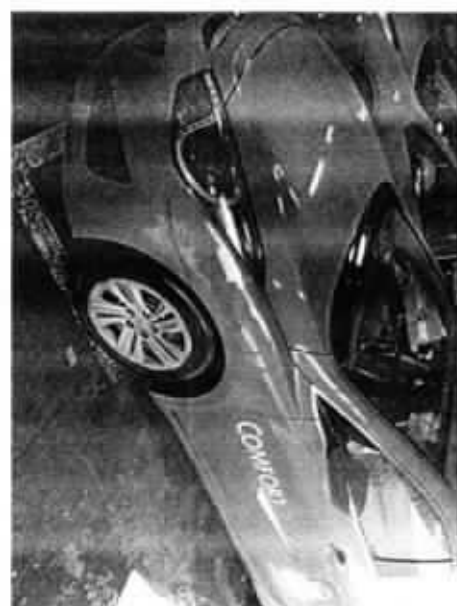
No.	Qty	Part No.	Particulars	Condition	Repairer's	Amount
1	1		*FRT BUMPER ASSY	Cut	544.50 FL	*544.50 FL
2	1		*FRT BUMPER GRILLE RH	Repair	41.60 FL	*- FL
3	1		*FRT BUMPER BRACKET TOP RH	Serviceable	22.40 FL	*- FL
4	1		*FRT BUMPER BRACKET RH	Serviceable	24.60 FL	*- FL
5	1		*HEADLAMP ASSY RH	Cracked	1,388.00 FL	*1,388.00 FL
6	1		*FRONT RH FENDER (NPA)	Repair	-	*- FL

No	Particulars	Lab.Type	Repairer's	Amount
<u>Labour Items</u>				
1	PANEL BEATING	New	400.00	200.00
2	SPRAYPAINT	New	600.00	400.00
3	TUFF KOTE	New	50.00	0.00
Gross Labour Cost (S\$)			1,050.00	600.00
