RE: ACCIDENT INVOLVING SKT 1452 L & GBG 4893 L ON 22.06.2018.

ACCIDENT DAMAGED VEHICLE INSPECTION REPORT (WITHOUT PREJUDICE)

Registration Number	:	SKT 1452 L	Mileage	:	56,422 km
Make & Model	:	Mitsubishi Outlander 2.4 CVT	Chassis Number	:	JMYXTGF3WFZ001970
Date of Registration	:	26 May 2015	Engine Number	:	4B12PL4690
Colour	:	Blue	Engine Capacity	:	2,360 cc

REPAIR DETAILS (SKT 1452 L)

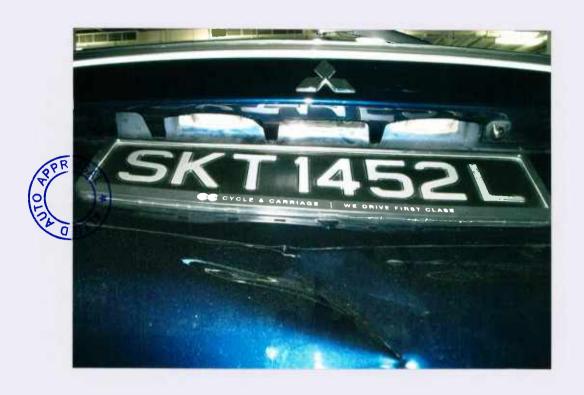
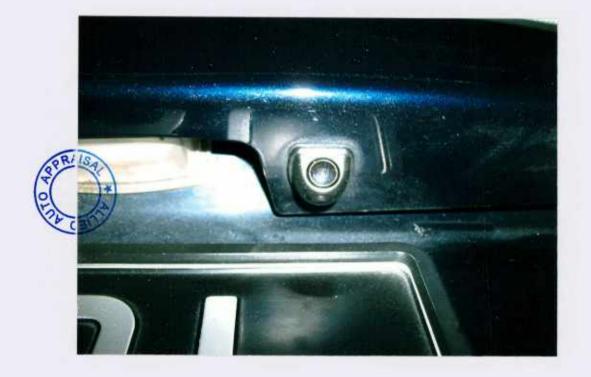
(5) POINT OF IMPACT

The impact of the collision has damaged/affected the tailgate, right rear combination lamp, rear end panel, rear bumper face and etc.

We have inspected thoroughly the actual damages found on the vehicle before we conclude as to whether the parts needed replacement or repairs. The estimated cost of repair submitted by the repairer is \$13,489.10. We have adjusted the cost to \$10,322.70 and recommend that the repairs to be taken on a lump sum basis of \$9,290.00. In our opinion, the damaged parts are consistent with that caused by the accident.
