# ***Injuries of the Thigh, Knee, and Ankle as Reconstructive Factors in Road Traffic Accidents***

*Grzegorz Teresiński, MD*

*Forensic Medicine of the Lower Extremity: Human Identification and Trauma Analysis of the Thigh, Leg, and Foot*

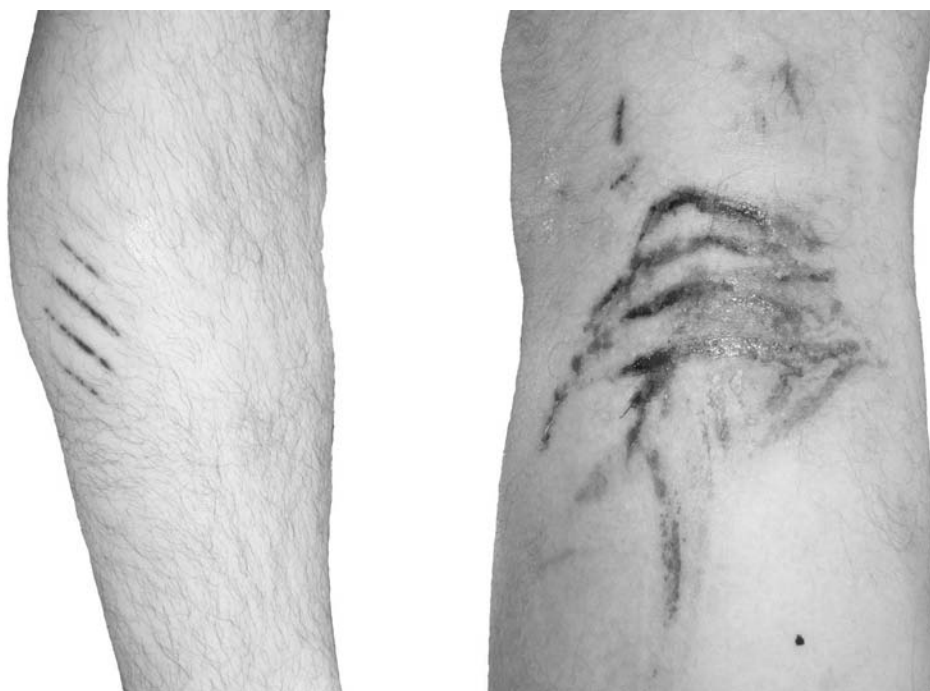
**Fig. 4.** Imprint injuries in the pedestrian victim.

Until the 1970s, the reconstruction of impact direction in erect-pedestrian hits was based on a search for visible external “imprint” injuries, i.e. a “stamp” of the car’s body elements on the victim’s body (Fig. 4), similar to those observed in nonbelted car

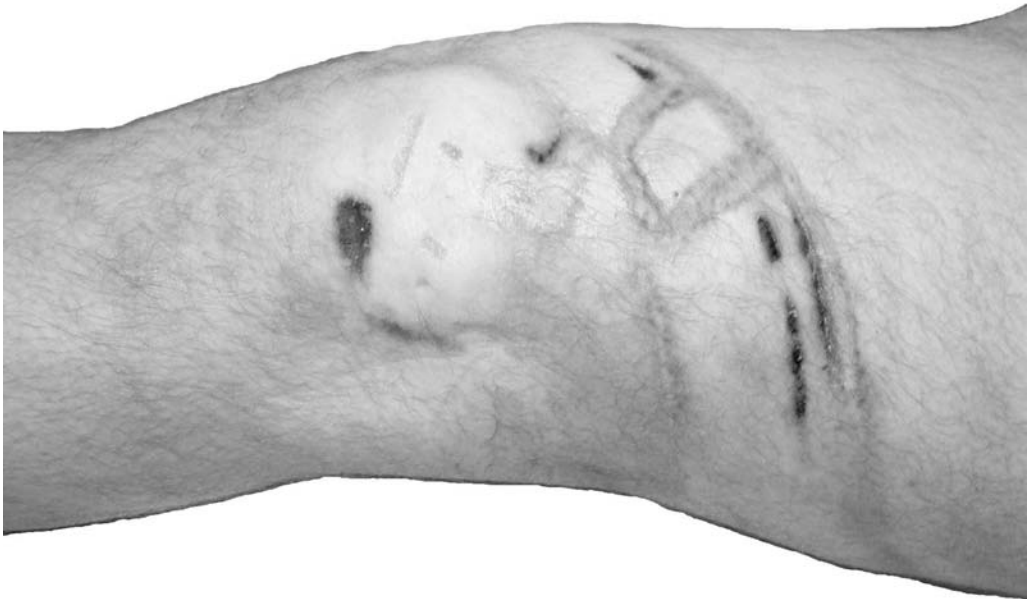
**Fig. 5.** External injuries from a dashboard.

occupants when a bent knee hits the instrument panel (Fig. 5) (3–5,9). However, the bodies (and interior) of modern vehicles are smooth, without edges or protruding elements and, thus, often do not cause any external injuries, even when internal injuries are extensive. Paint or dust chafing may be observed on the cloth of the trousers where the lower limbs contacted the car body (Fig. 6) (4,9a). At present, the majority of external injuries (wounds, excoriations) found on the body of the pedestrian (or cyclist) victim are caused by further phases of the accident—impact and rubbing against the rough road surface (Fig. 7), rather than contact with the car body (except for those caused by glass chips). Only some open-extremity fractures are relevant for evaluation of the mechanism of injury (9) because the bone fragments often pierce the skin on the side opposite the injury (Fig. 8). If the victim dies directly after being hit, skin bruises are rarely observed; such bruises may occur in survivors, however, even few days after the injury due to the spread of deep bruises (*see also* Subheading 2.2).

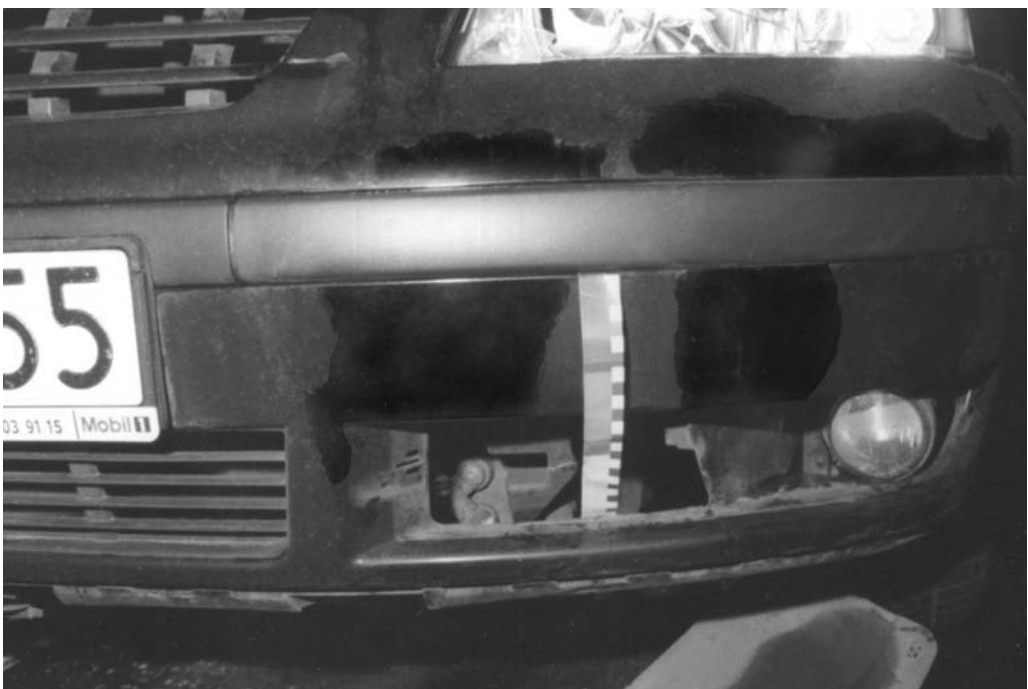
**Fig. 6.** Dust wipes on the bumper due to contact with both of the pedestrian's legs.

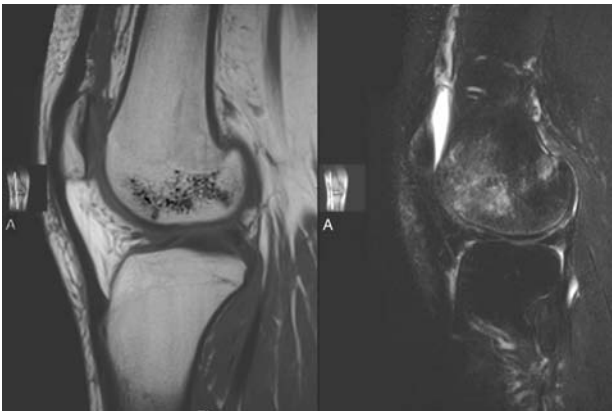
**Fig. 17.** Magnetic resonance images of a bruise in the lateral femoral condyle (image courtesy of Marzena Janczarek, MD, from the Department of Interventional Radiology and Neuroradiology, Medical University of Lublin, Poland).

trauma. To determine the mechanism of joint injury, it may be helpful to evaluate bone bruises; however, it is necessary to differentiate those caused by condylar compression from those resulting from tearing forces (22–25). The former are usually extensive, located in the central and deep condyle structures, and reach under the articular surfaces of femoral and tibial condyles. They may be accompanied by macroscopically visible fissures of fractures or compression of bone trabeculae, occasionally with an indented or lowered condyle. On the other hand, the bone bruises resulting from avulsion (Fig. 16) are usually small and located peripherally within the lateral parts of the condyles (i.e., in the region of capsule attachments and collateral ligaments) or under the intercondylar prominence (in crucial ligament avulsions). They may be accompanied by small bone fragments tearing off at the site of ligamentous attachments. In living persons, bone bruises can be detected by magnetic resonance imaging (Fig. 17) (22,23,25).

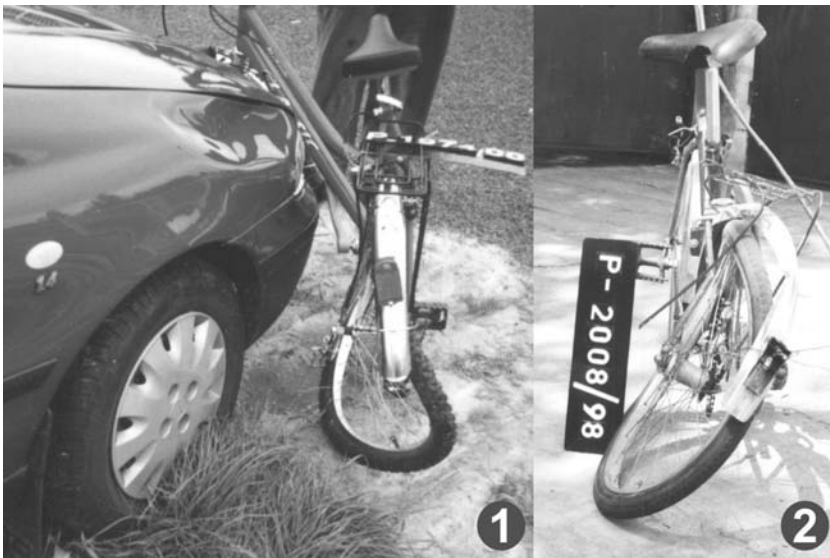
**Fig. 28.** The direction of rotation of the saddle in car-to-bicycle collisions in the left oblique hit (1) and left perpendicular hit (2).
