To Inspect Vehicle No: SKH 7658J

Make: Mercedes Benz E200 cc. 1796

PRE-REPAIR INSPECTION - ACCIDENT INVOLVING OUR INSURED VEHIC...

VEHICLE DAMAGE INSPECTION REPORT

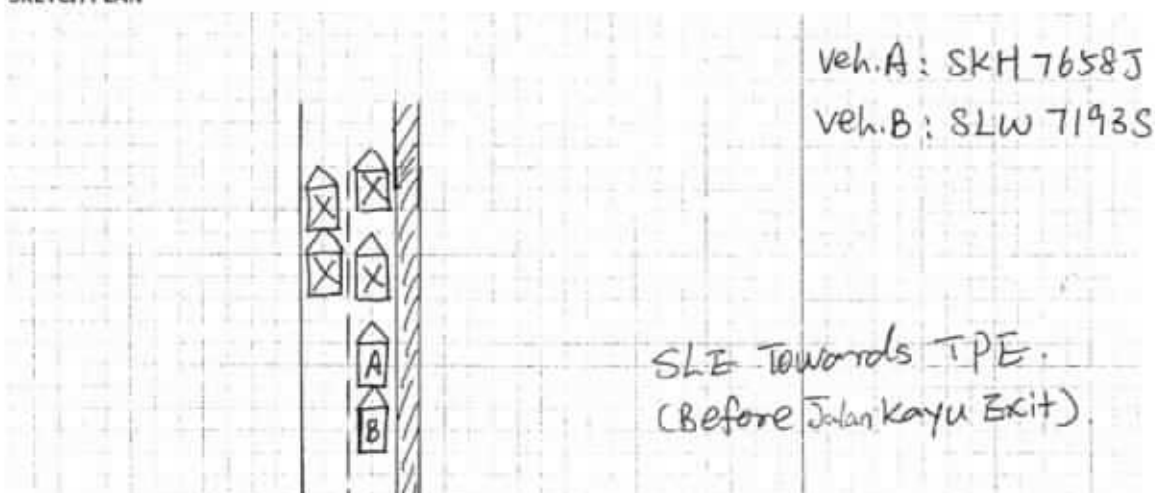
SKETCH PLAN

DESCRIBE CIRCUMSTANCES OF THE ACCIDENT

On the said date & time of accident, I was driving my vehicle (A) (SKH 76585) along SLE towards TPE (Before Jalan Kayu Exit).
Vehicle ahead slow and I followed too. Vehicle (B) (SLW 71935) unable to brake in time and collided onto my vehicle rear portion. I will go to see doctor if I feel any uncomfortable after this. My vehicle did install car camera recorder and I willing to provide my video footage for my accident claim purpose.
