VEHICLE DAMAGE INSPECTION REPORT

Our File No: CC3/TMI19008484/K1TD3E2

Claimant Vehicle No : SHD3671C

Make & Model: TOYOTA PRIUS, 1.5 HYBRID (A)

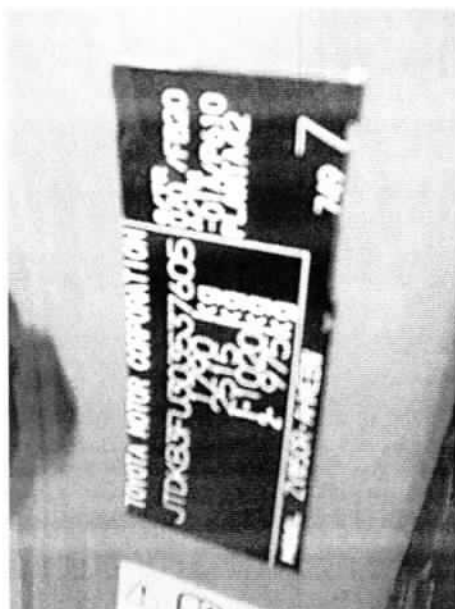
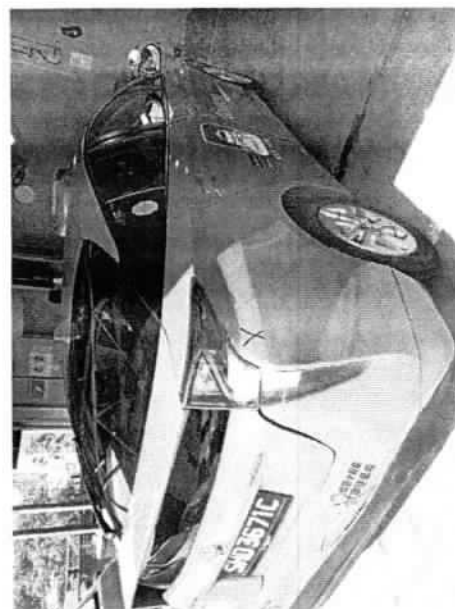
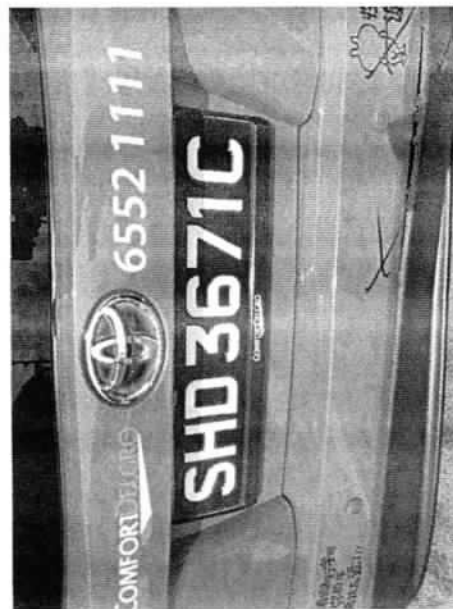
Remark: The veh had commenced its
 repair at the time of inspection.

Ver: 1/3 **SHD 3671C** (Reg: **18 Nov 2016**)
 Type: M.Car / M.Cycle / Bus / Van / Lorry / Taxi / Prime Mover /
 Truck / Trailer or
 Make: **Toyota Prius** c.c. **1798**
 Colour: **Blue** A/C: **Ins** / Std / NI / NA
 Sp. Reading: **135536** T/Radio: **Ins** / Std / NI / NA
 Eng/No: _____
 C/No: **57PKB3F4303537605**
 Gen. Cond: Good / **6** / Poor / Burnt
 Steering: Inor **6** / Jammed / Leaked / Burnt or
 Brake: Inor **6** / Jammed / Leaked / Burnt or
 Modi: Nil / S/Rim / STD **6** Rim or
 Tyre Size: F: **195/65R15**
 R: _____
 BS / DUN / EXNOVA / GY / FS / LIZA / MIC / OHTSU / PIR / SUMI /
 TOYO/YOKO or **Mich**
 Front: _____ Rear: _____
 R/Bal. **7** mm R/Bal. **7** mm
 L/Bal. **7** mm L/Bal. **1** mm
 D.O.A. **13/5/19** D.O.I. **13/5/19**
 Survey held at **CDDE (Logan)**
 Des. of Damages: Frl / Rear / O/S / N/S / U/C / Rooftop or
Rear o/s
 The U/C / Chassis frame / Body Structure affected due to collision.

PARTS DESCRIPTION	QTY	UNIT PRICE	AMOUNT
REAR BUMPER			\$ 458.60
REAR BUMPER RE-INFORCEMENT			\$ 318.80
REAR BUMPER UNDER COVER			\$ 552.60
REAR BUMPER CLIPS			\$ 22.00
SUB TOTAL			\$ 1,352.00
LESS 25%			\$ 338.00
DISCOUNTED TOTAL			\$ 1,014.00
REAR BUMPER REVERSE SENSOR			\$ 135.70
LABOUR CHARGE			
Panel Beating			\$ 400.00
Spray Painting Charge			\$ 300.00
Wiring Charge			\$ 30.00
Remove/Refix Reverse Sensor			\$ 80.00
Minimum fee			\$ 10.00
TOTAL LABOUR			\$ 810.00
ESTIMATE TOTAL			\$ 1,959.70
<p>Kahm 14/16/</p> <p>13/5/19 1515h</p> <p>2h,</p> <p>PIP</p> <p>Before Paint photo</p>

No.	Qty	Part No.	Particulars	Condition	Repairer's	Amount
1	1		*REAR BUMPER	Deformed	458.60 FL	*458.60 FL
2	1		*REAR BUMPER RE-INFORCEMENT	Bent	318.80 FL	*318.80 FL
3	1		*REAR BUMPER UNDER COVER	Cracked	552.60 FL	*552.60 FL
4	1		*REAR BUMPER CLIPS	Necessary	22.00 FL	*22.00 FL
5	1		*REAR BUMPER REVERSE SENSOR	Shorted	135.70 FS	*135.70 FS
					Sub Total (S\$)	1,487.70
					- List Item Discount on L Items 25.00/25.00% (S\$)	338.00
					Total Parts (S\$)	1,149.70
