VEHICLE DAMAGE INSPECTION REPORT

Our File No: CS/CTI19008875/K1TD3E2

Reg No: **SBS6527J**

Make & Model: MERCEDES-BENZ CITARO O530, 6.4 L AT TURBO ABS (A) Engine No: 902926C1071134

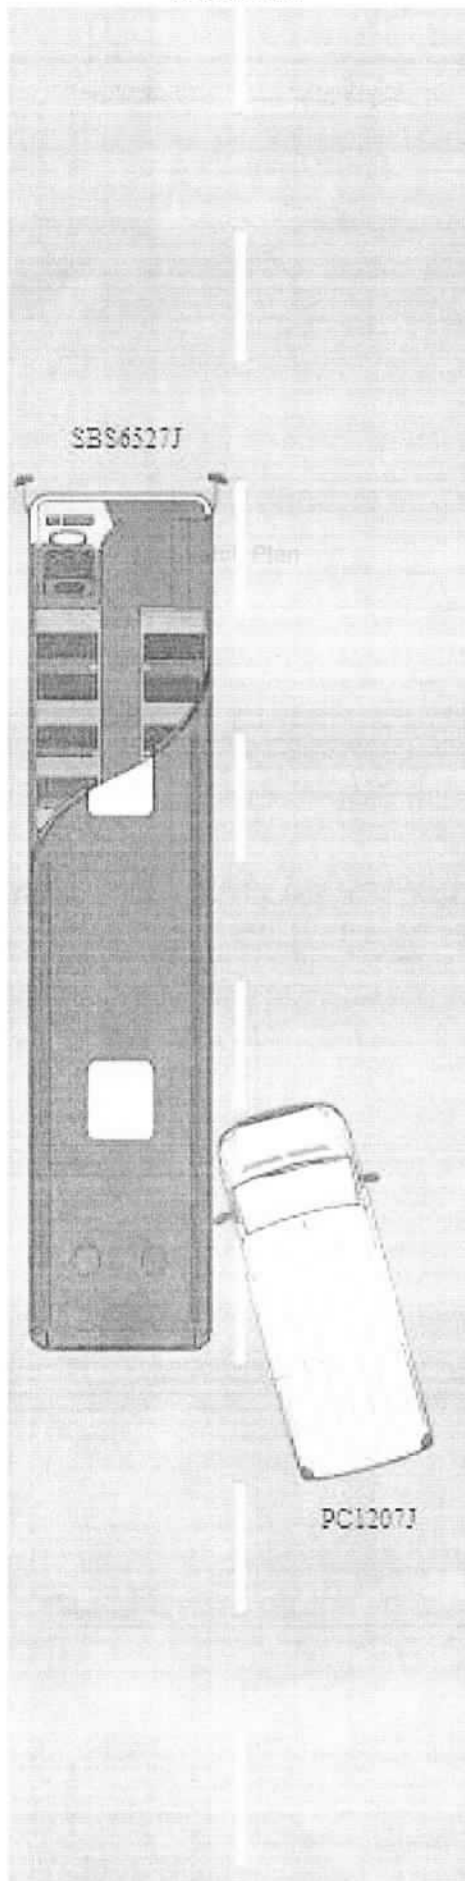
Sketch Plan

WHILST I WAS TRAVELLING OFF-SERVICE ON MY WAY TOWARDS P'GGOL INT @ P'GGOL PL VIA TPE, A WHITE GOLDEN DRAGON MINI BUS THAT WAS TRYING TO OVERTAKE MY BUS FROM THE ADJACENT LANE SKIDDED & COLLIDED ON TO THE REAR RIGHT WINDOW GLASS & BODY PANEL OF MY BUS
