VEHICLE INSPECTION REPORT

Reg No: SLA 7700 B
Year: 2011
Make & Model: BMW 523i
Colour: White

VEHICLE DAMAGE INSPECTION REPORT

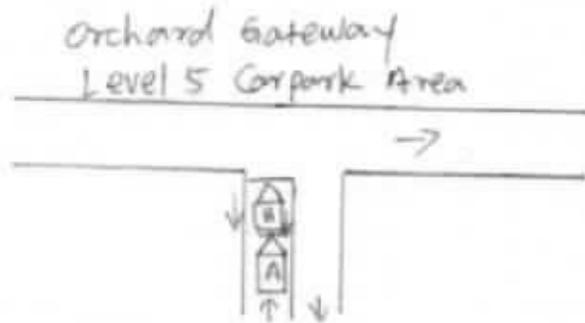
SKETCH PLAN

Veh. A: SLK 77005

Veh. B: SLK 78866

On the said date & time of accident, I was driving my vehicle (A) (SLK 77005) along Orchard Gateway Level 5 Carpark Area. Vehicle (B) (SLK 78866) in front of me slow down and stopped and I follow to stopped. Suddenly vehicle (B) reverse and collided into my vehicle front portion.

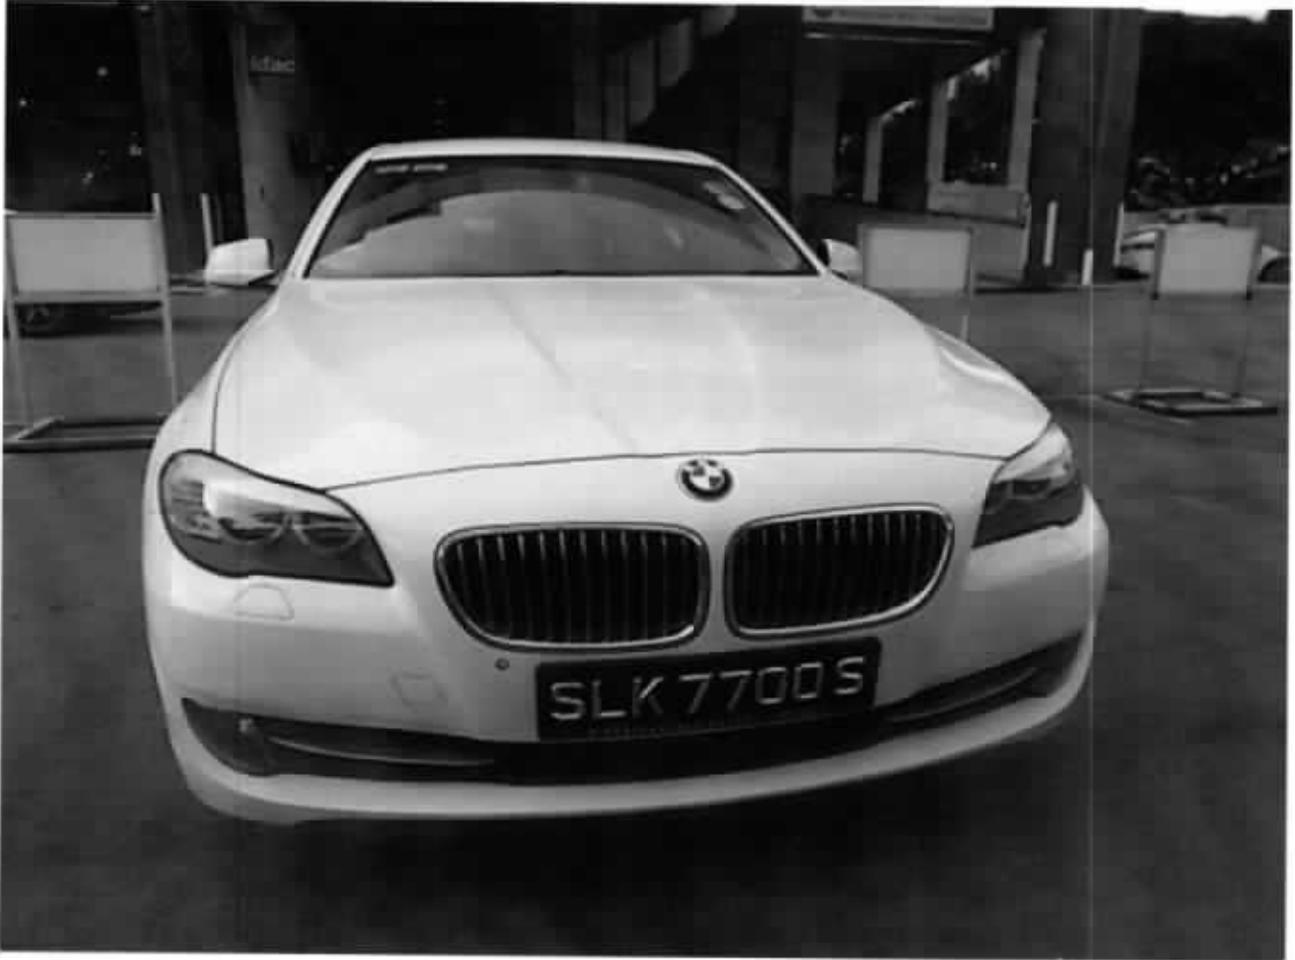
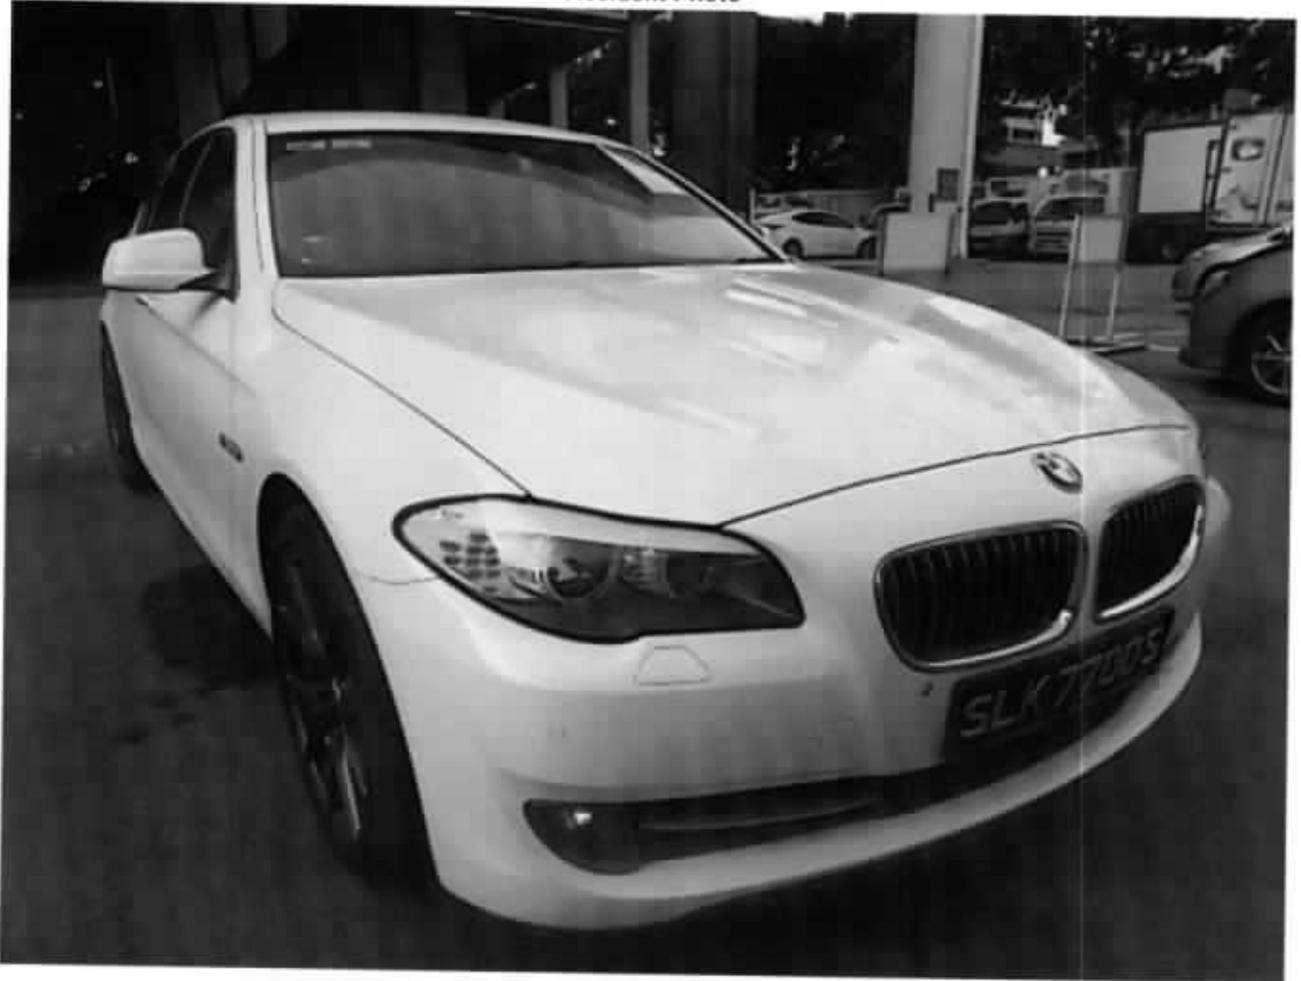
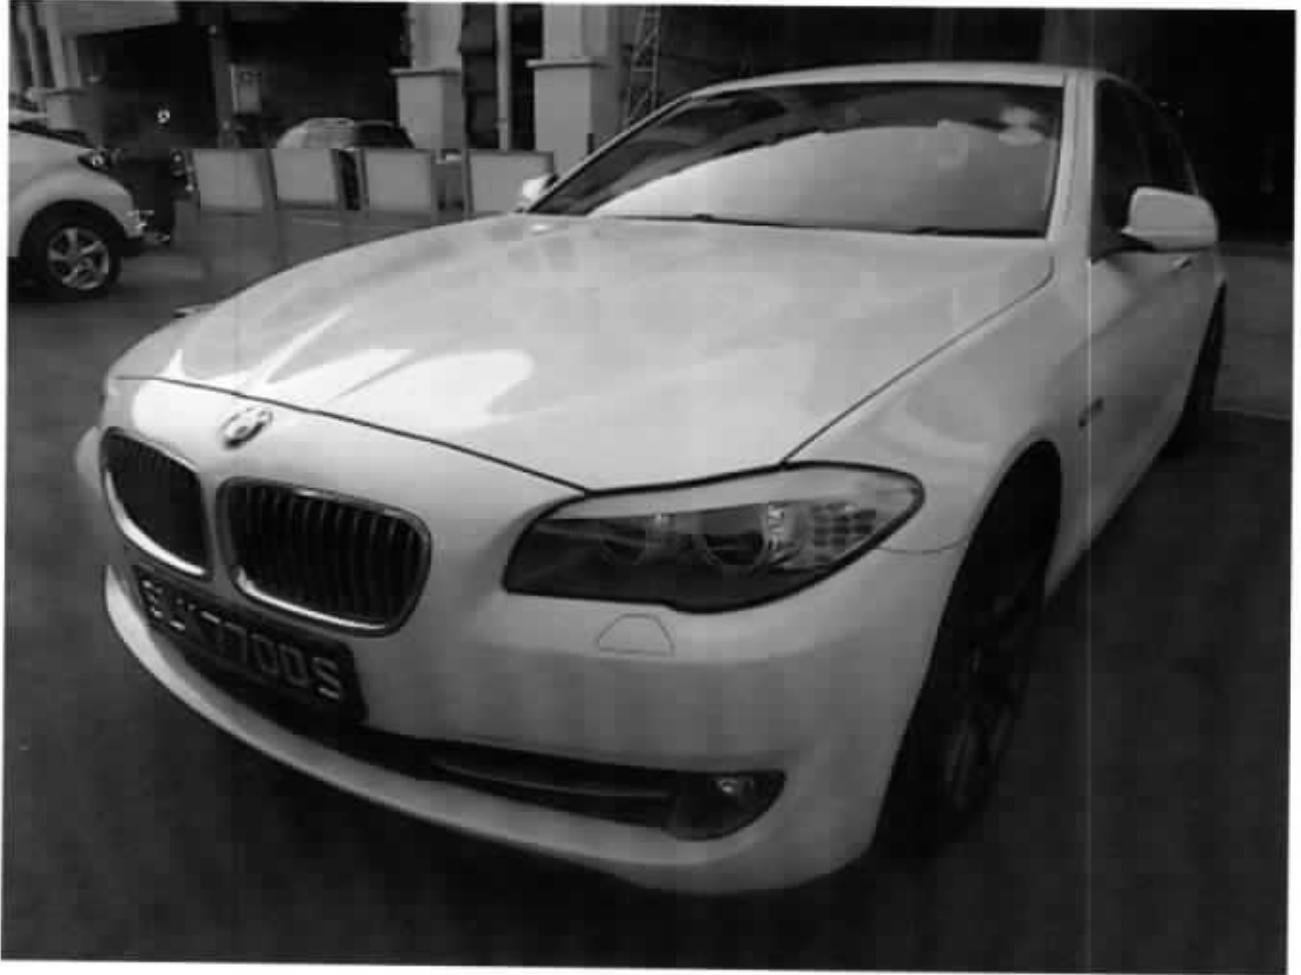
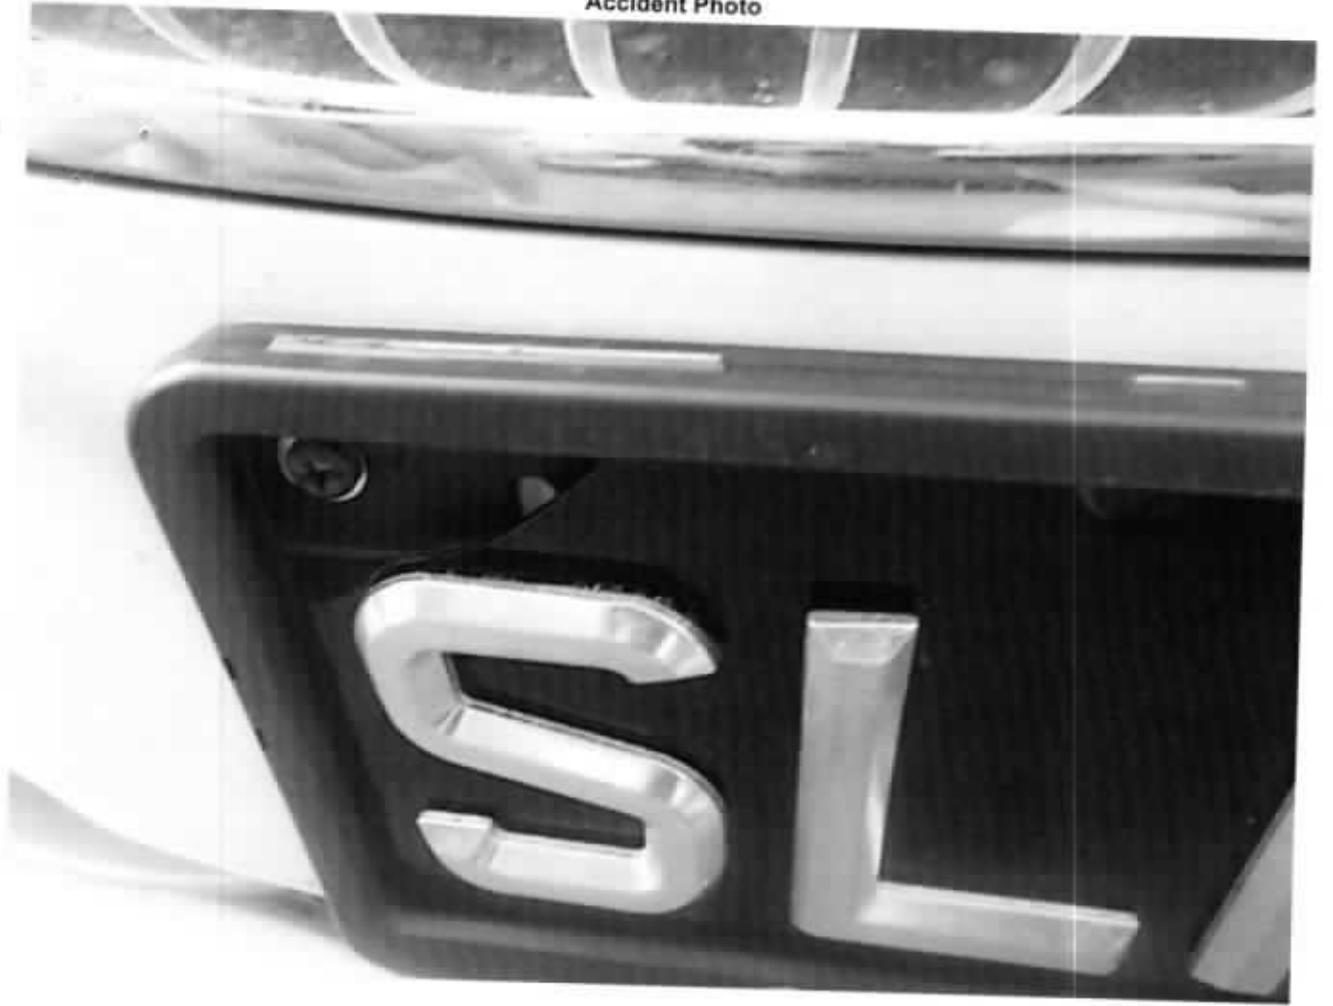
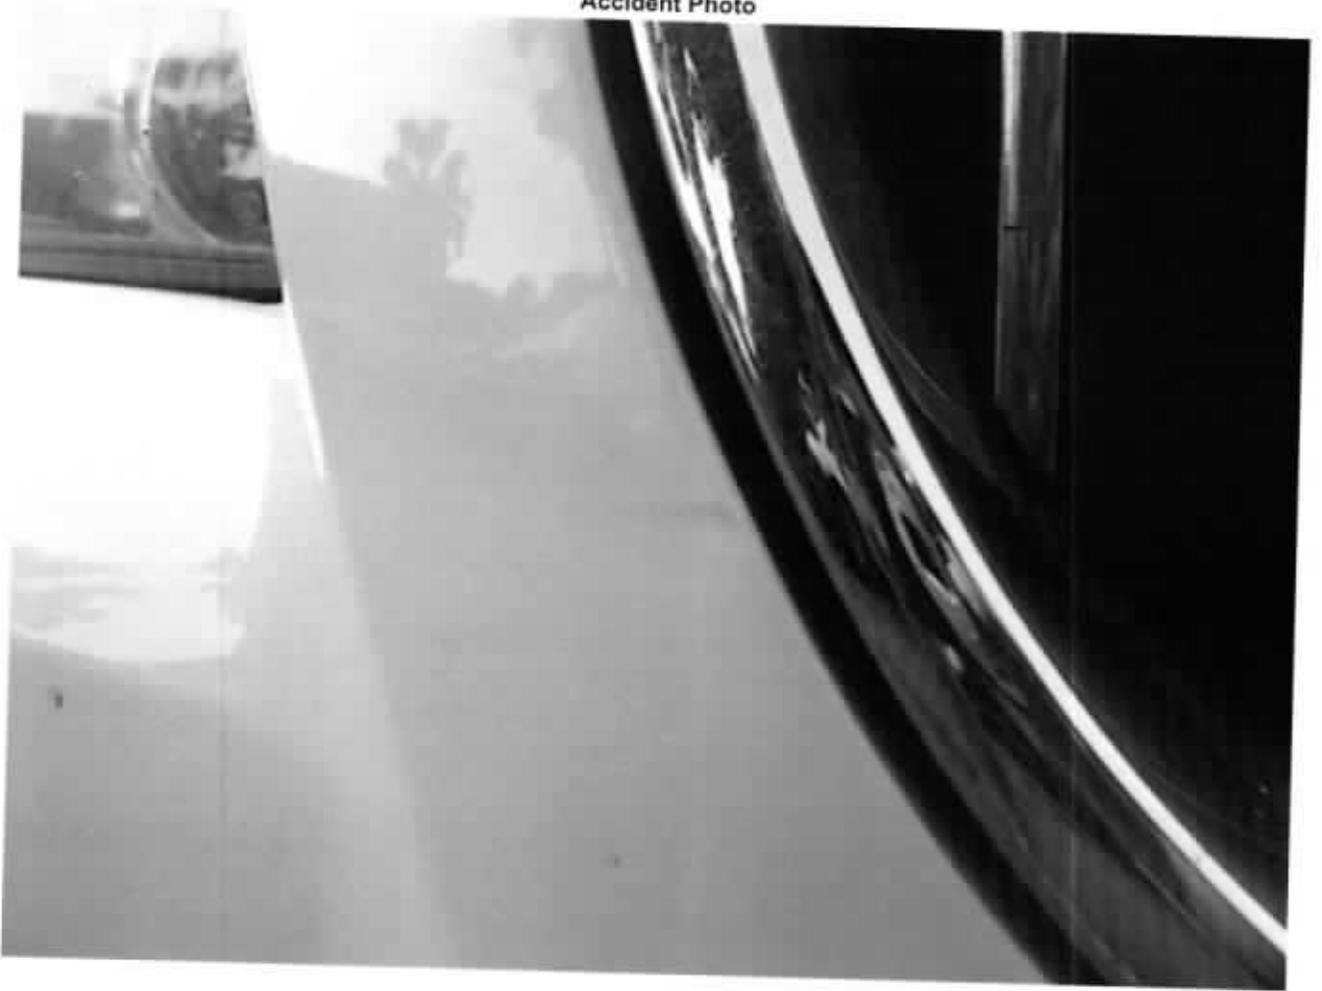
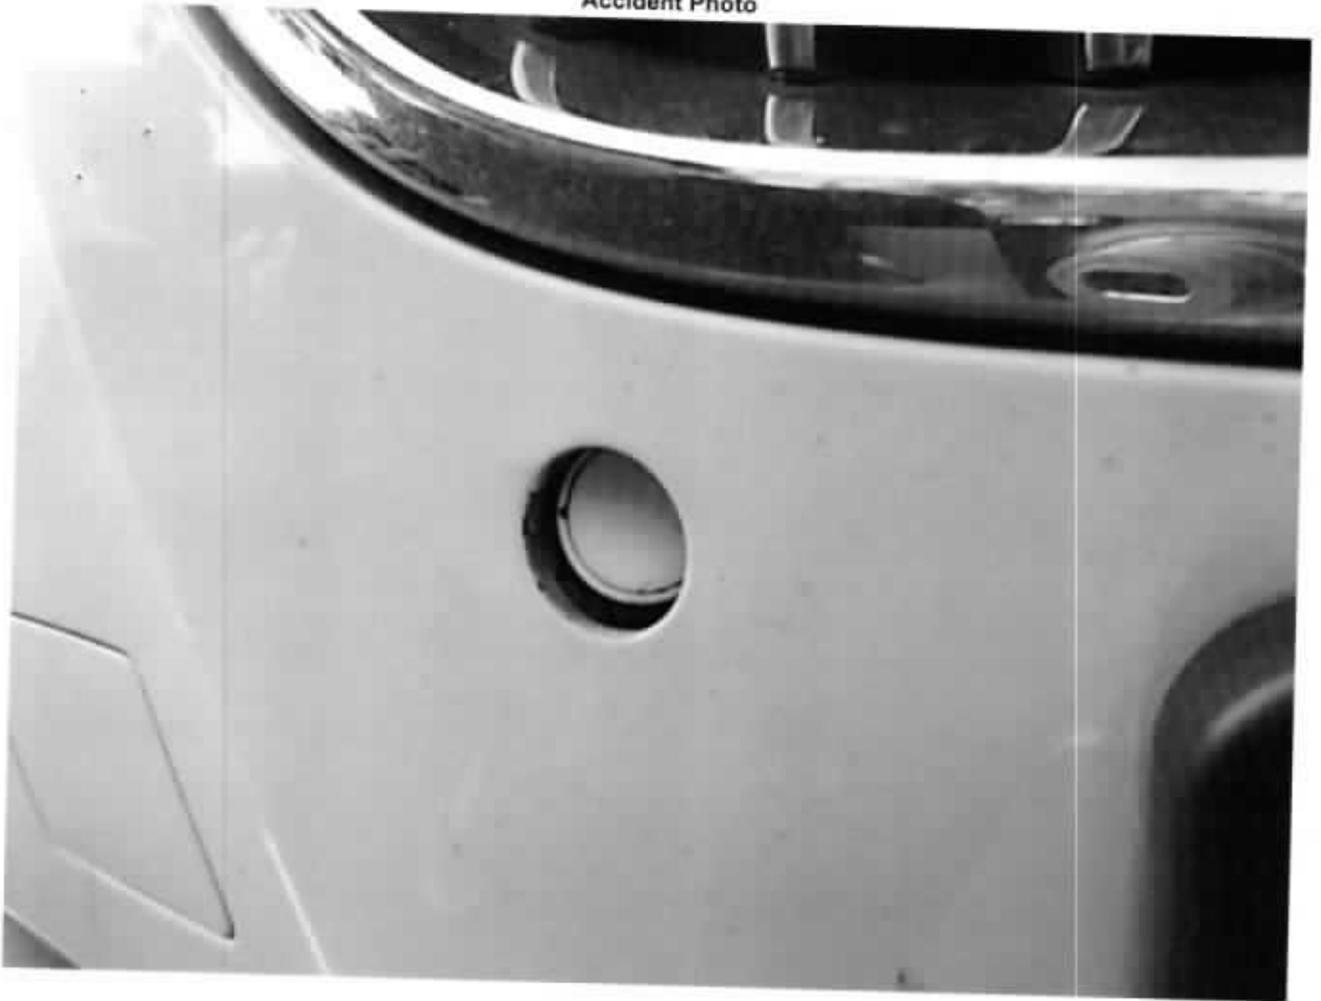
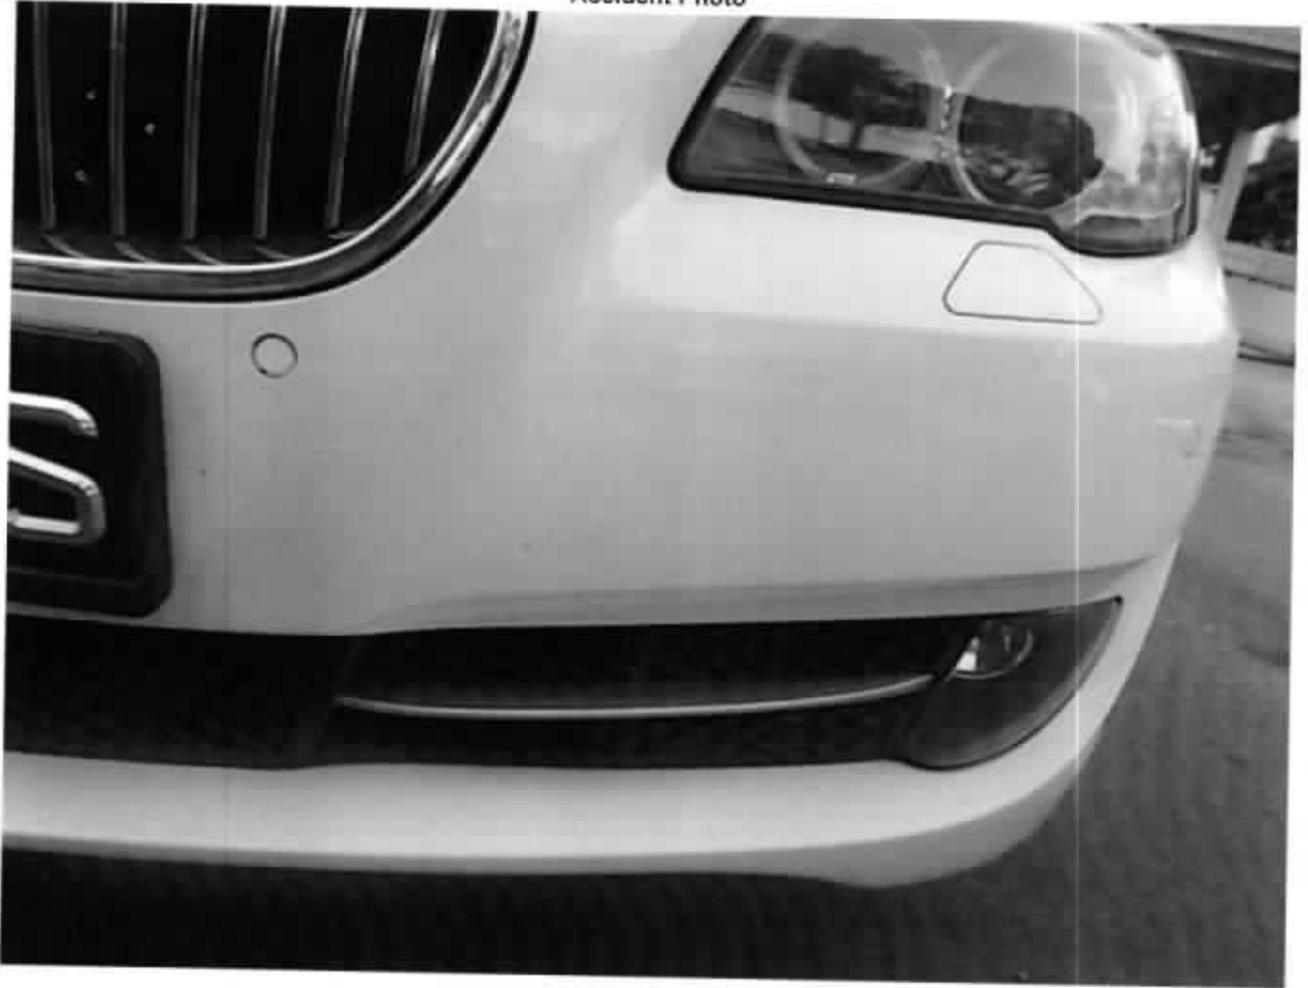
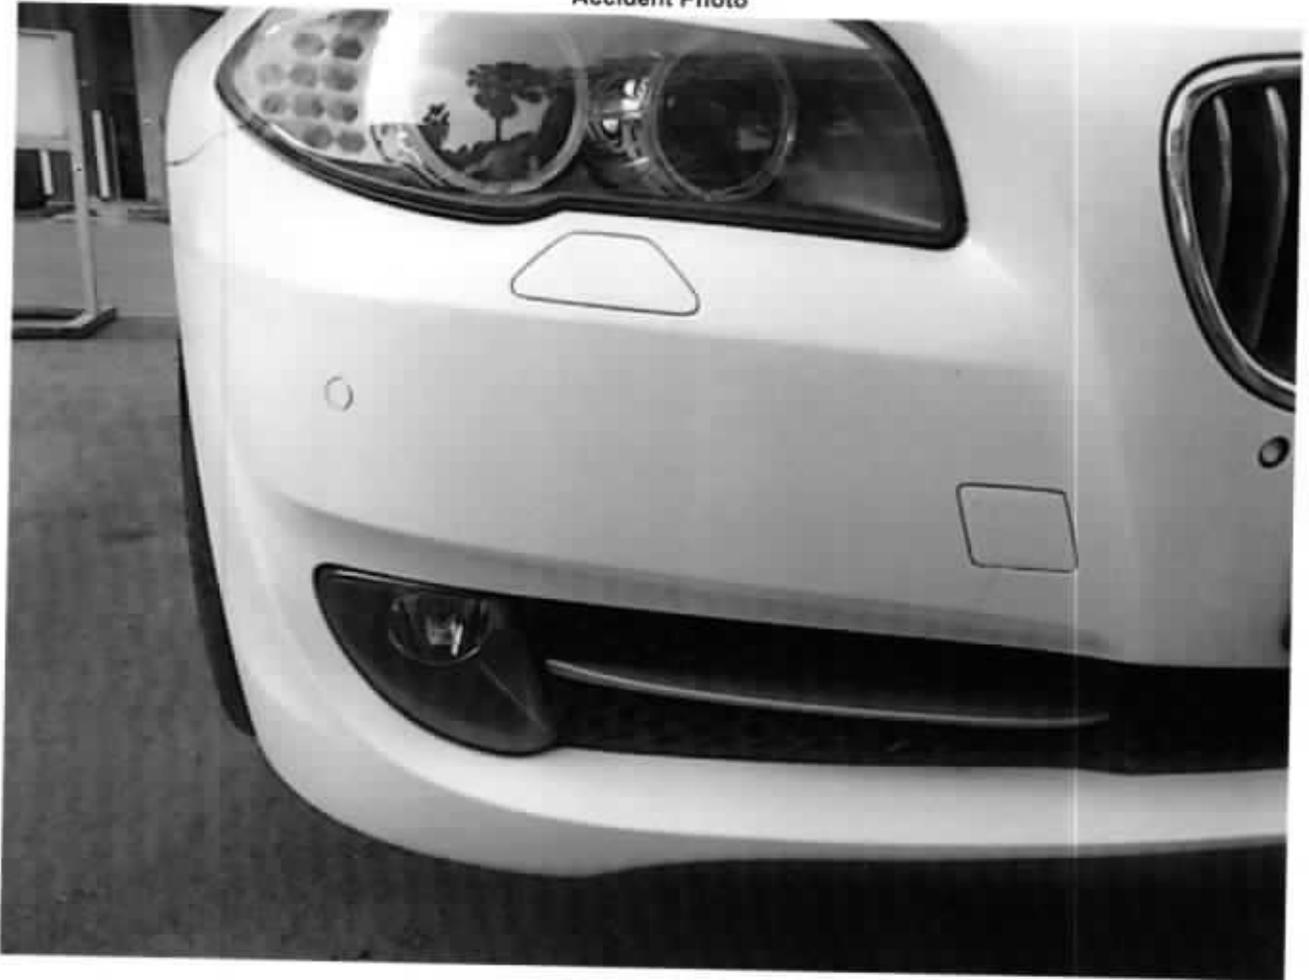
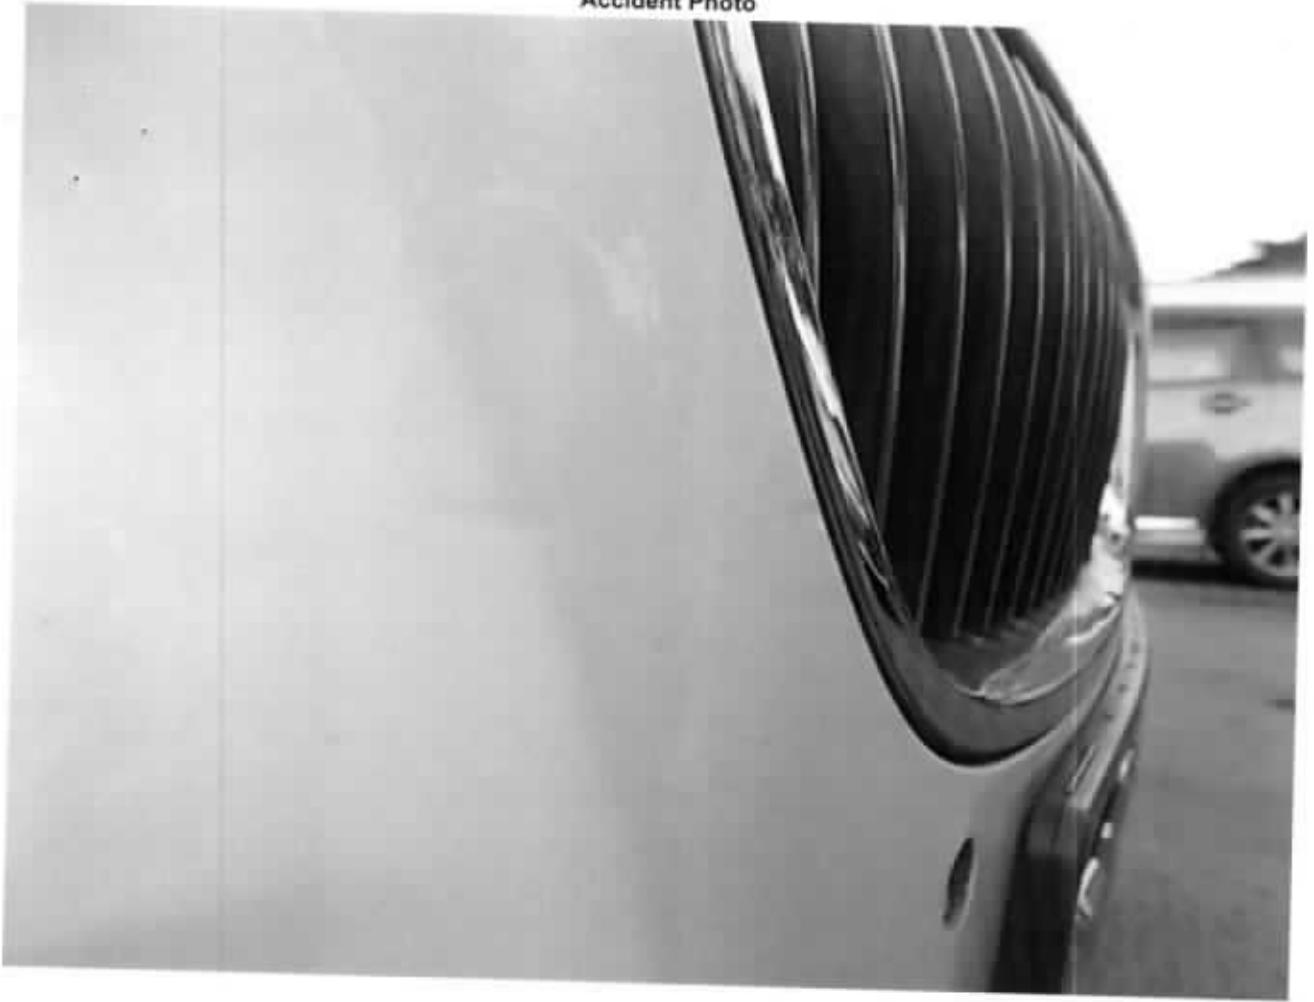
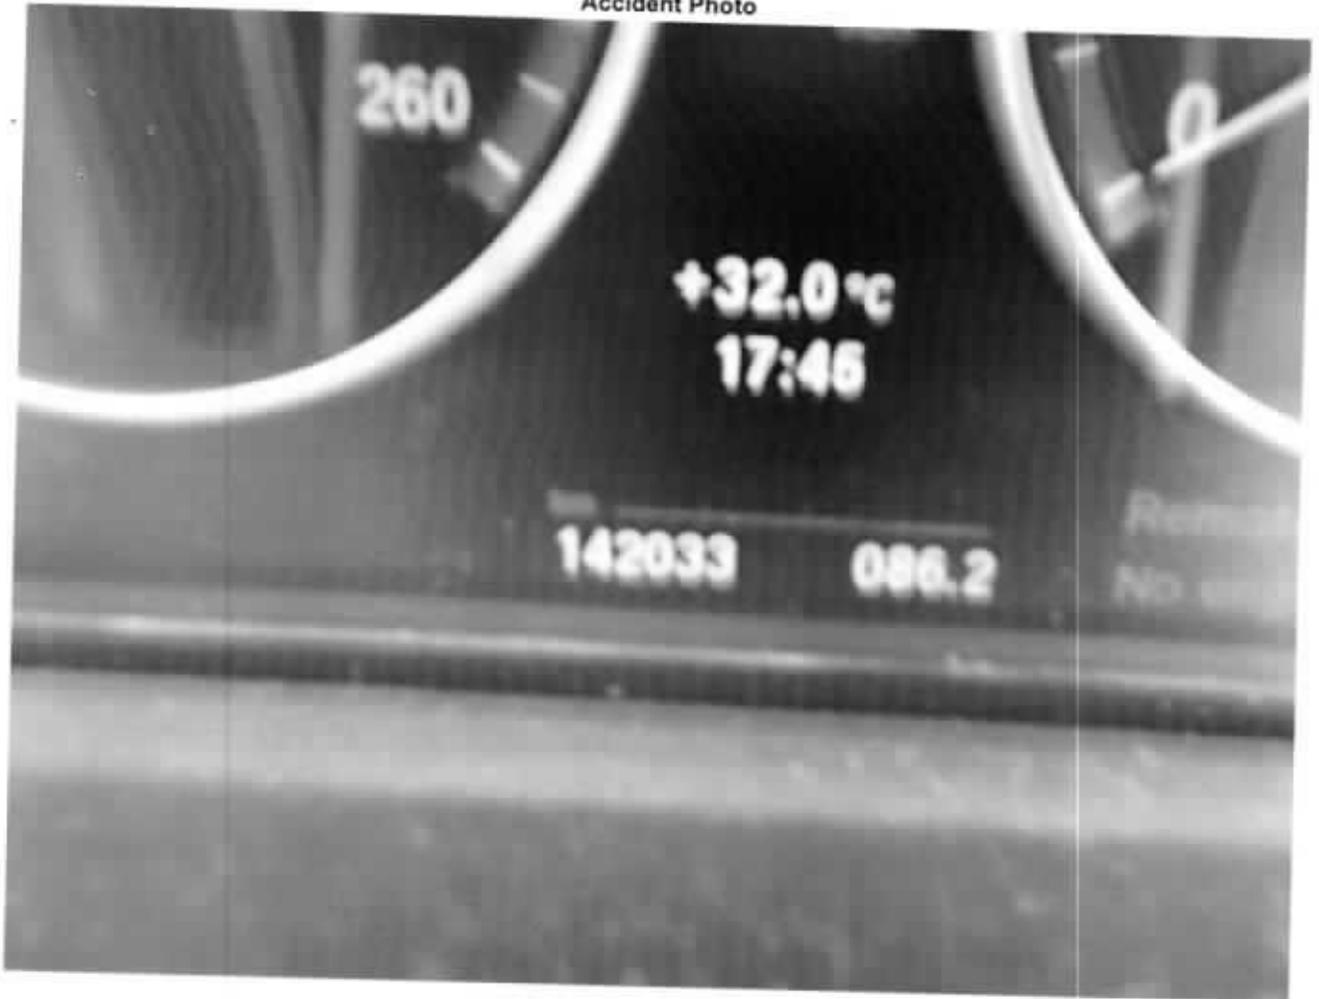
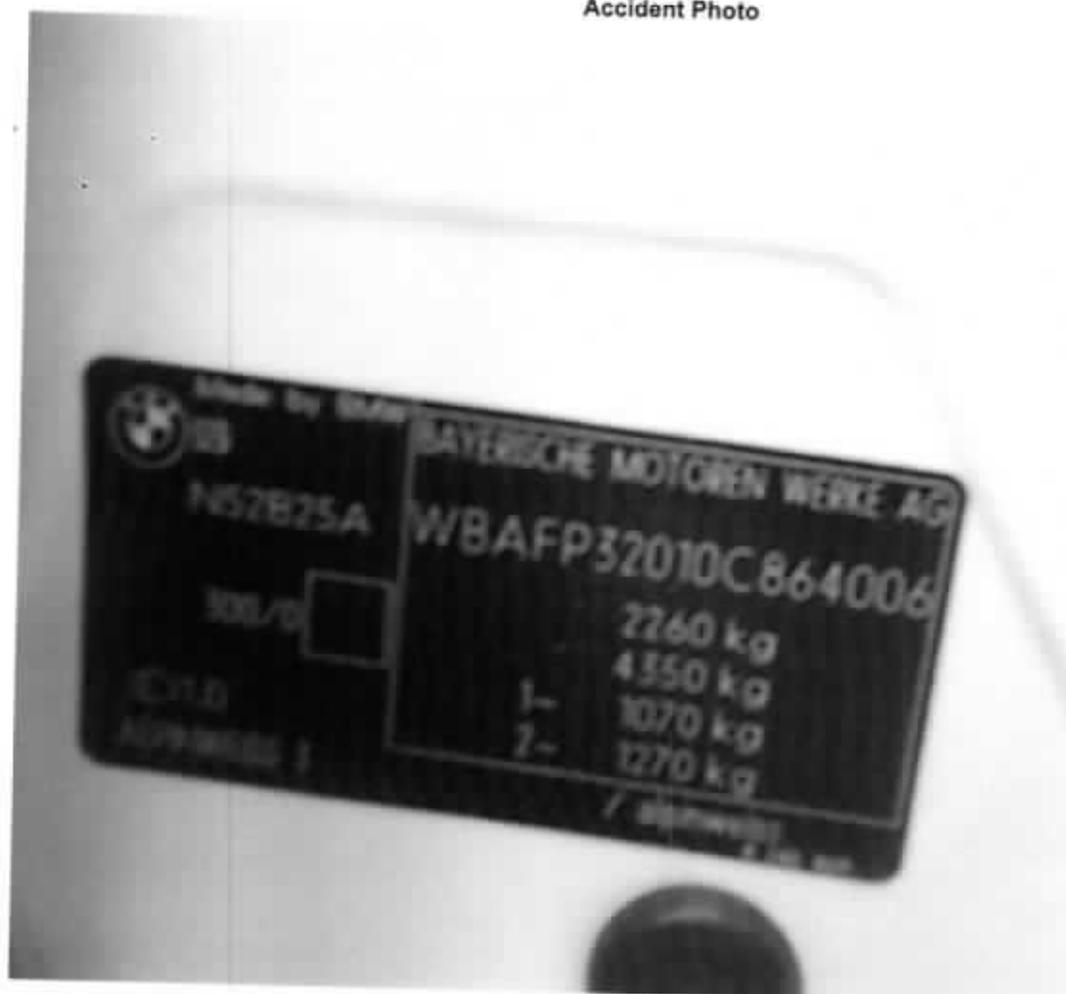
The above vehicle sustained damaged were front o/s & n/s chassis frame - buckled,
front o/s & n/s chassis frame cracked - bent.

Replaces of Parts	Conditions	Repairs Est.	Our Recommendation
<u>To Supply :-</u>			
1 pc Front Bumper	Buckled/Cracked	\$ 1,200.00	\$ 1,200.00
10 pcs Front Bumper Clips	Necessary	60.00	60.00
1 pc Front Bumper Reinforcement	Bent	708.00	708.00 X
1 pc Front Bumper Insulator	Cracked	160.00	160.00
1 pc Front Bumper Tow Cover	Cracked	29.00	29.00 X
1 pc Front Bumper o/s Parking Sensor	Cracked	380.00	380.00
4 pcs Front Bumper o/s Parking Sensor holder	Cracked	112.00	112.00
1 pc Front Bumper o/s Parking Sensor Wire	Torn	185.00	185.00
2 pcs Front Grille	Cracked	176.00	176.00
2 pcs Front Grille Garnish	Cracked	66.00	66.00
1 pc Front Support Panel Grille Garnish (Centre)	Cracked	125.00	125.00
1 pc Front o/s Head-Lamp	Cracked	2,302.00	2,302.00
1 pc Front o/s Head-Lamp Bracket (Lower)	Cracked	200.00	200.00
1 pc Front Air Baffle (Upper)	Cracked	105.00	105.00
1 pc Front Air Baffle (Lower)	Cracked	146.00	146.00
		\$ 3,954.00	\$ 3,954.00

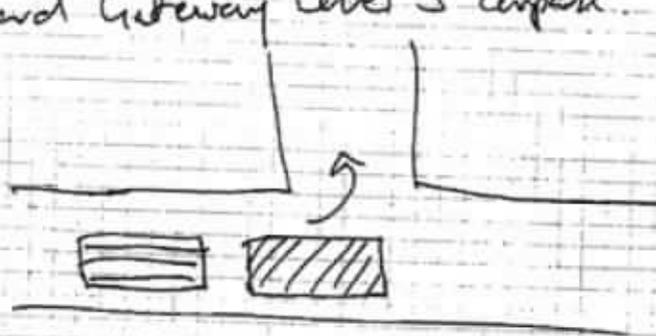
SKETCH PLAN

Orchard Gateway level 5 carpark.
