NS/INC19009109/Rev302

**TP Claims against NTUC Income: Follow-Through Survey**

Code: INC4	
<b>1. Policy Particulars :- THIRD PARTY CLAIM</b>			
Insured Veh.	SKF 328T	Veh. Inspected	SHC 4628C
Policy No.	5100087942-01	Coverage (\$)	0.00
Claim No.	MT/1052657-001	Excess (\$)	0.00
Assign From		Assign Date	22/05/2019
<b>2. Vehicle Particulars &amp; Condition</b>			
Make & Model	TOYOTA PRIUS	c.c	1798
Engine No.	HIDDEN	Year of Reg.	2014
Chassis No.	JTDKN36U405748033	Colour	MAROON
Odometer	511976	Steering	IN ORDER
Brakes	IN ORDER	Modification	STANDARD ALLOY RIM
General	FAIR		
<b>3. Conditions of Tyres</b>			
	Size	Make	Balance
R/H Front Tyre	195/65 R15	NEUTON	5 mm
L/H Front Tyre	195/65 R15	NEUTON	5 mm
R/H Rear Tyre	195/65 R15	NEUTON	5 mm
L/H Rear Tyre	195/65 R15	NEUTON	5 mm
<b>4. Description of Damages</b>			
THE VEHICLE SUSTAINED DAMAGES AT THE O/S FRONT PORTION. DAMAGES SEE DETAILS.

## ADJUSTMENT ON REPAIR COST FOR VEHICLE NO. SHC 4628C

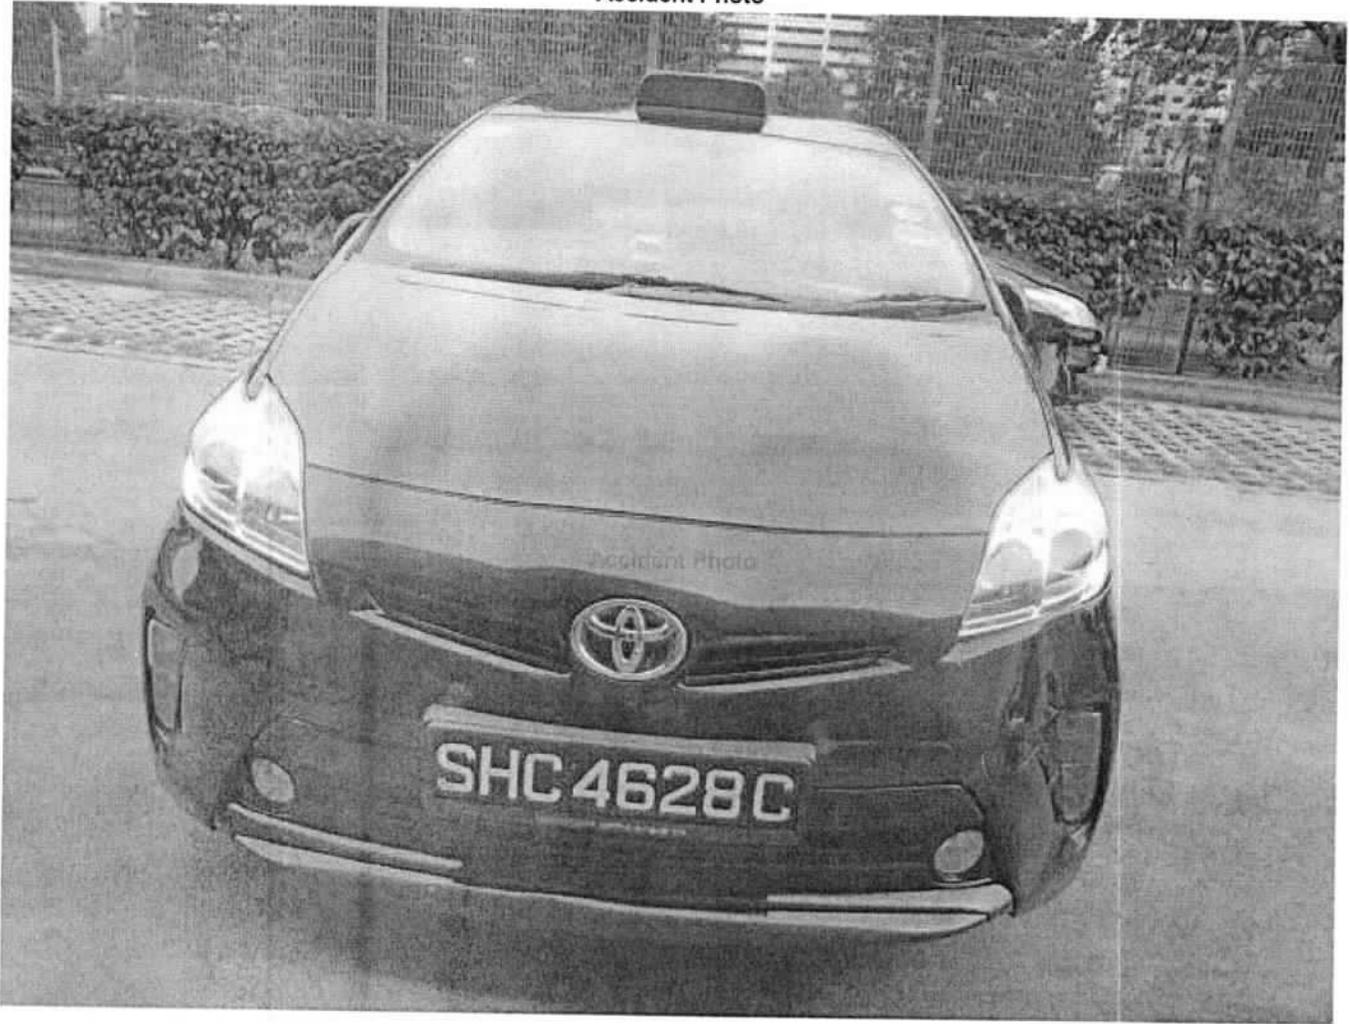
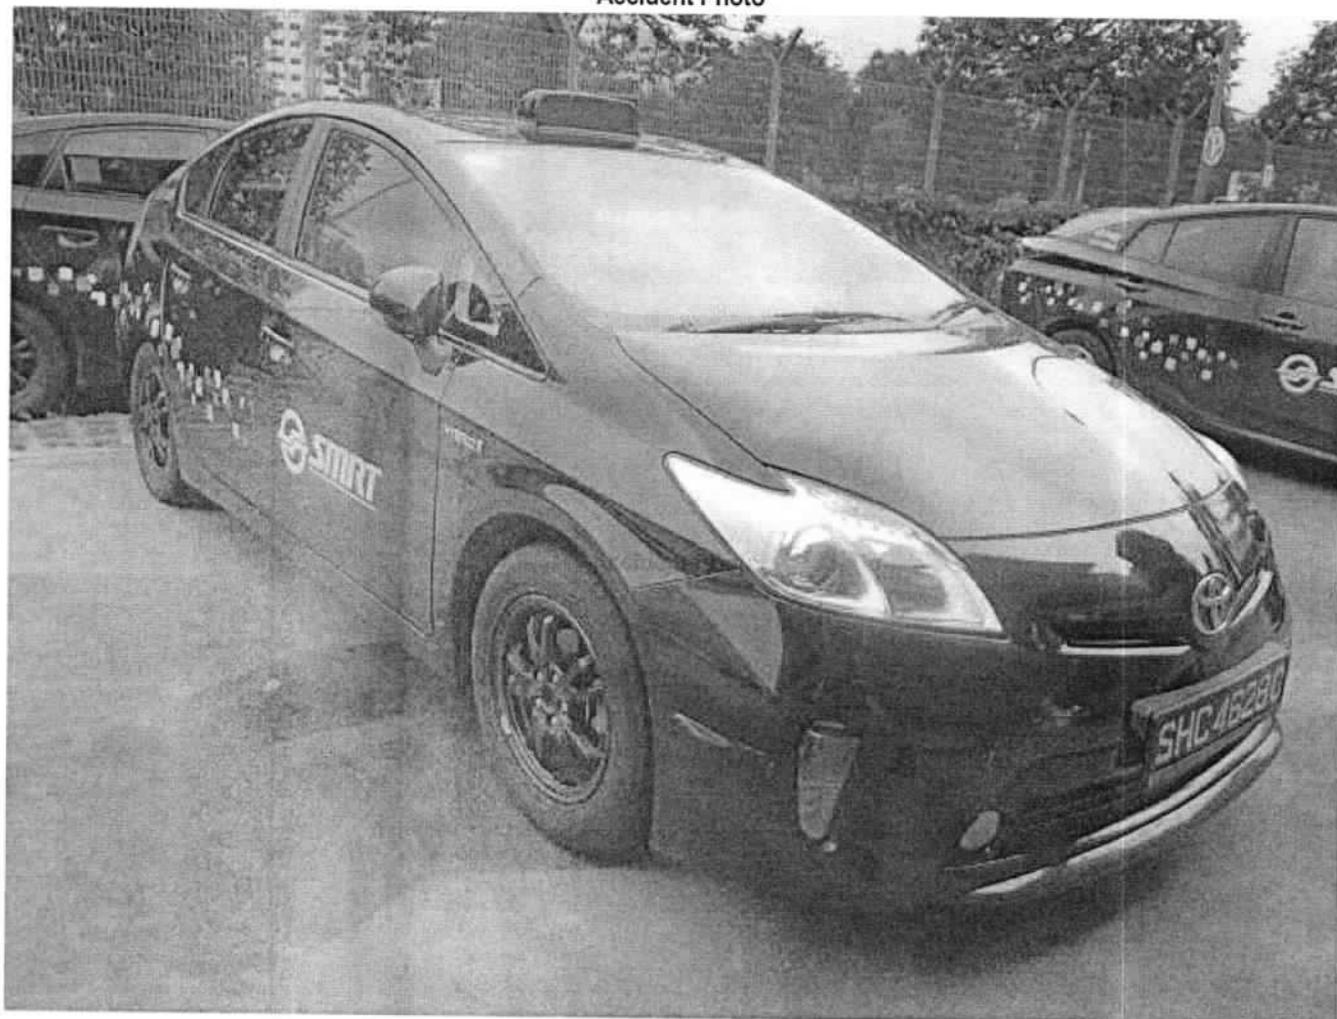
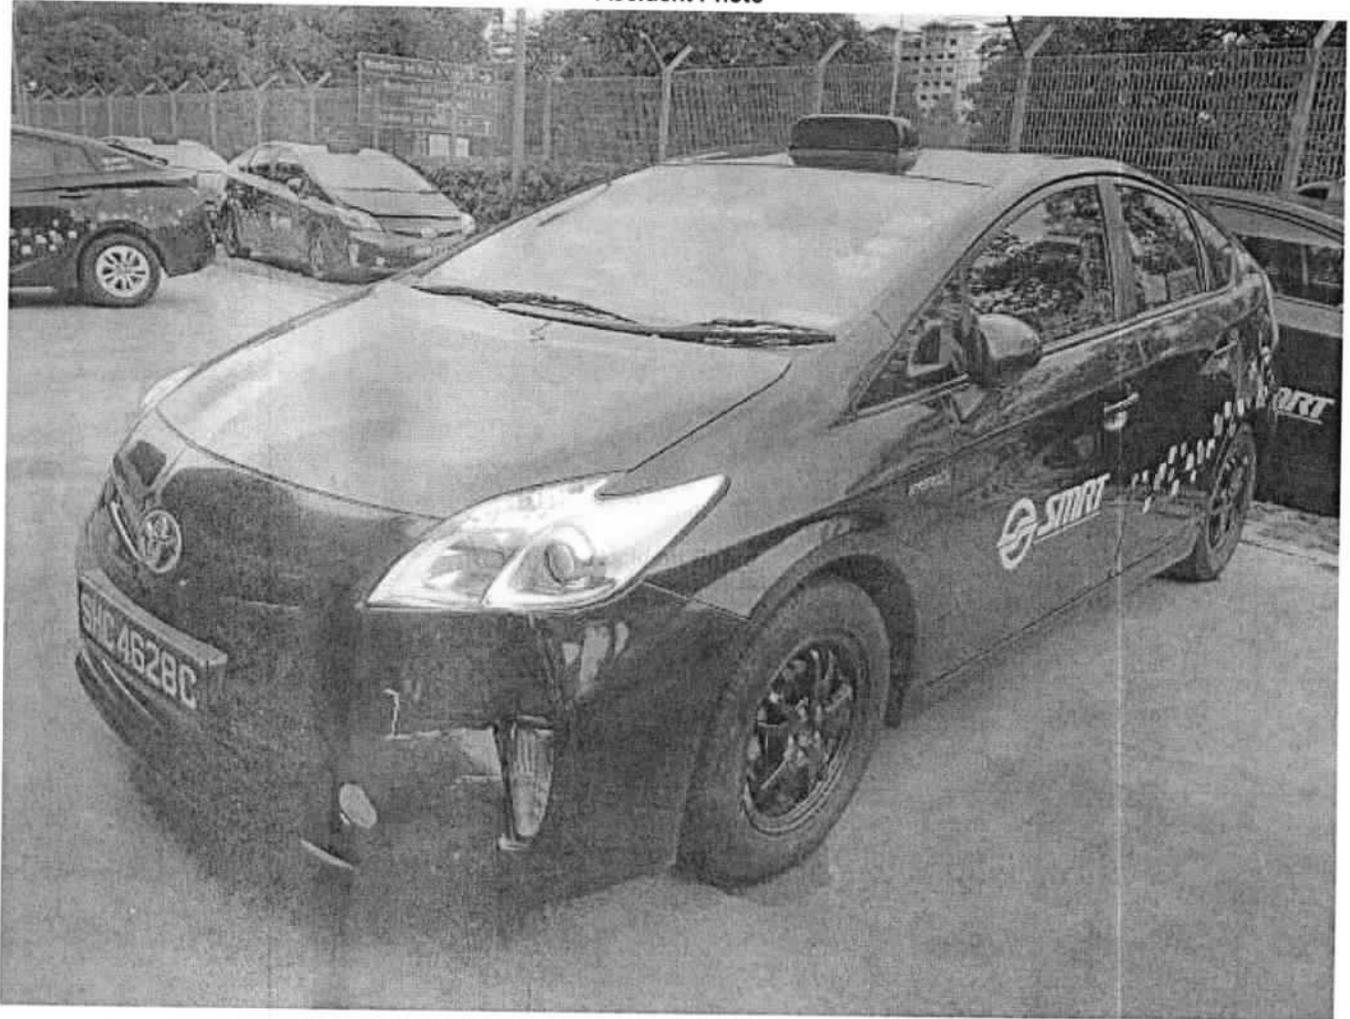
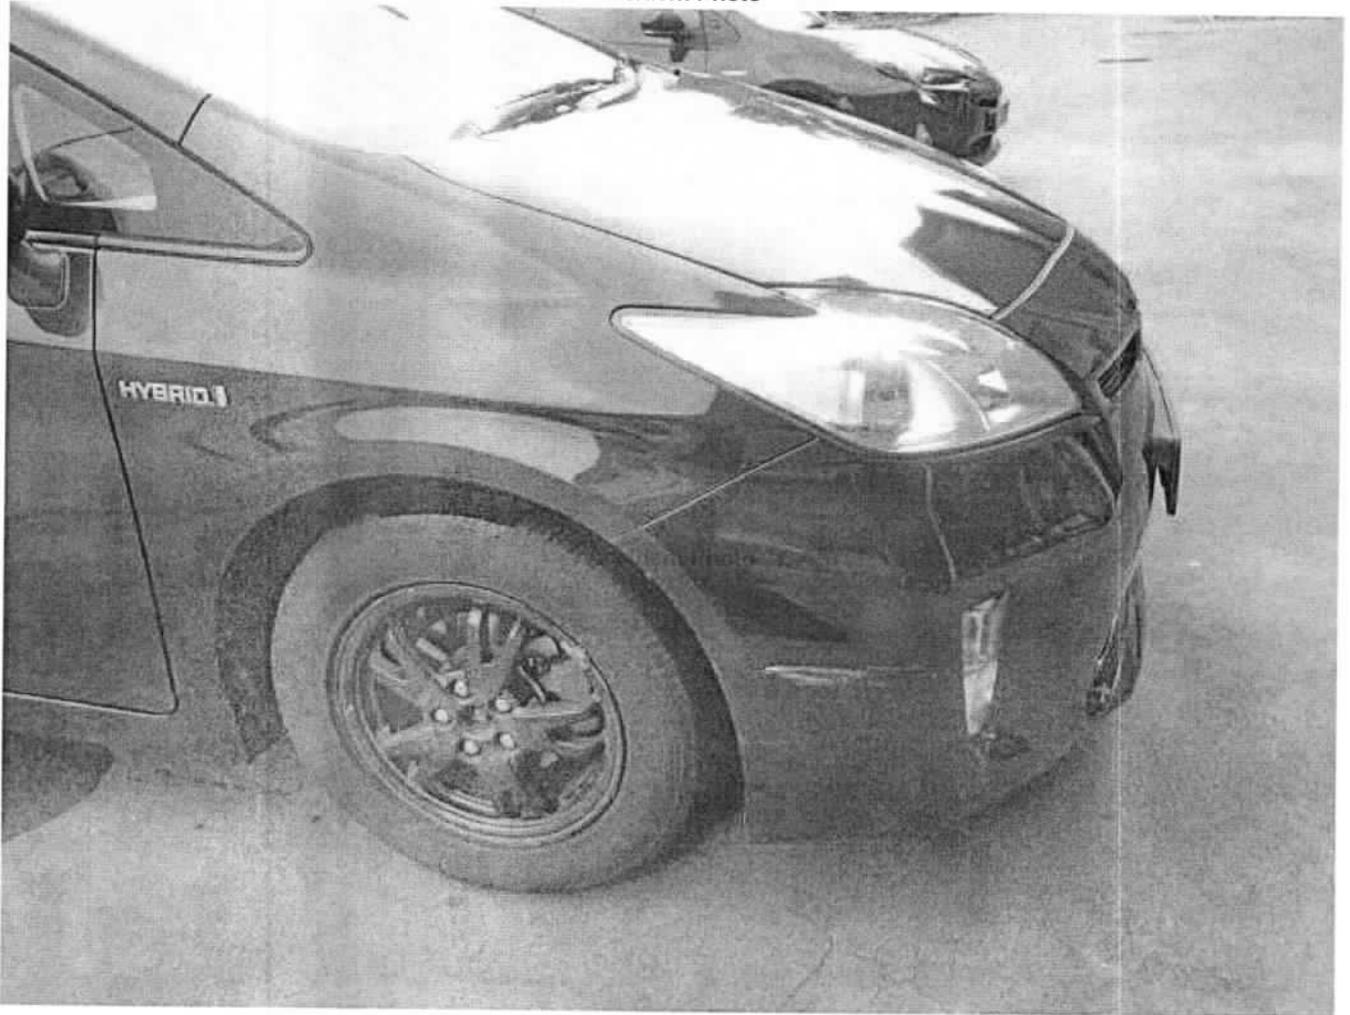
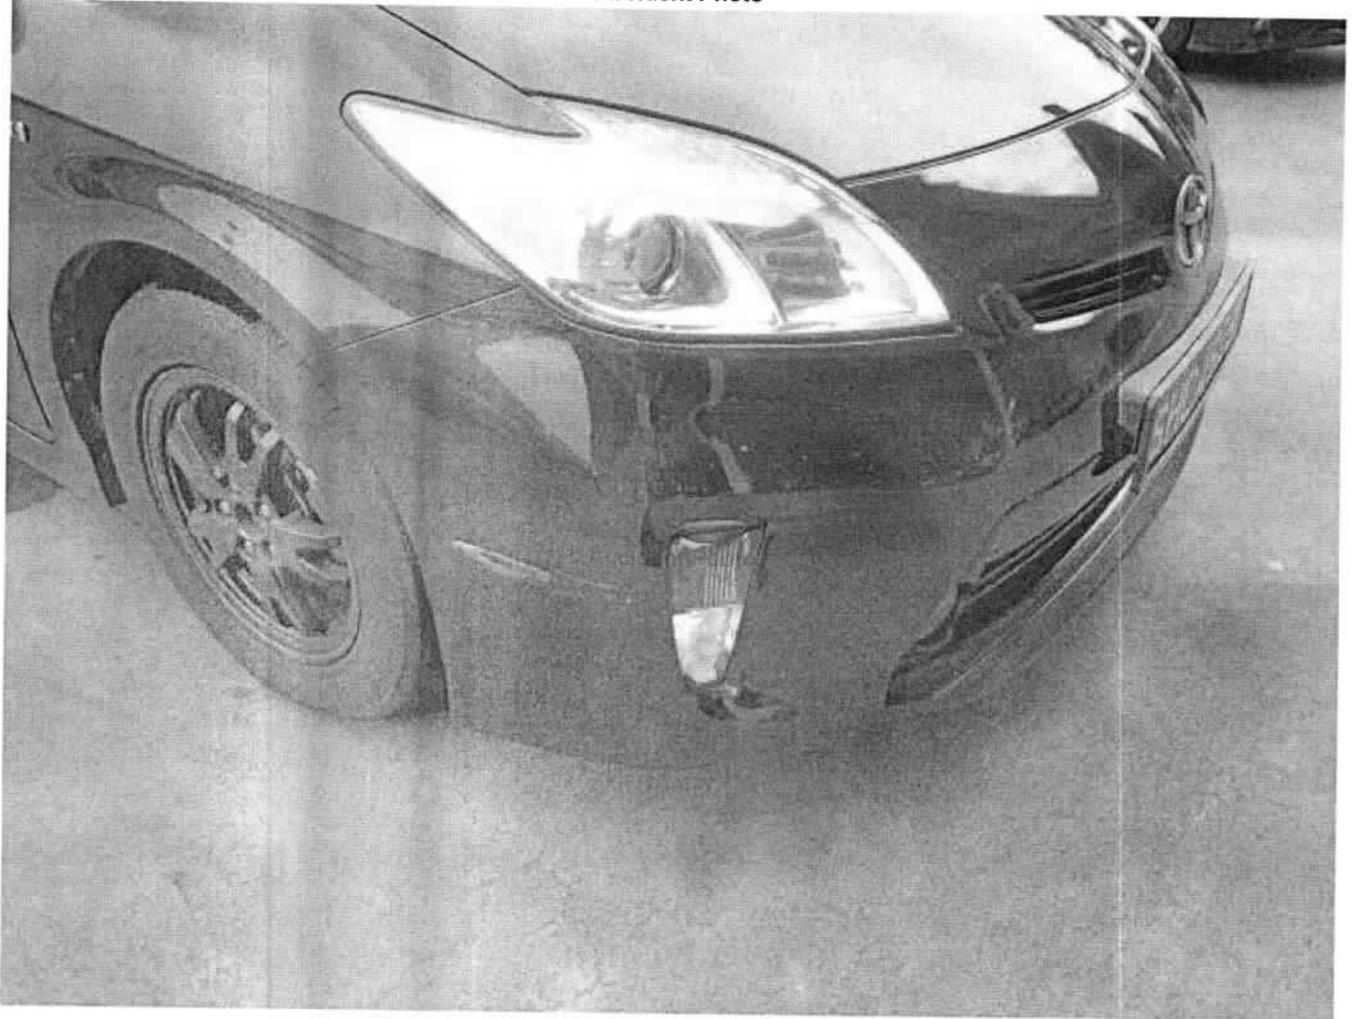
MY TAXI WAS STATIONARY ALONG THE DRIVE WAY OF DROP OFF BAY WAITING FOR THE FRONT VEHICLES TO MOVE. THE VEHICLE SKF328T CUT INTO MY PATH AND STOPPED BESIDE MY RIGHT SIDE TO ALIGHTED THE PASSENGER. WHILE THE VEHICLE SKF328T OPENED THE REAR SLIDING DOOR, IT BRUSHED AGAINST THE RIGHT FRONT PORTION OF MY TAXI.

Accident Photo

Qty	Description of Parts	Condition	Estimate By Workshop (\$)	Our Adjusted (\$)
	<b>REPLACEMENT OF PARTS</b>			
1	BUMPER SUPPORT F/RH	SERVICEABLE	76.40	-
1	BUMPER FRT	TO REPAIR SEE LABOUR	482.00	-
			558.40	-
	<b>LABOUR</b>			
	PANEL BEATING & BODY WORK. INCLUSIVE OF THE REPAIR OF BUMPER FRT.		338.00	200.00
	SPRAY PAINT.		378.00	200.00
	TO WASH AND VACUUM.	NOT NECESSARY	60.00	-
			776.00	400.00
	<b>GRAND TOTAL</b>		<b>1,334.40</b>	<b>400.00</b>
	<b>RECOMMENDED COST OF LUMP SUM REPAIRS (TO ITS PRE-ACCIDENT CONDITION) (CONFIRMED)</b>			<b>300.00</b>

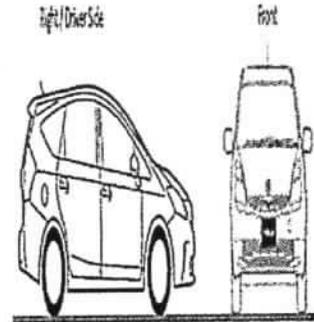
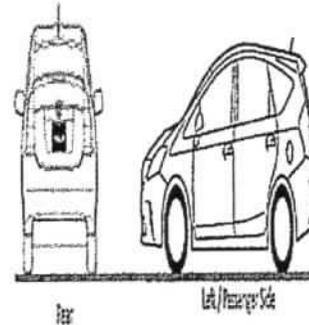
Prius

Section A - Accident Details	
Registration Number	SHC4628C
Case Reference Number	TAX/05/19/2091
Registration Date	3/9/2014
Company Type	SMRT Taxis Pte Ltd
Make	TOYOTA
Model	PRIUS
Name of Driver	YUE SEE PENG
Type of Accident	Open Door Case
Accident Date and Time	19/5/2019 8:38 PM
Accident Reported Date and Time	21/5/2019 2:50 PM
Is Surveyor Required?	Yes
Survey by	
Vehicle Is Towed Back?	No
Towed Back Date and Time	
Replacement Vehicle Issued?	No
Job Card Number	24101573
Special Instruction to ARC, if any	TP
Prepared Date and Time	22/5/2019 11:19 AM
Chassis Number	
Mileage	
Work Shop	
Repair Completion Date and Time
