INC

1. Policy Particulars :- THIRD PARTY CLAIM			
Insured Veh.	SGE 754Z	Veh. Inspected	SHB 322R
Policy No.	5082312468-02	Coverage (\$)	0.00
Claim No.	MT/1045235-002	Excess (\$)	0.00
Assign From		Assign Date	22/05/2019

4. Description of Damages			
THE VEHICLE SUSTAINED DAMAGES AT THE REAR PORTION. DAMAGES SEE DETAILS.			
5. General Information			
Accident Date	18/05/2019	Inspection Date	22/05/2019
Survey held at	SMRT AUTOMOTIVE SERVICES PTE LTD 60 WOODLANDS INDUSTRIAL PARK E4 SINGAPORE 757705		
5a. Remarks			
A)THE INSPECTION WAS CONDUCTED ON A"WITHOUT PREJUDICE" BASIS. B)IN ACCORDANCE TO YOUR INSTRUCTIONS, WE HAVE NOT AUTHORISED REPAIRS.			
5b. Estimate Days of Repair			
ESTIMATED NORMAL PERIOD FOR REPAIR:		2 Working Days

ADJUSTMENT ON REPAIR COST FOR VEHICLE NO. SHB 322R

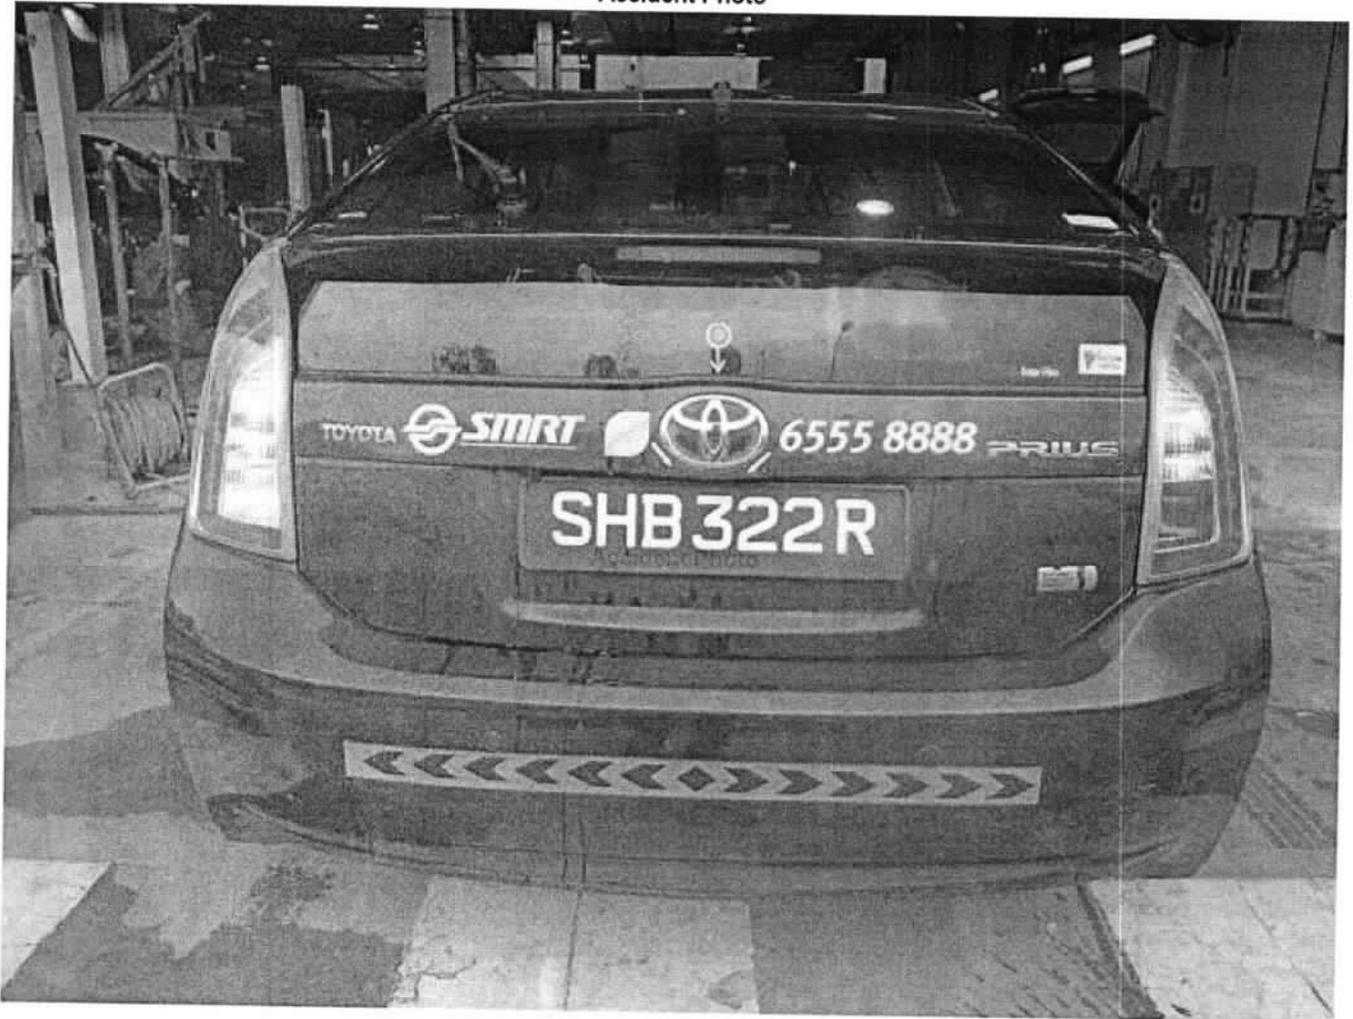
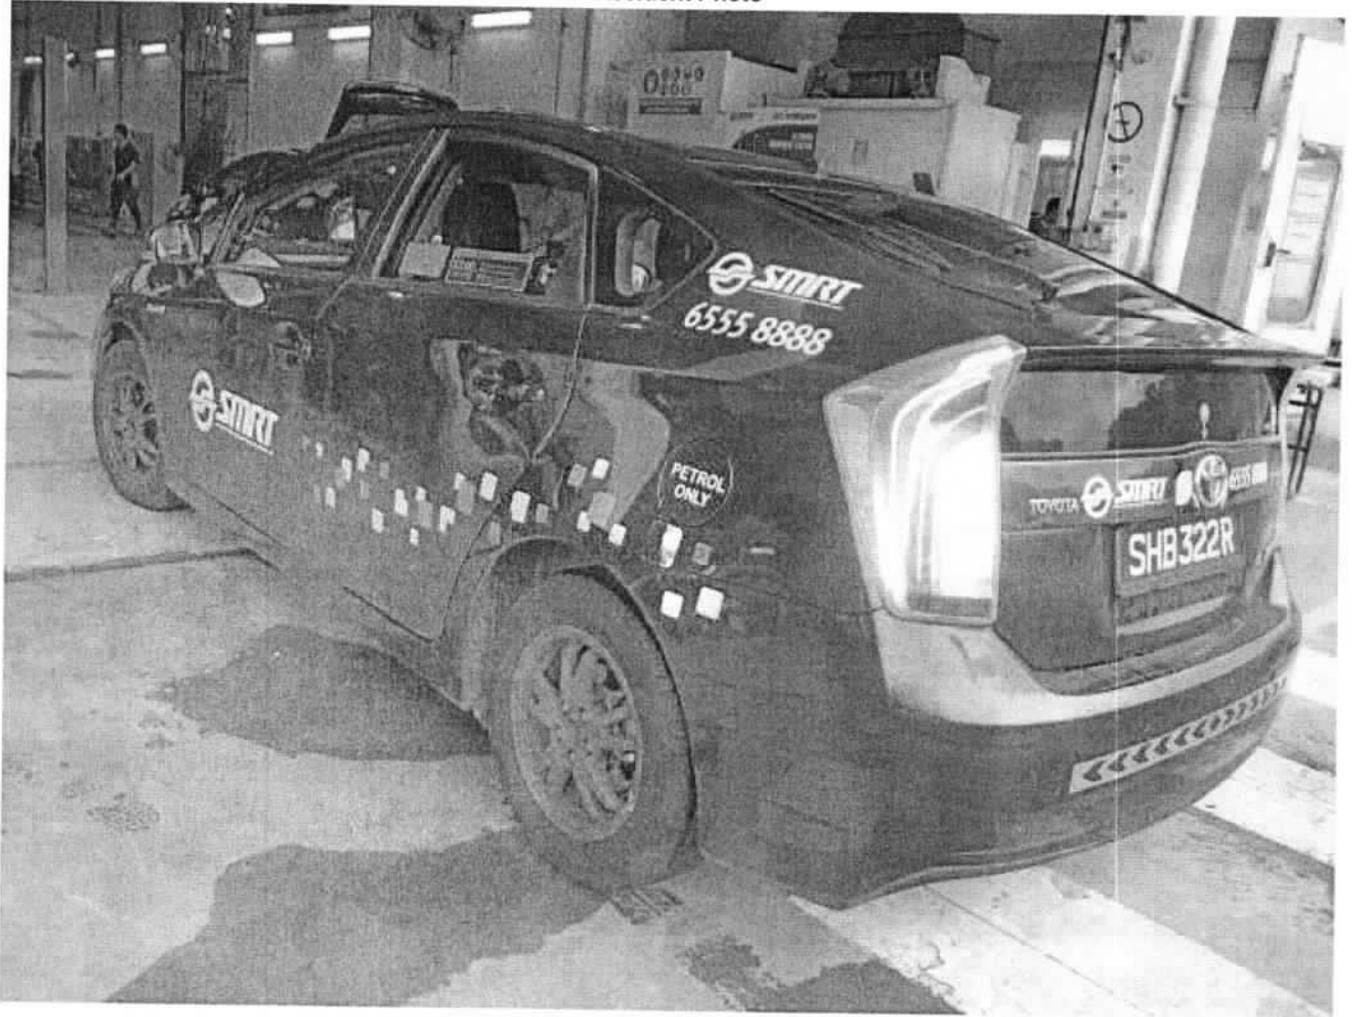
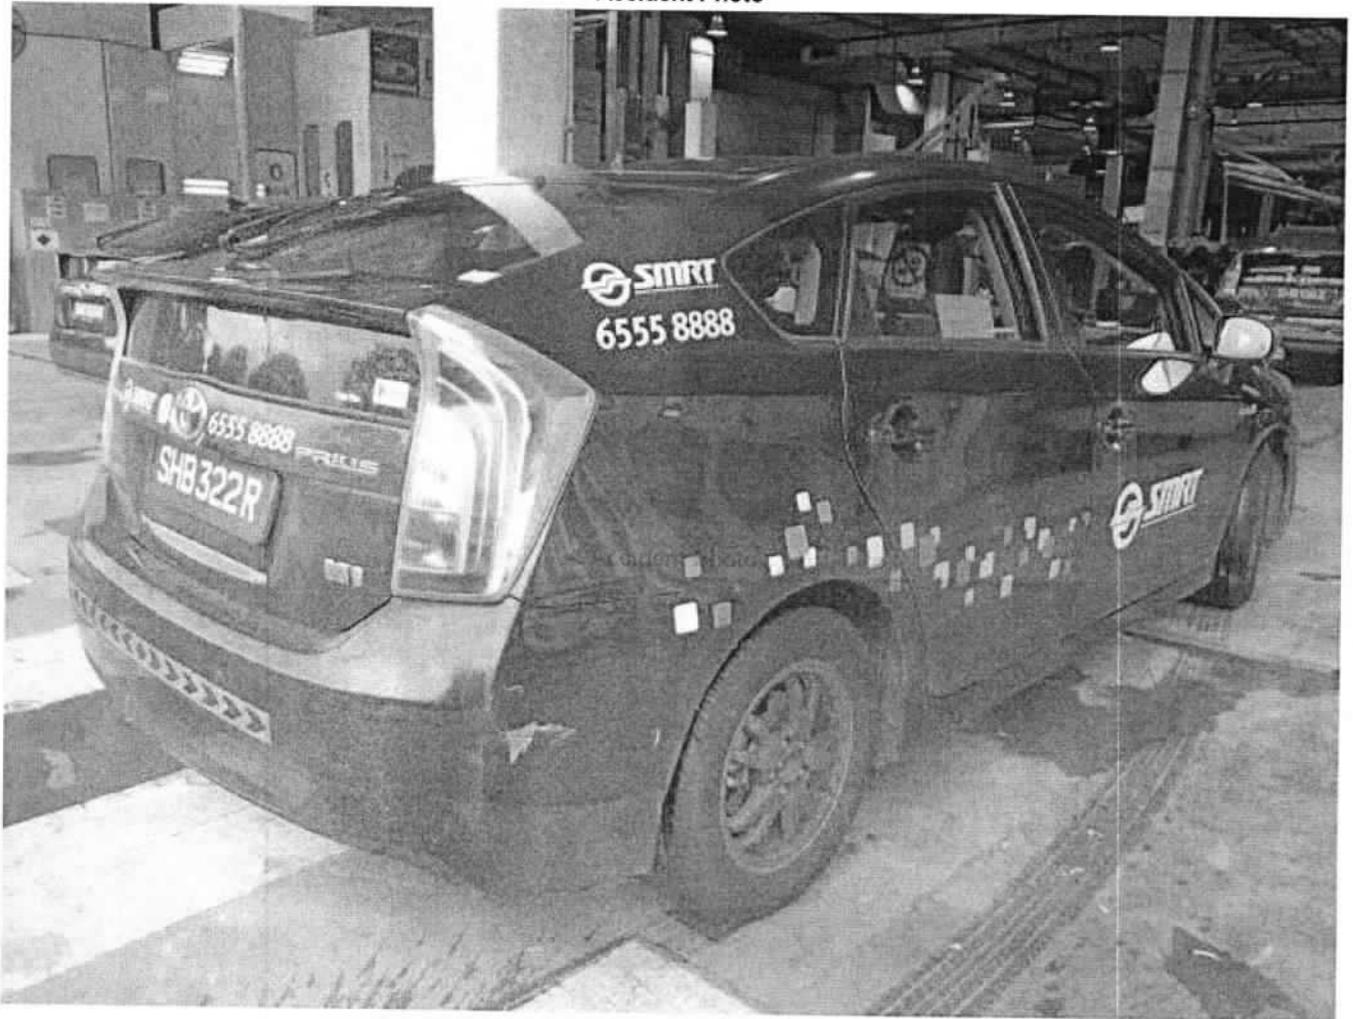
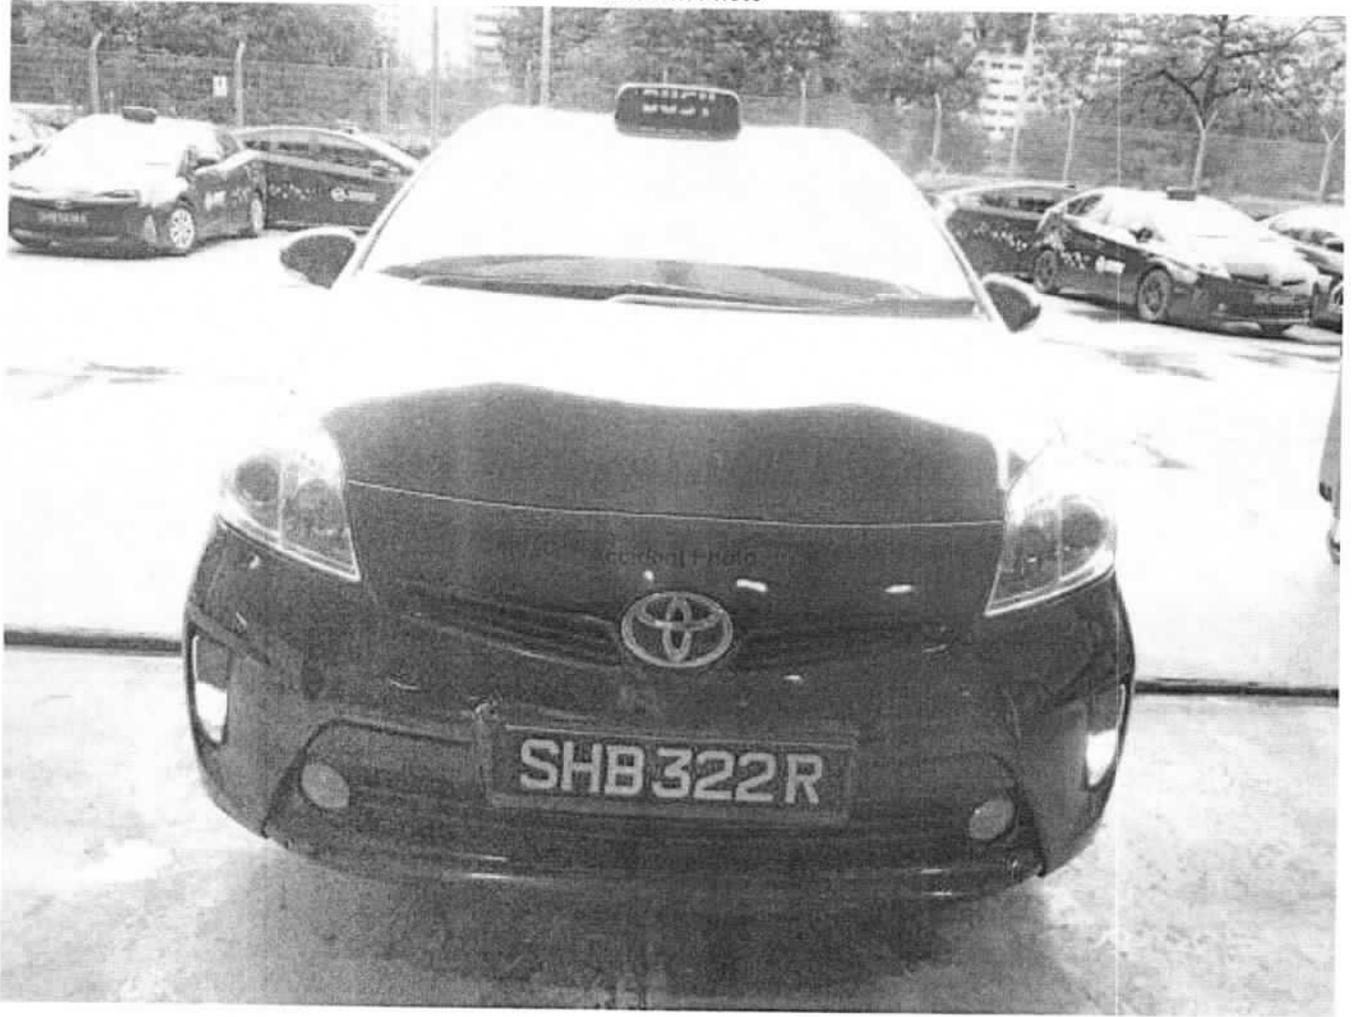
I WAS STATIONARY ALONG WHAMPOA TAXI STAND AS A PASSENGER WAS GOING TO BOARD MY TAXI. SUDDENLY I FELT AN IMPACT AT THE RIGHT REAR PORTION OF MY TAXI. A VEHICLE SGE754Z HAD HIT ONTO THE RIGHT REAR PORTION OF MT TAXI AND DROVE AWAY WITHOUT STOPPING. I WENT AFTER THIRD PARTY AND STOPPED HER A DISTANCE AWAY

Accident Photo

Qty	Description of Parts	Condition	Estimate By Workshop (\$)	Our Adjusted (\$)
REPLACEMENT OF PARTS				
1	BUMPER REAR (DISC 25%)	CRACKED	458.60	343.95
2	PIXEL STICKER @\$60.00 (SN)	NECESSARY	120.00	120.00
1	BUMPER LIP COVER RR/RH	SERVICEABLE	118.10	-
1	BUMPER SIDE RETAINER RR/RH	SERVICEABLE	94.80	-
1	BUMPER SEAL, RR RH	NOT NECESSARY	65.70	-
			857.20	463.95
LABOUR				
PANEL BEATING & BODY WORK.			338.00	200.00
SPRAY PAINT.			378.00	200.00
TO CHECK WIRING AND SYSTEM FUNCTION.			80.00	-
TO TEST AND REFIX REVERSE SENSOR SYSTEM.			120.00	30.00
TO WASH AND VACUUM.			60.00	-
			976.00	430.00
GRAND TOTAL			1,833.20	893.95
RECOMMENDED COST OF LUMP SUM REPAIRS (TO ITS PRE-ACCIDENT CONDITION) (CONFIRMED)				700.00

Section D - Details of Repair Estimates		
Part 1 - Labour Works		
Job Scope	Quotation from AR	Adjusted by Surveyor, if applicable
TO REPAIR RH REAR PORTION	\$338.00	\$200.00
Total Labour	\$338.00	\$200.00

Part 2 - Spray Painting & Panel Beating Related Works		
Job Scope	Quotation from ARC	Adjusted by Surveyor, if applicable
TO RESPRAY REAR BUMPER	\$378.00	\$200.00
Total Spray Painting & Panel Beating	\$378.00	\$200.00
