## VEHICLE DAMAGE INSPECTION REPORT

Our File No: CS/SMO19009256/BTD3E2

Reg No: PC5587K

Make &amp; Model: TOYOTA HIACE, 3.0 D Commuter (M)

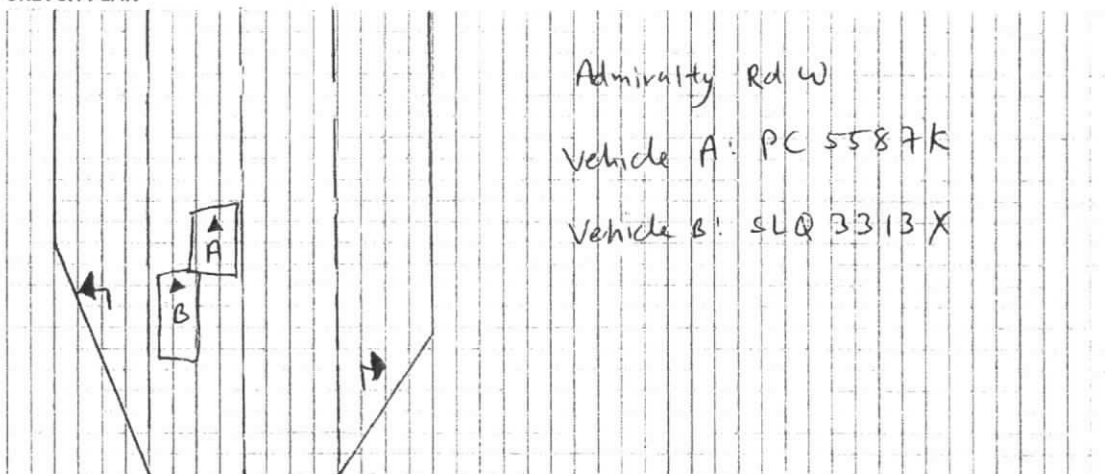
SKETCH PLAN

On the stated date and time, I vehicle A stopped as the vehicle in front of me stopped. All vehicles are waiting for the traffic light to turn green. One minutes later, Vehicle B suddenly hit onto my stationary vehicle rear portion.
