On 27/5/19 at about 08:10 hrs, I was driving at above said location with a male pax onboard. Shortly Veh B encroached into my lane from left hand side. Due to this cause, it right portion hit onto the left wing mirror of my taxi. NO injury reported in this accident.

VEHICLE DAMAGE INSPECTION REPORT

Our File No: CS/TMI19009374/K1VD3N2
Date: 30/05/2019**REFERENCE**

Handling Insurer:	Tokio Marine Insurance Singapore Ltd	Policy No:	MV002977
Claimant Vehicle No :	SHB3009B	Insured Vehicle No :	GR1070M
Date of Loss:	27/05/2019	Nature of Claim:	TP
		Claim No:	M1903877

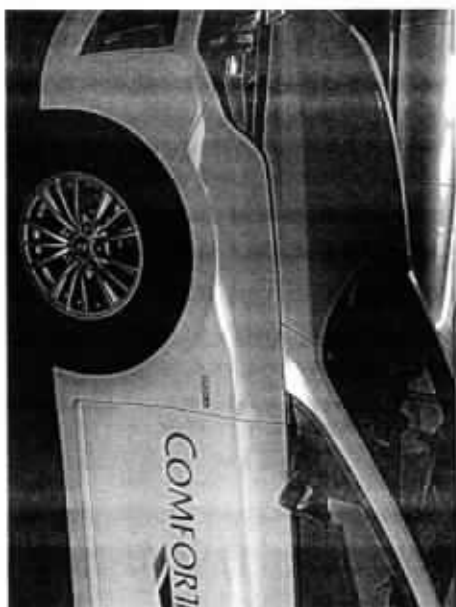
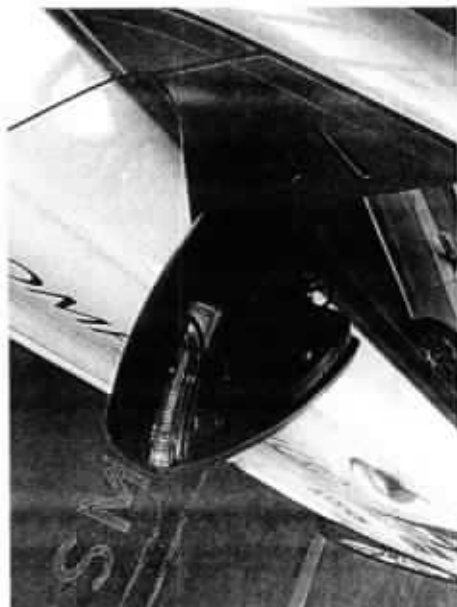
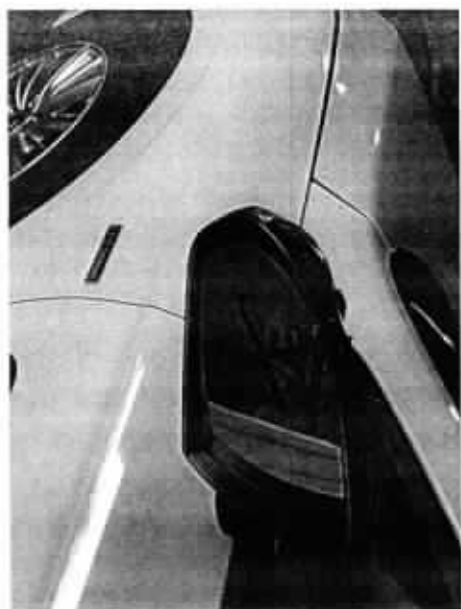
No.	Qty	Part No.	Particulars	Condition	Repairer's	Amount
1	1		*FRONT DOOR MIRROR LH	Cracked	1,054.60 FL	*1,054.60 FL
				Sub Total (S\$)	1,054.60	1,054.60
				- List Item Discount on L Items 20.00/20.00% (S\$)	210.92	210.92
				Total Parts (S\$)	843.68	843.68

No	Particulars	Lab.Type	Repairer's	Amount
<u>Labour Items</u>				
1	PANEL BEATING	New	100.00	100.00
2	SPRAY PAINTING	New	100.00	50.00
Gross Labour Cost (S\$)			200.00	150.00
