**THIRD PARTY SURVEY**  
**ACCIDENT HAPPENED ON 29 Apr 2019**

As per your instruction dated 3 May 2019 with regard to the above matter, We have carried out a physical inspection on the said vehicle **GBC 8186 E**. We enclosed herewith our report and findings as follows:

Vehicle No: GBC 8186 E  
Report No: TP/ 19006-05/AY / 2019

## VEHICLE DAMAGE INSPECTION REPORT

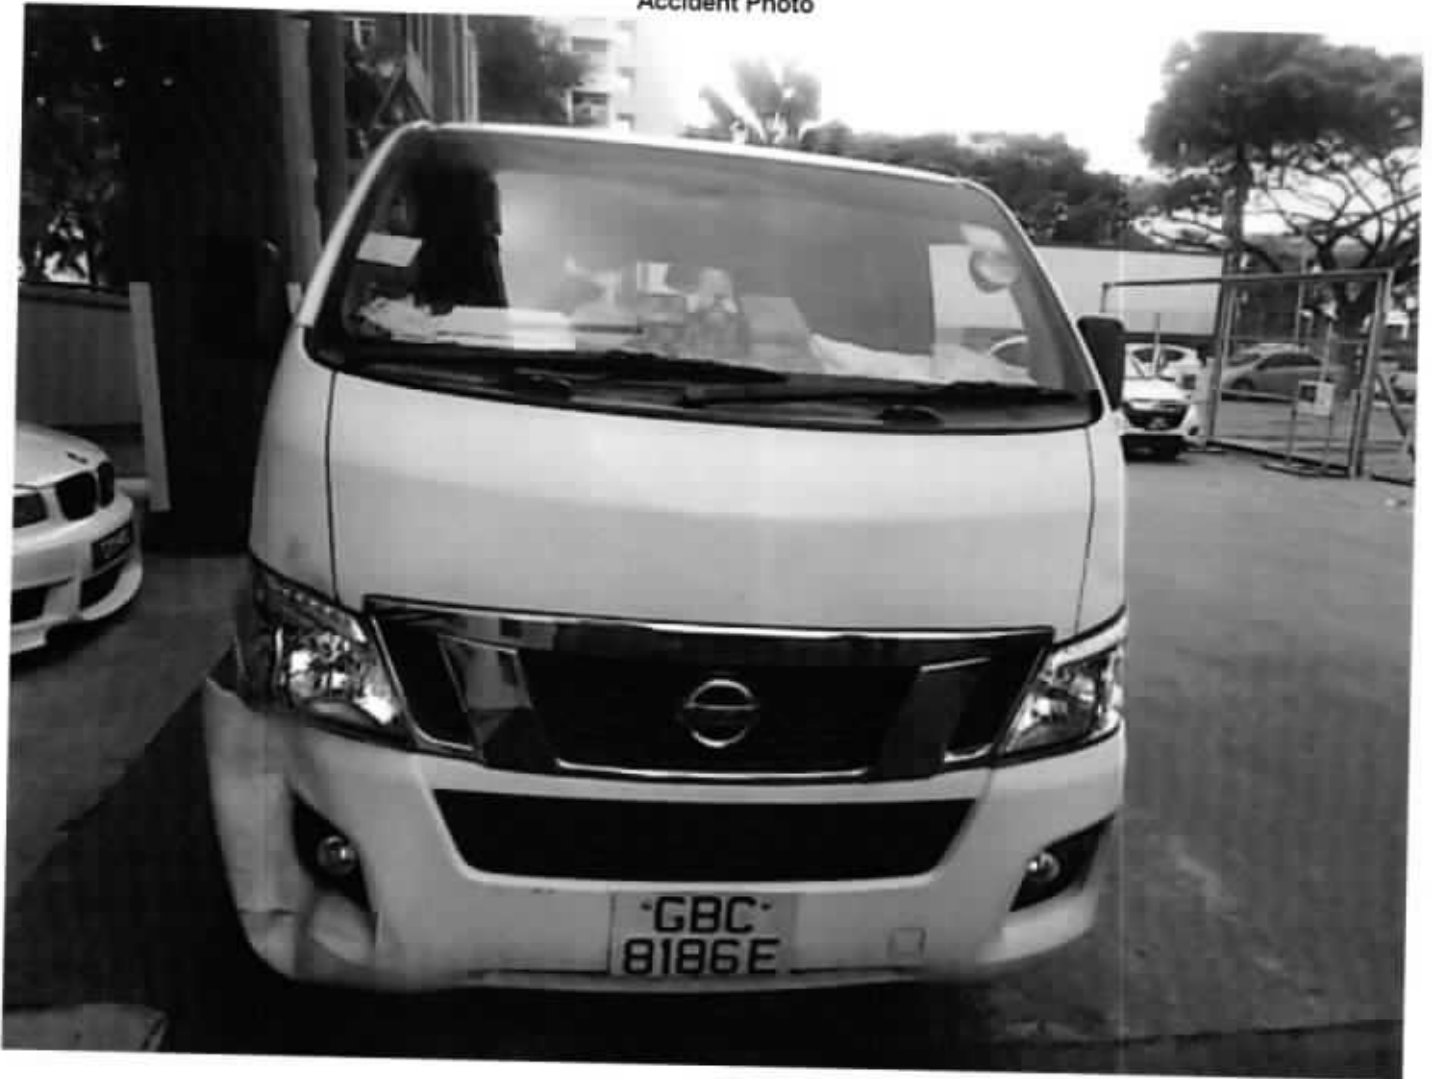
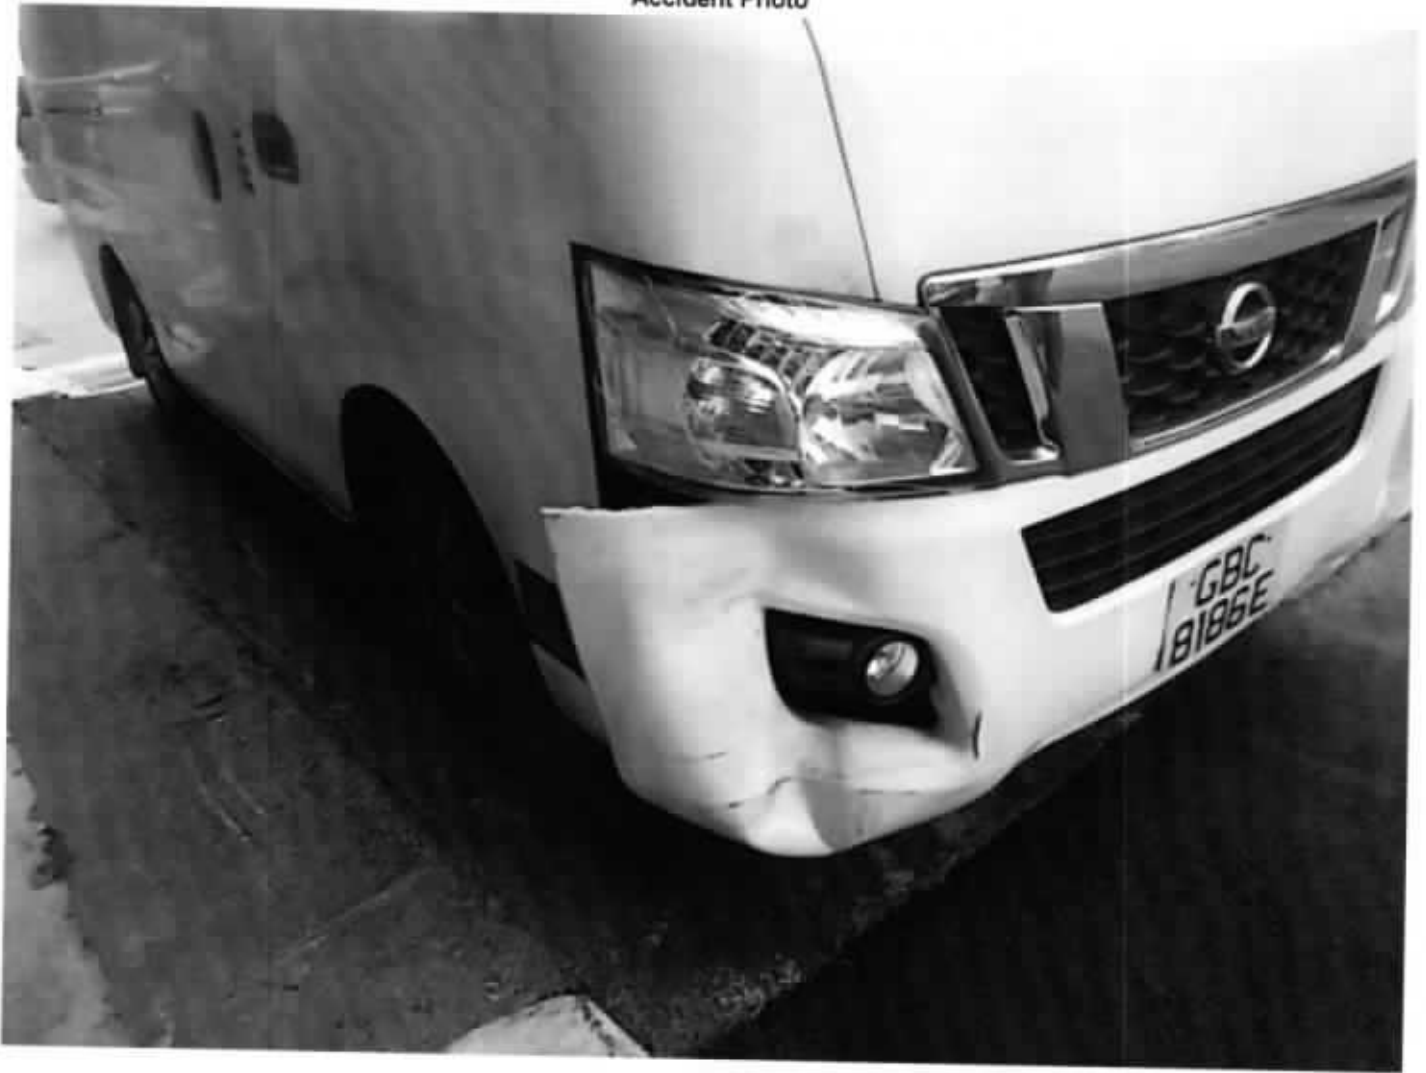
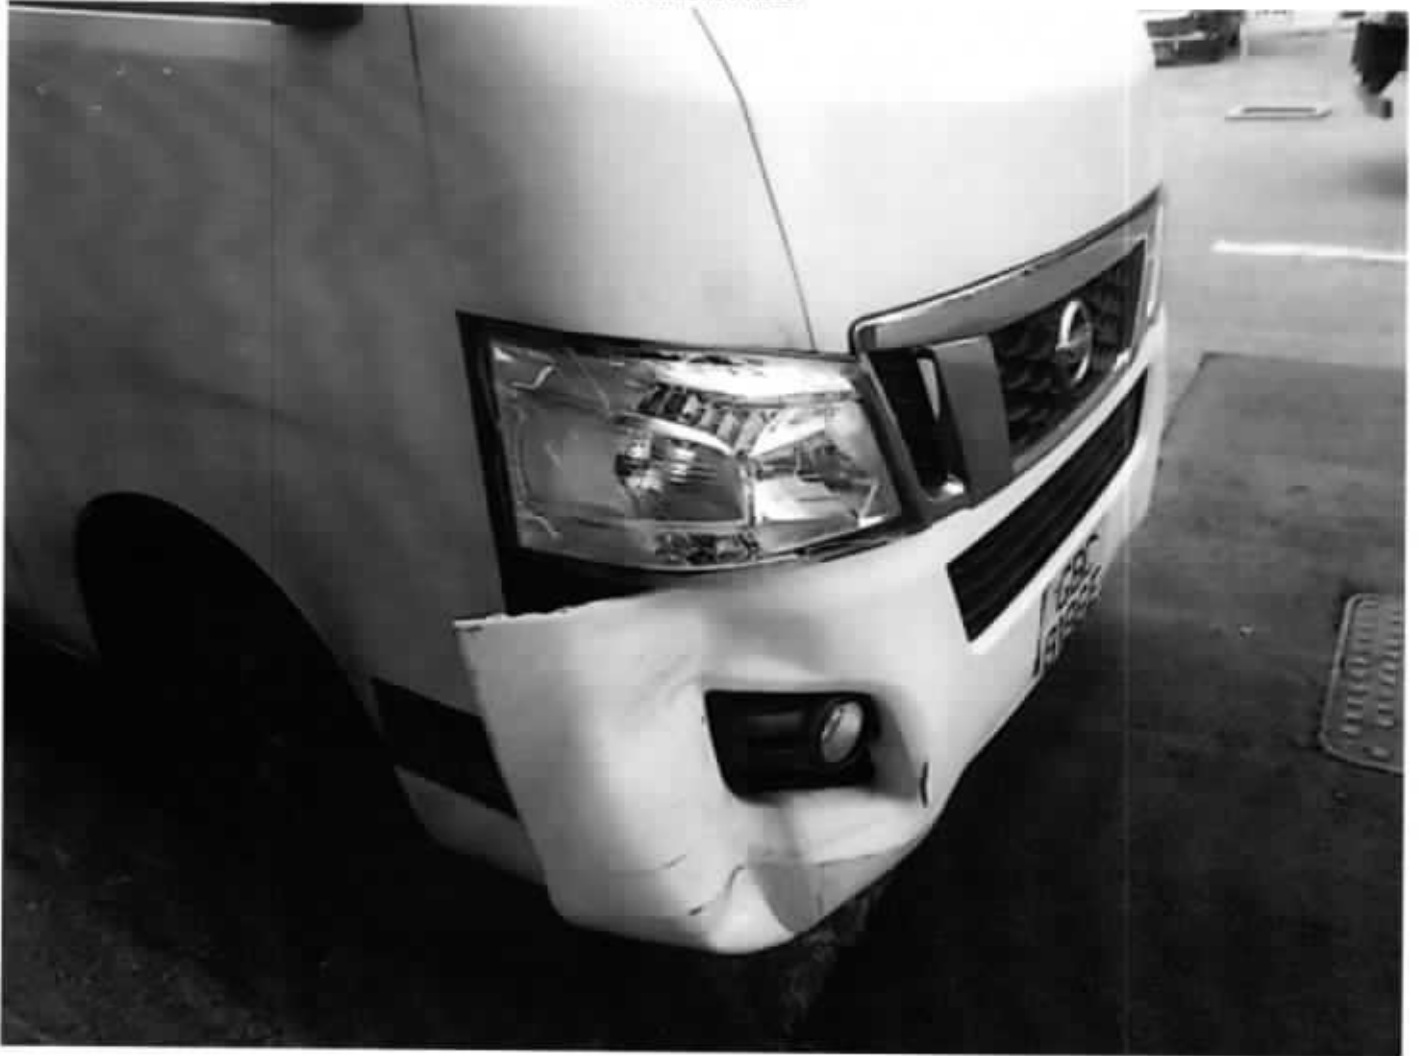
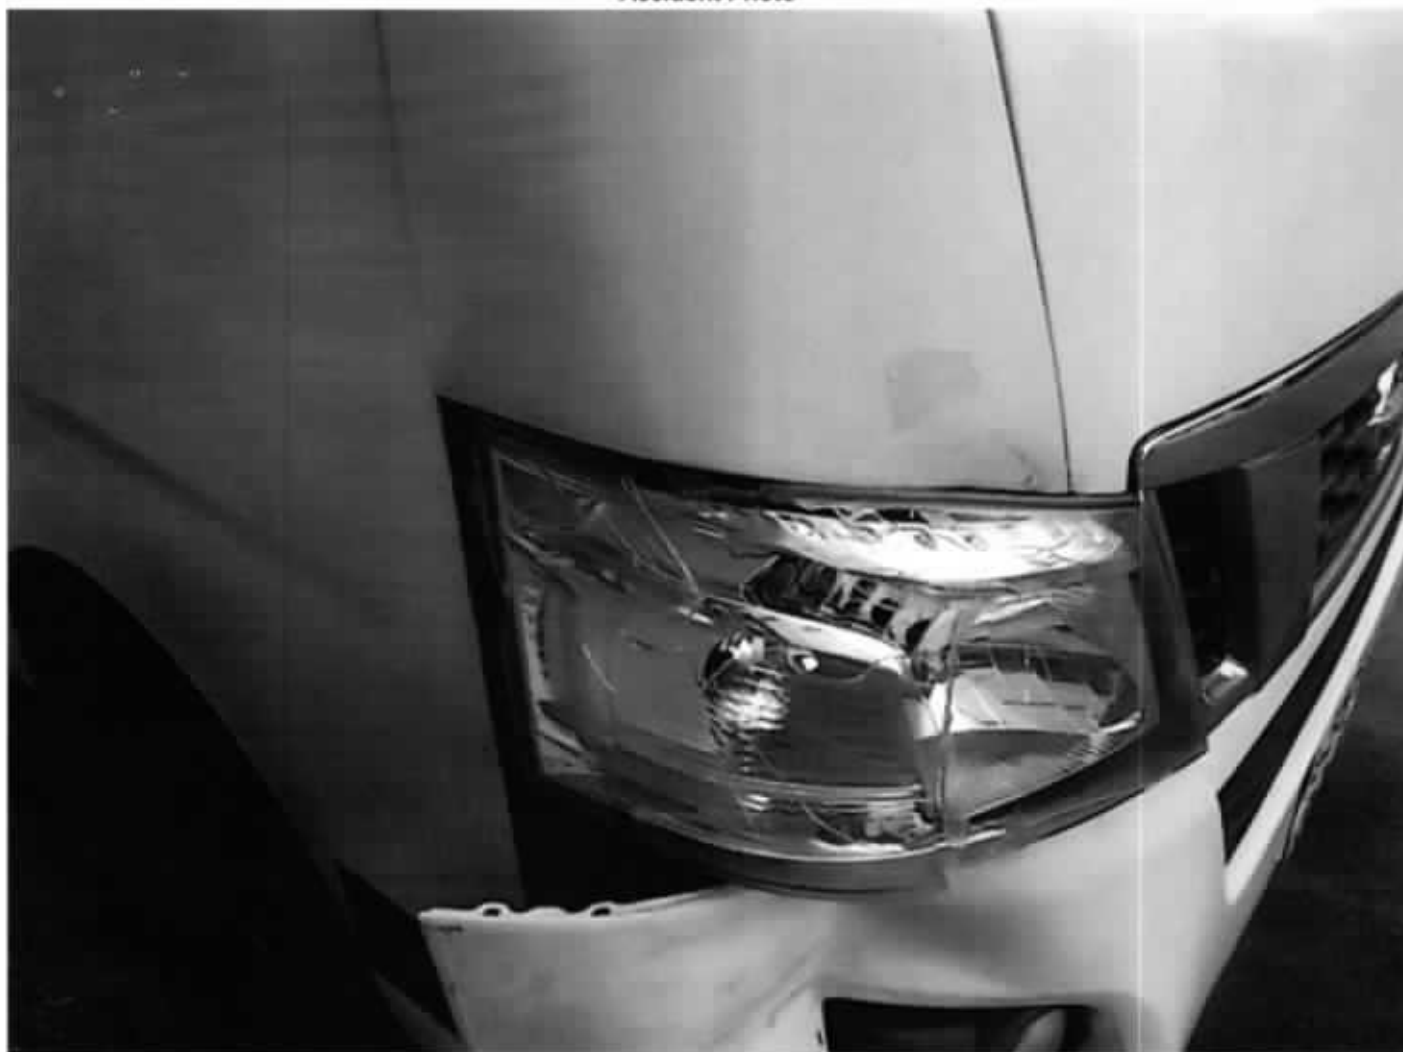
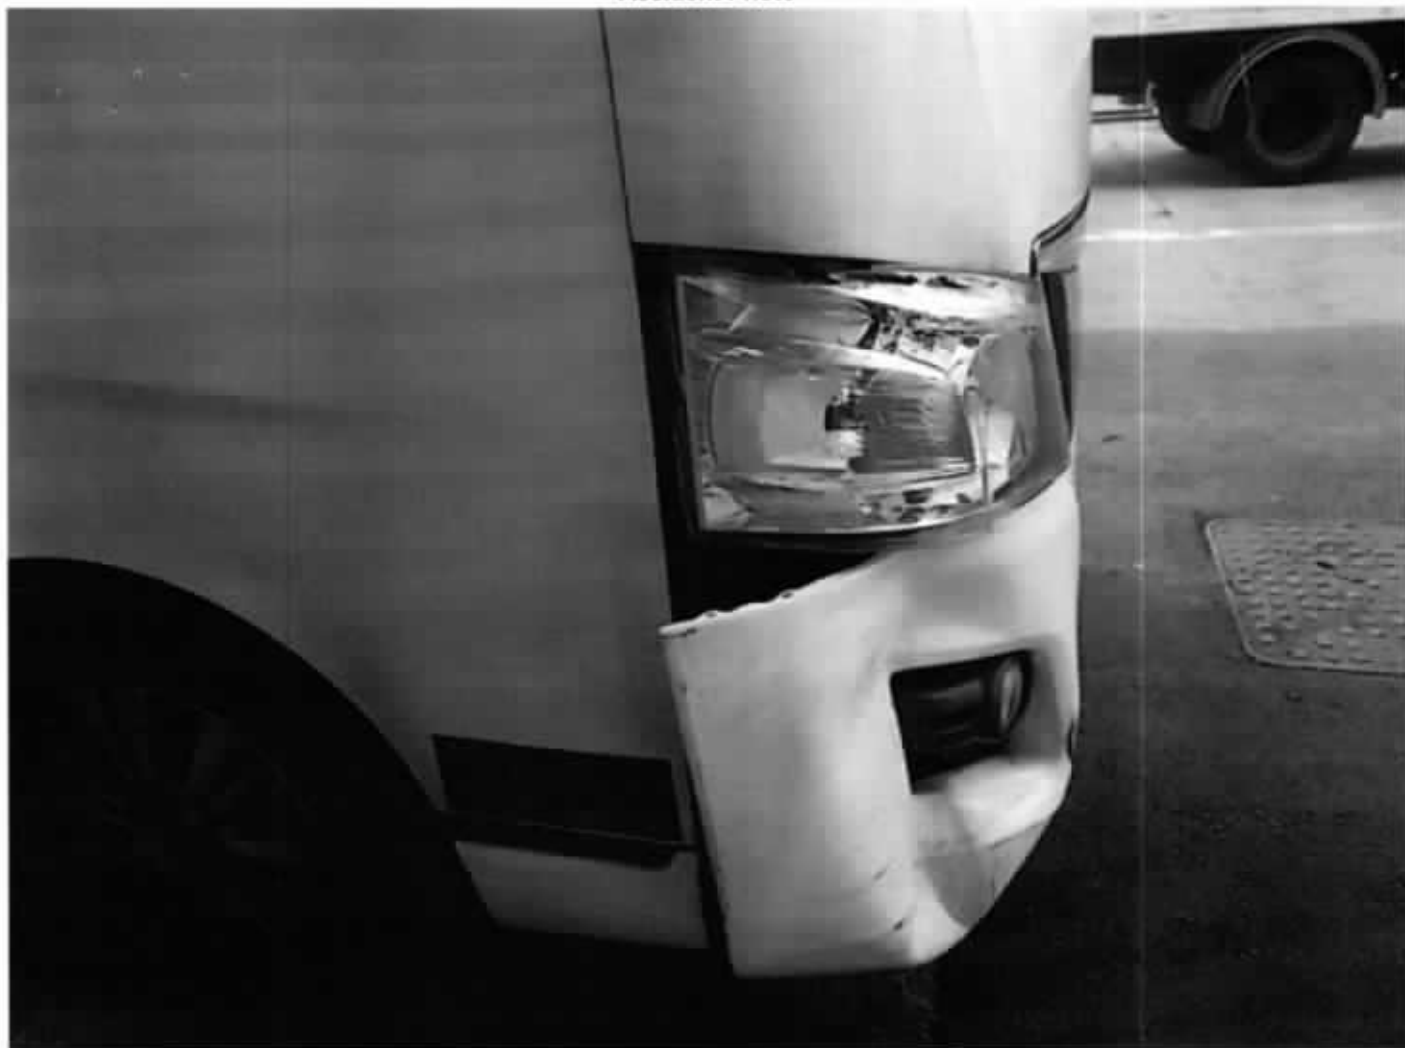
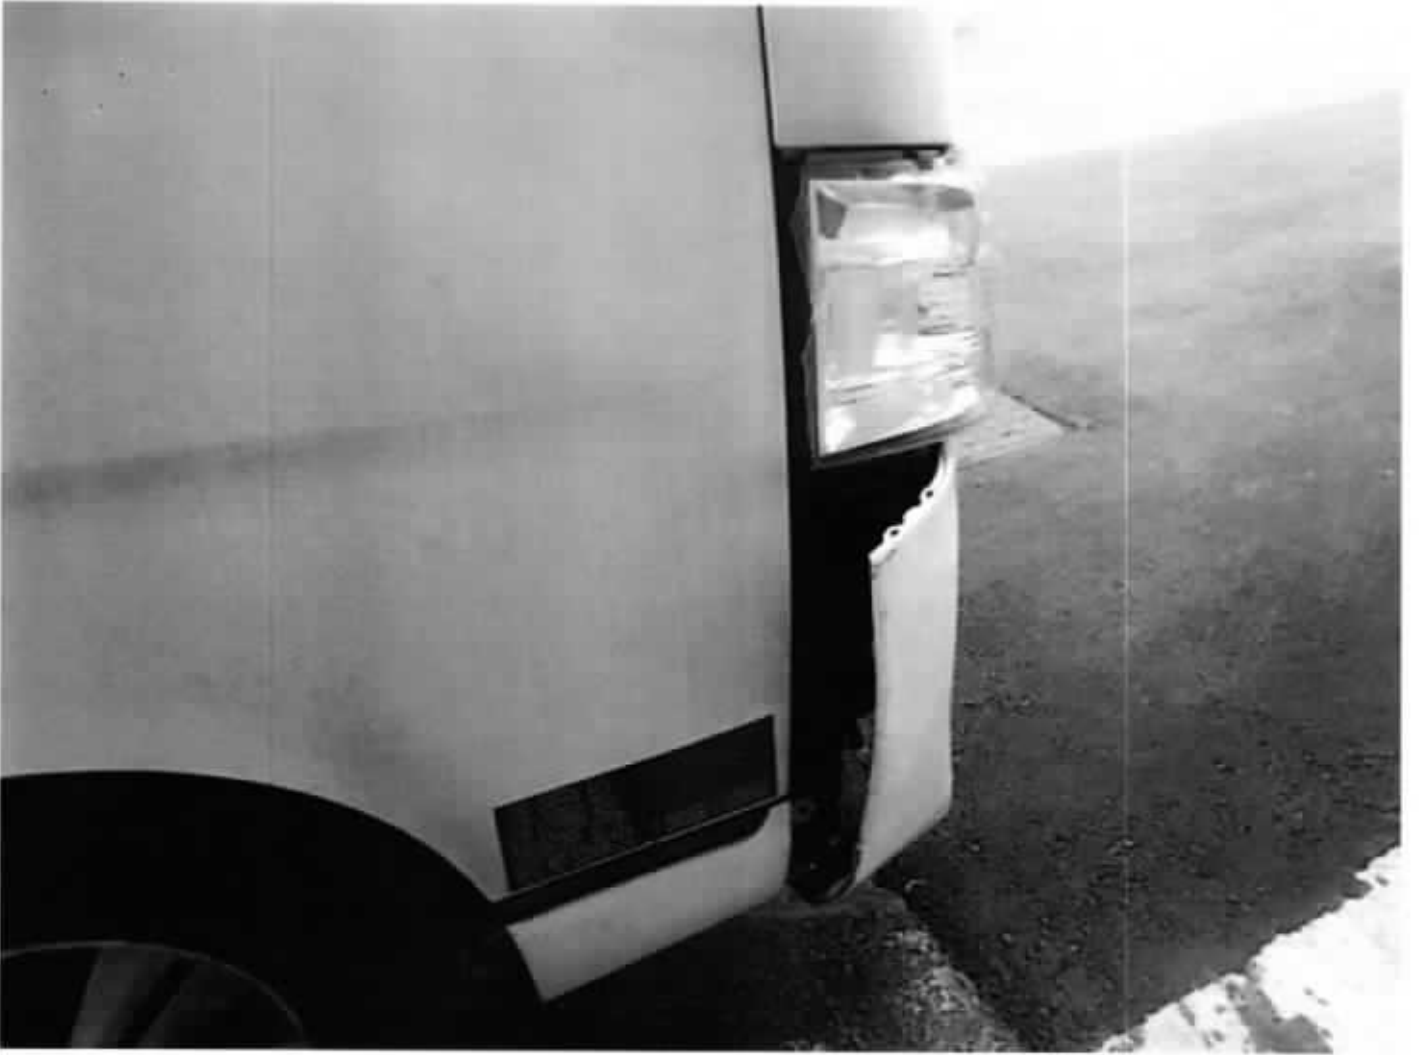
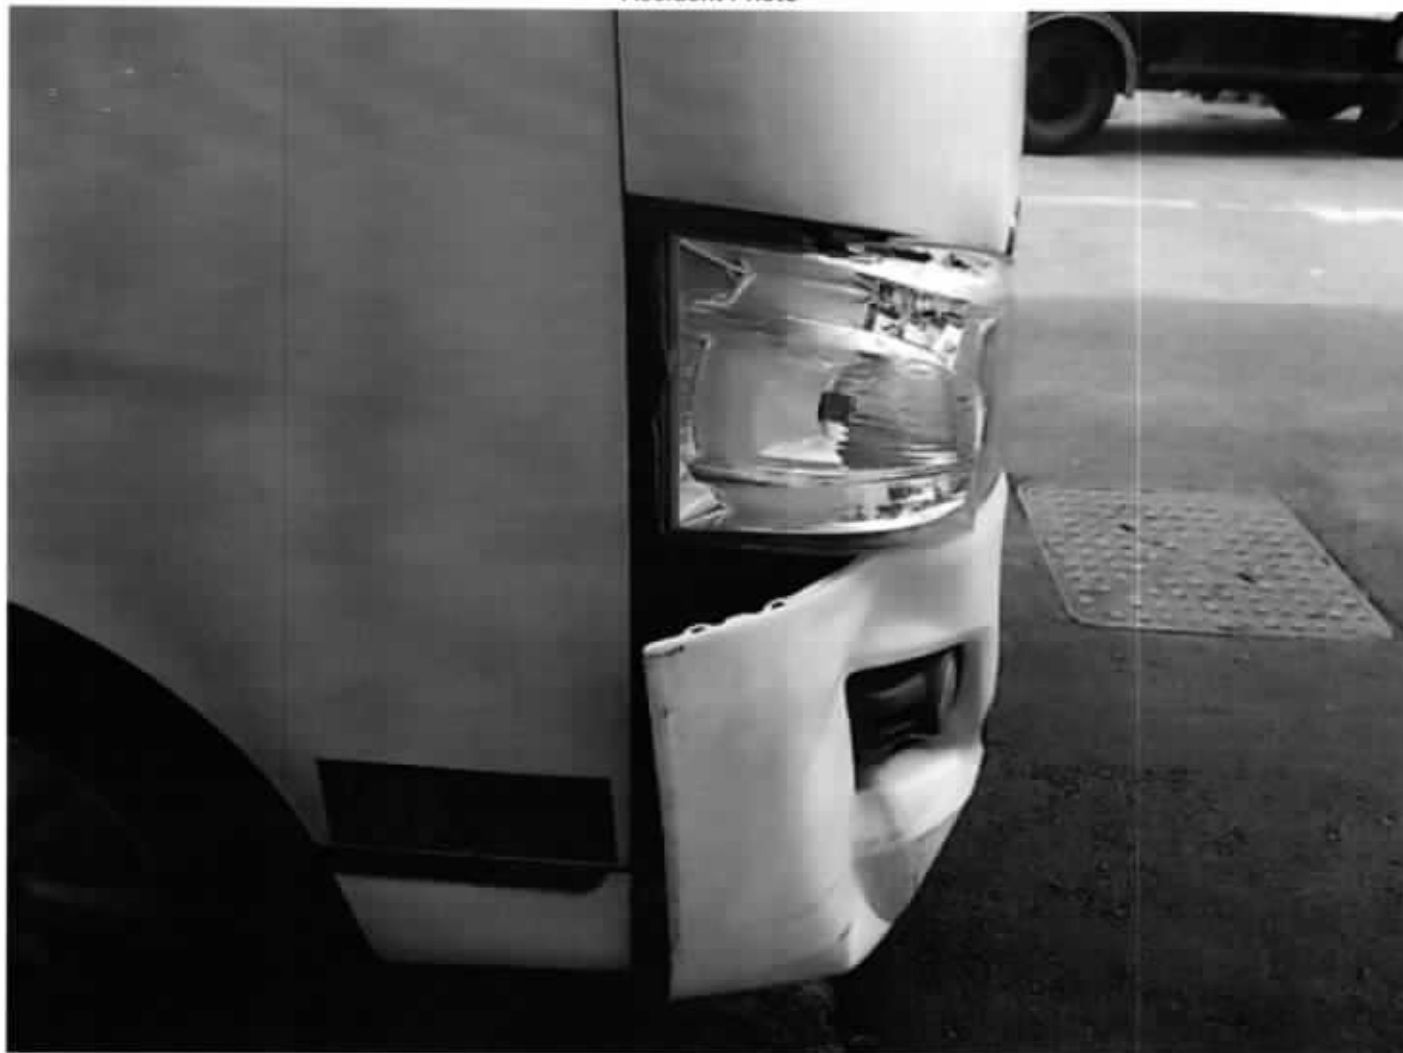
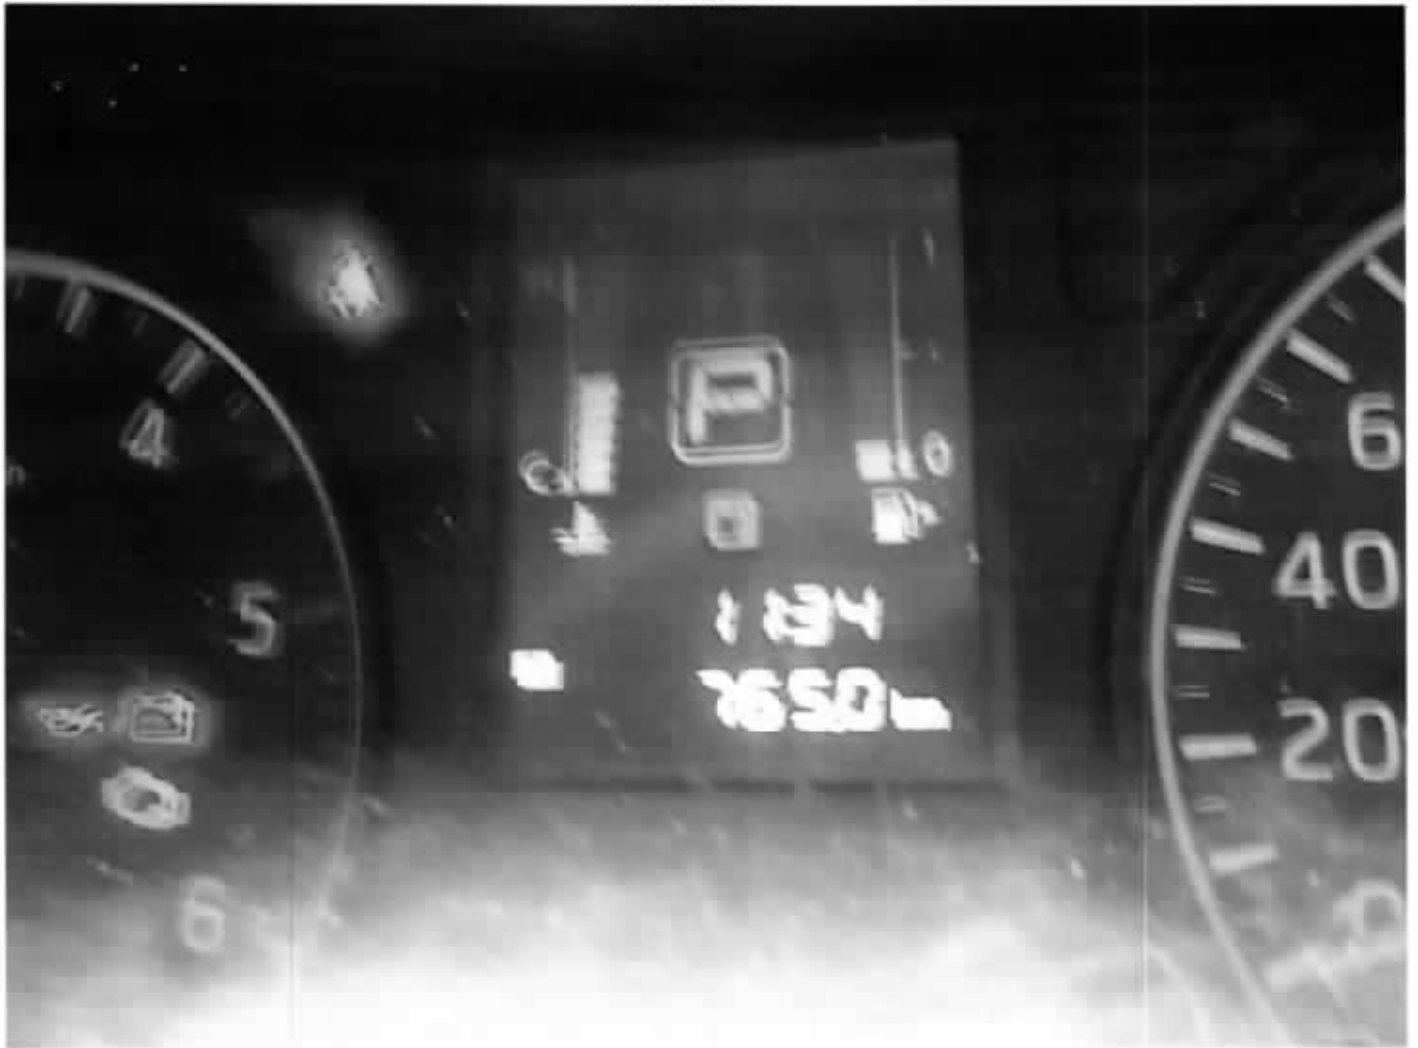
Accident Photo

At the time of inspection, we noted that the vehicle has sustained an impact damages on the front o/s portion(s). For more detail of the damages, please see photograph attached.
