ASSIGNMENT

Veh No: SHD 7213R Yr Regn: 18 Nov 2016

SINGAPORE ACCIDENT STATEMENT

VEHICLE DAMAGE INSPECTION REPORT

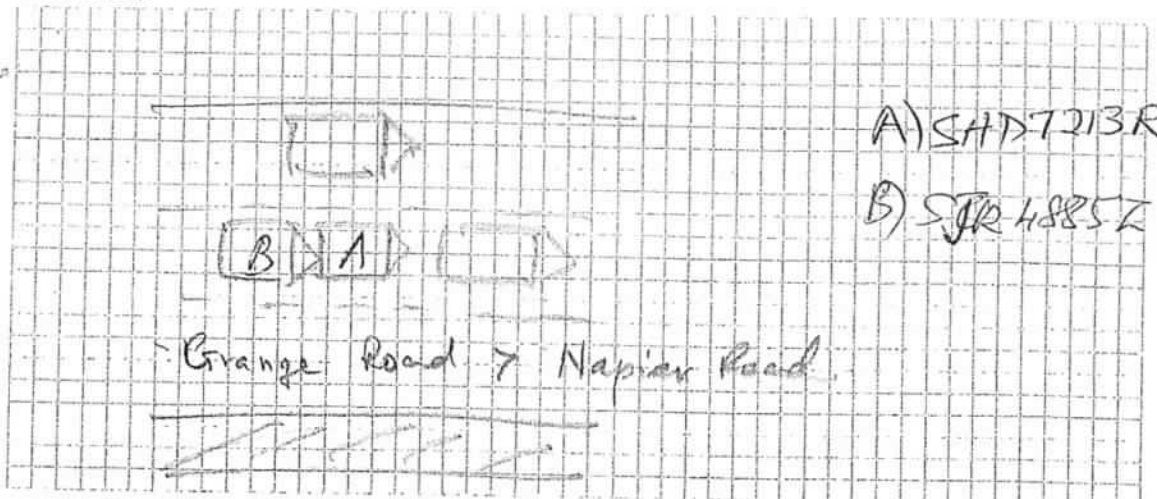
SKETCH PLAN

On 2/5/19 at about 1625hrs when I veh A gradually behind other vehicles in front. Veh B collided onto the rear of my stationary vehicle.

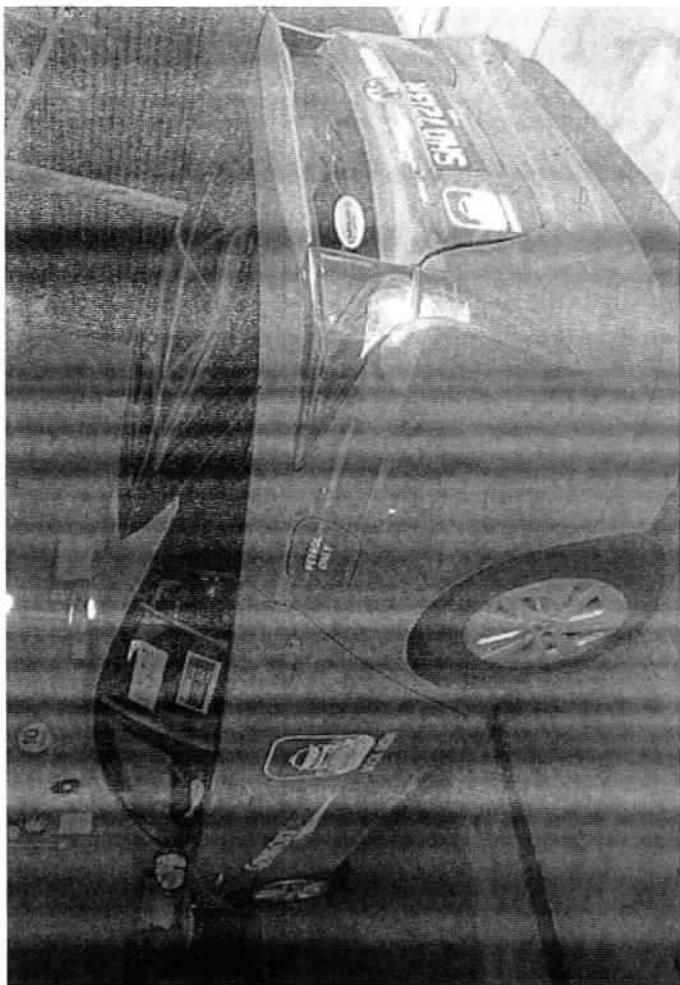
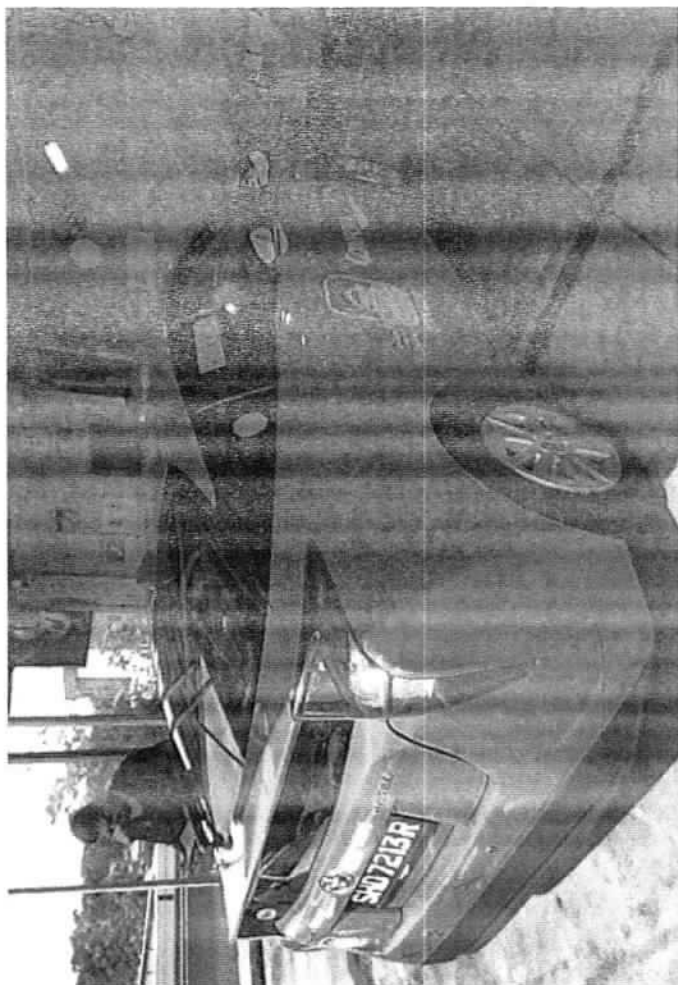
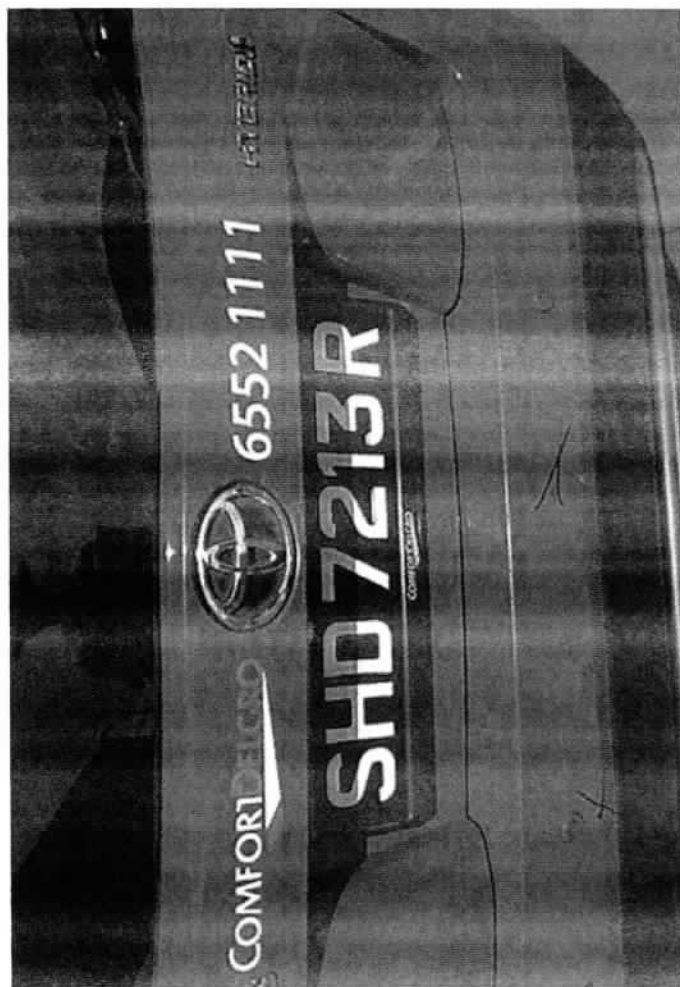
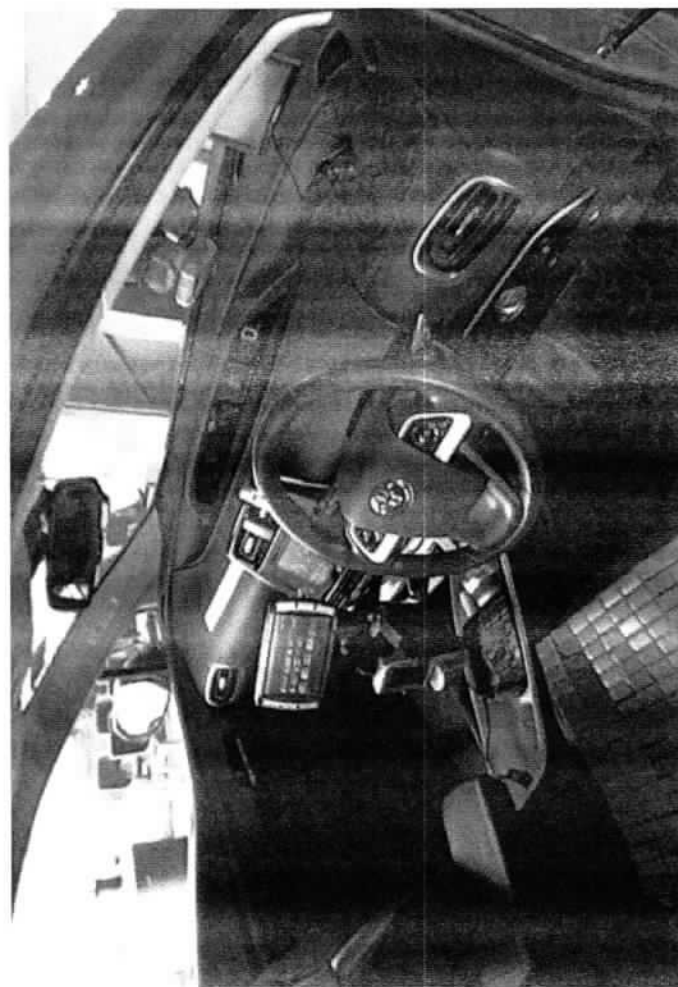
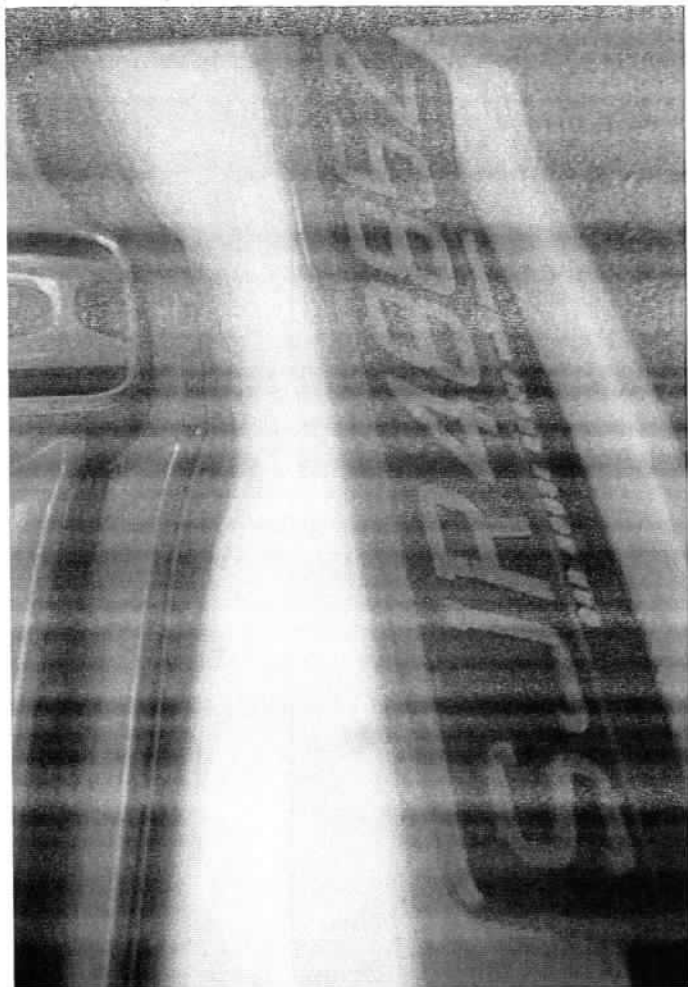
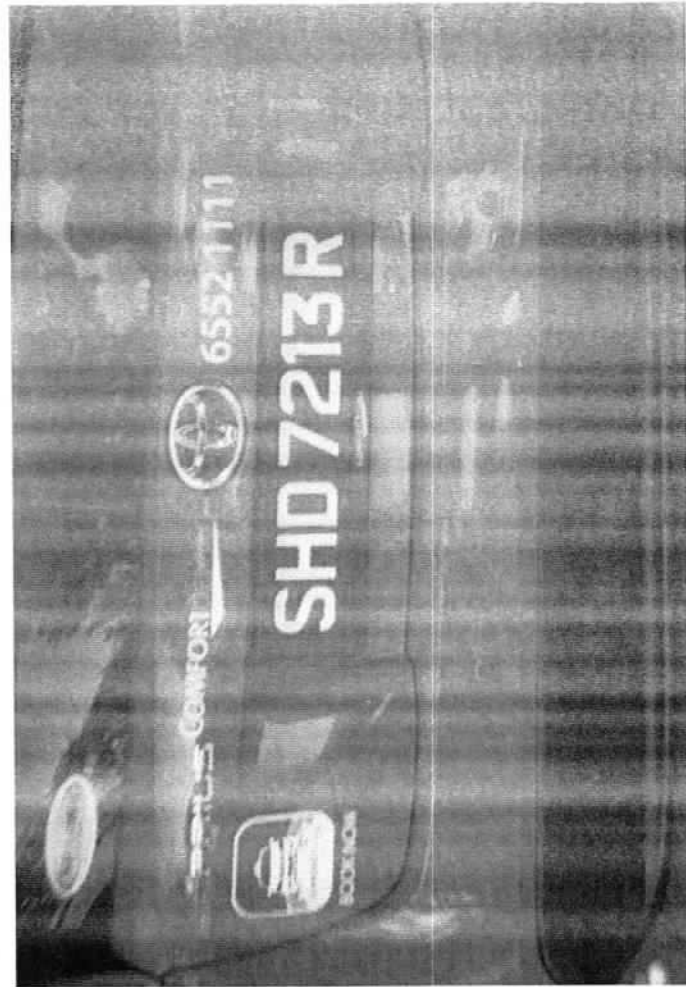
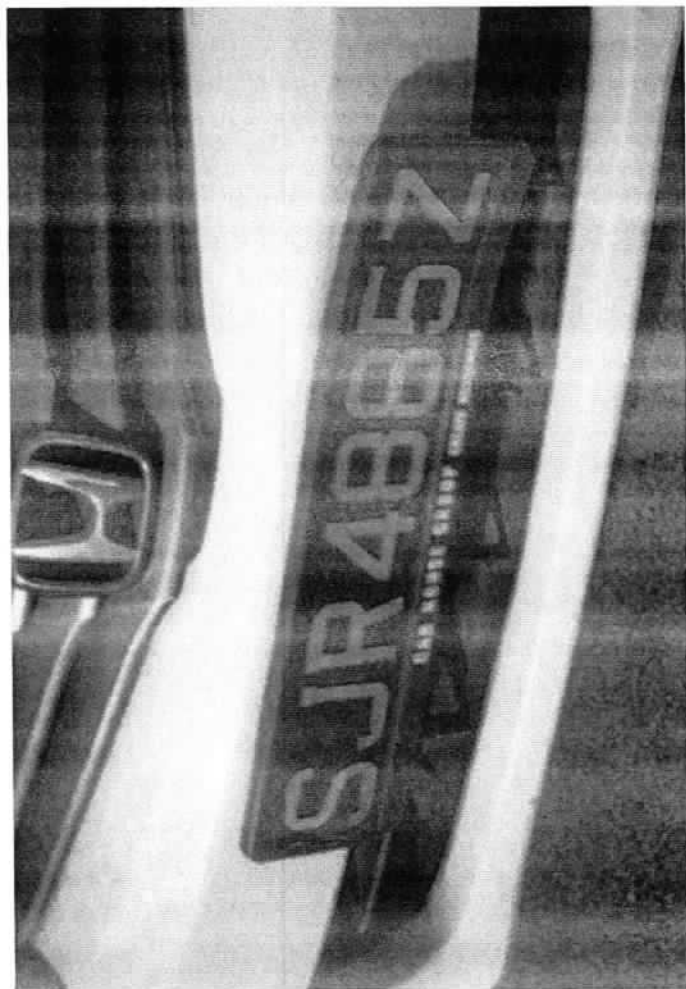
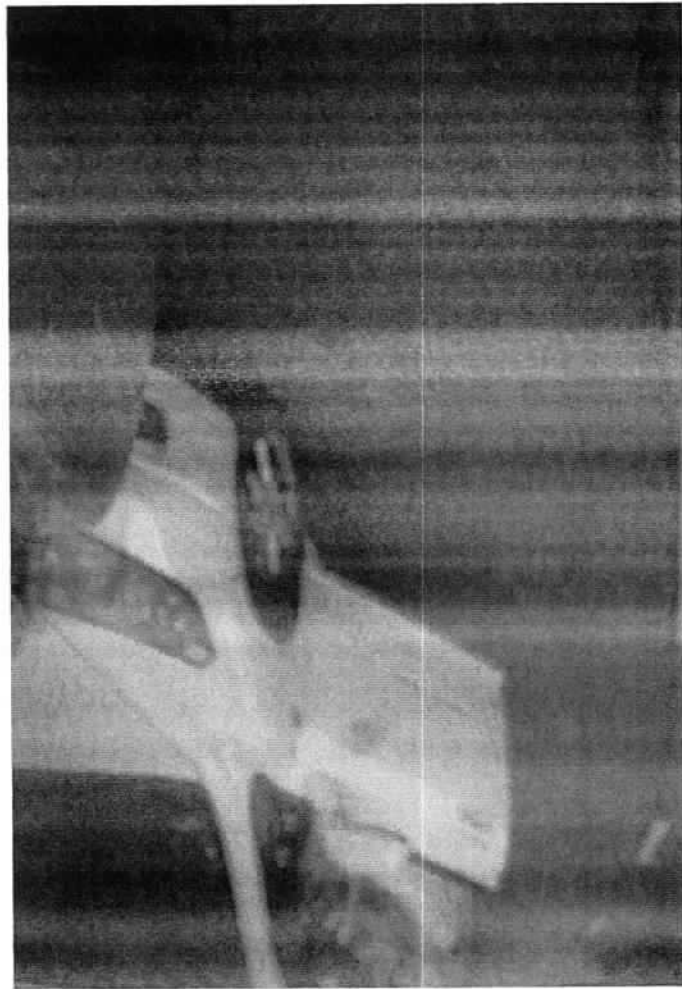
Rear

The U/C / Chassis frame / Body Structure affected due to collision.

No.	Qty	Part No.	Particulars	Condition	Repairer's	Amount
1	1		*REAR BUMPER	Deformed	458.60 FL	*458.60 FL
2	1		*REAR BUMPER UNDER COVER	Cut	552.60 FL	*552.60 FL
3	10		*REAR BUMPER CLIPS	Necessary	22.00 FL	*22.00 FL
Supplementary #1						
4	1		*REAR BUMPER REINFORCEMENT	Bent	318.80 FL	*318.80 FL
					Sub Total (S\$)	1,352.00
					- List Item Discount on L Items 25.00/25.00% (S\$)	338.00
					Total Parts (S\$)	1,014.00

No	Particulars	Lab.Type	Repairer's	Amount
<u>Labour Items</u>				
1	PANEL BEATING	New	400.00	200.00
2	SPRAY PAINTING	New	300.00	200.00
3	WIRING	New	30.00	0.00
4	REMOVE/REFIX REVERSE SENSOR	New	80.00	30.00
Gross Labour Cost (S\$)			810.00	430.00
