THIRD PARTY SURVEY  
ACCIDENT OCCURED ON 08 FEB 2019

Registration No : SGN3432K  
Model : TOYOTA COROLLA ALTIS 1.6  
Year / Capacity : Nov 2006 / 1598 cc  
Chassis No : MR053ZEC107136437

Vehicle Number : SGN3432K

## VEHICLE DAMAGE INSPECTION REPORT

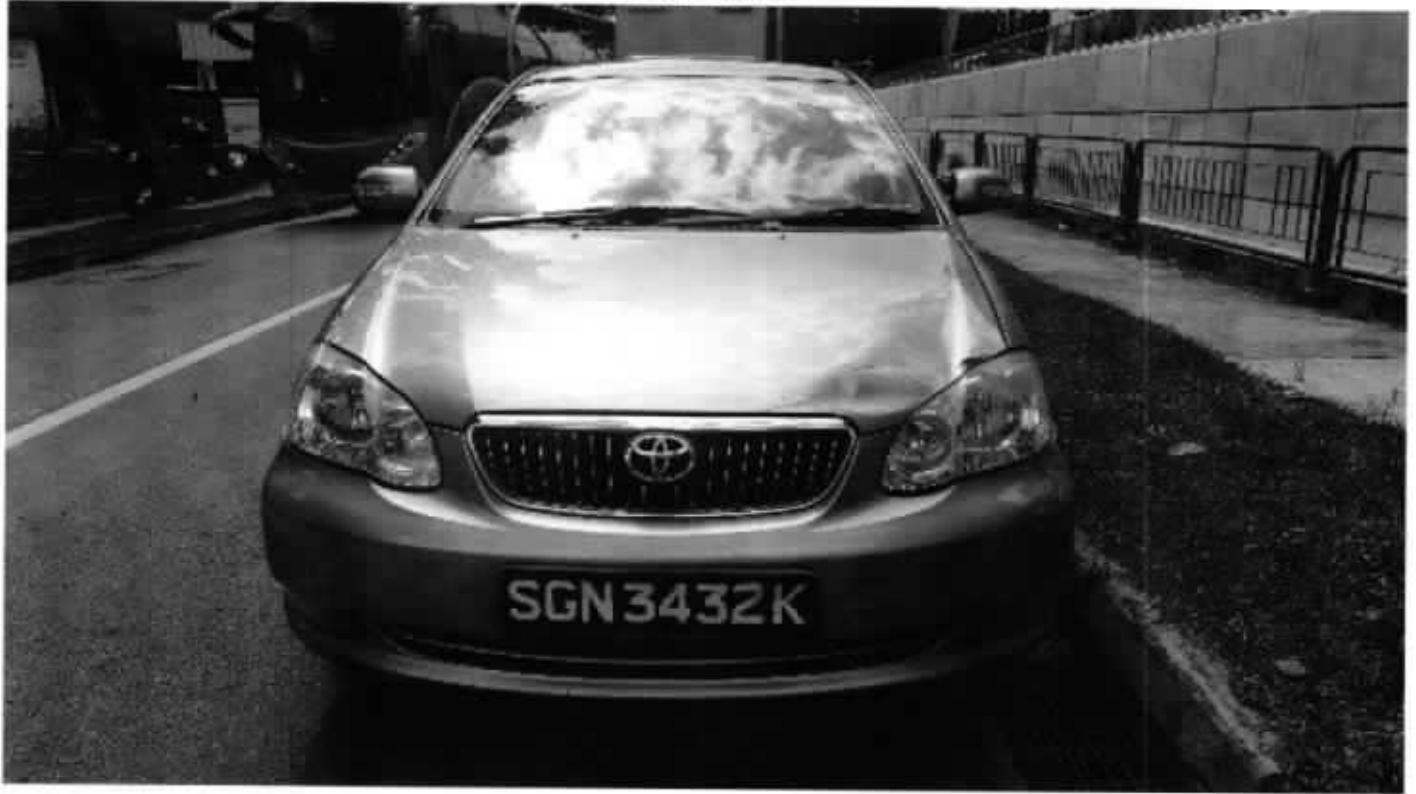
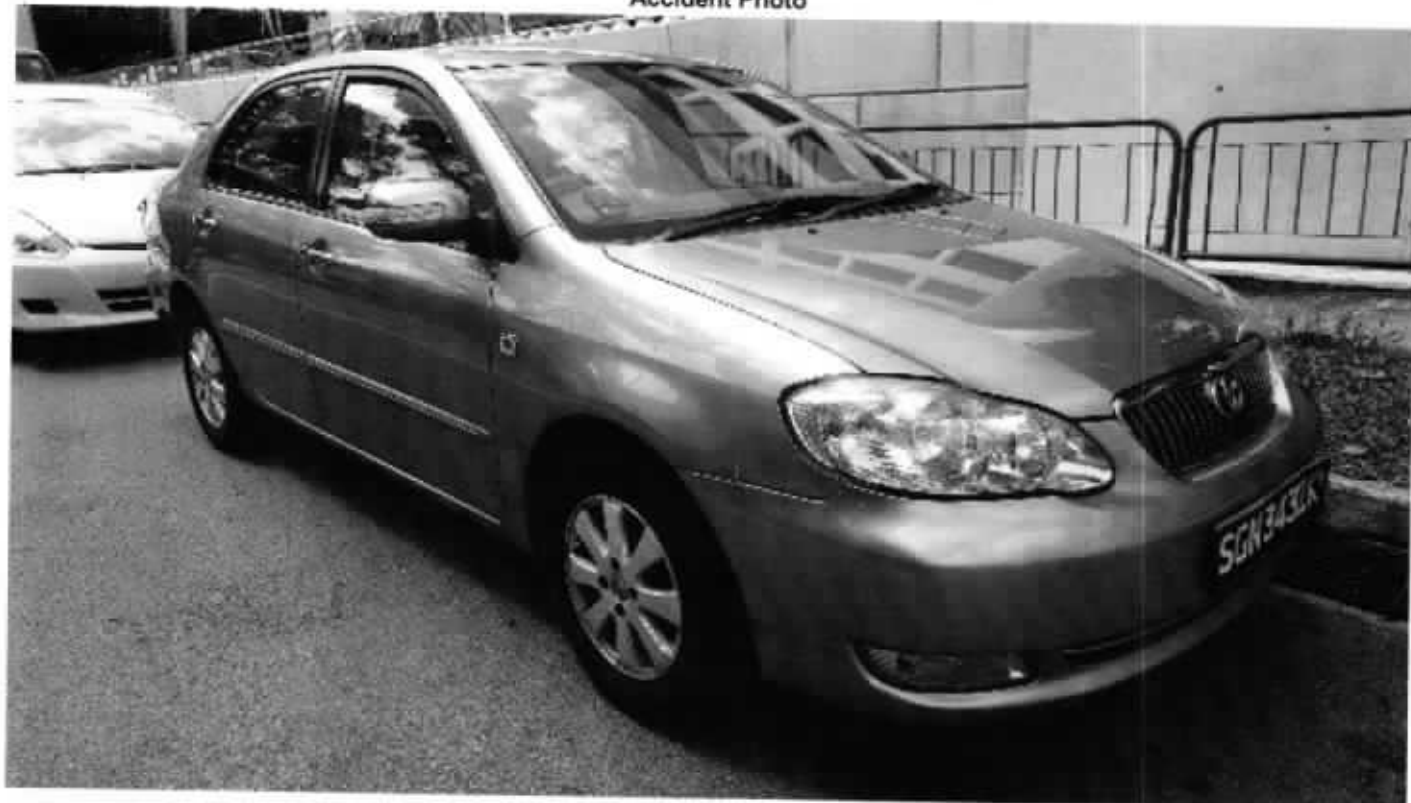
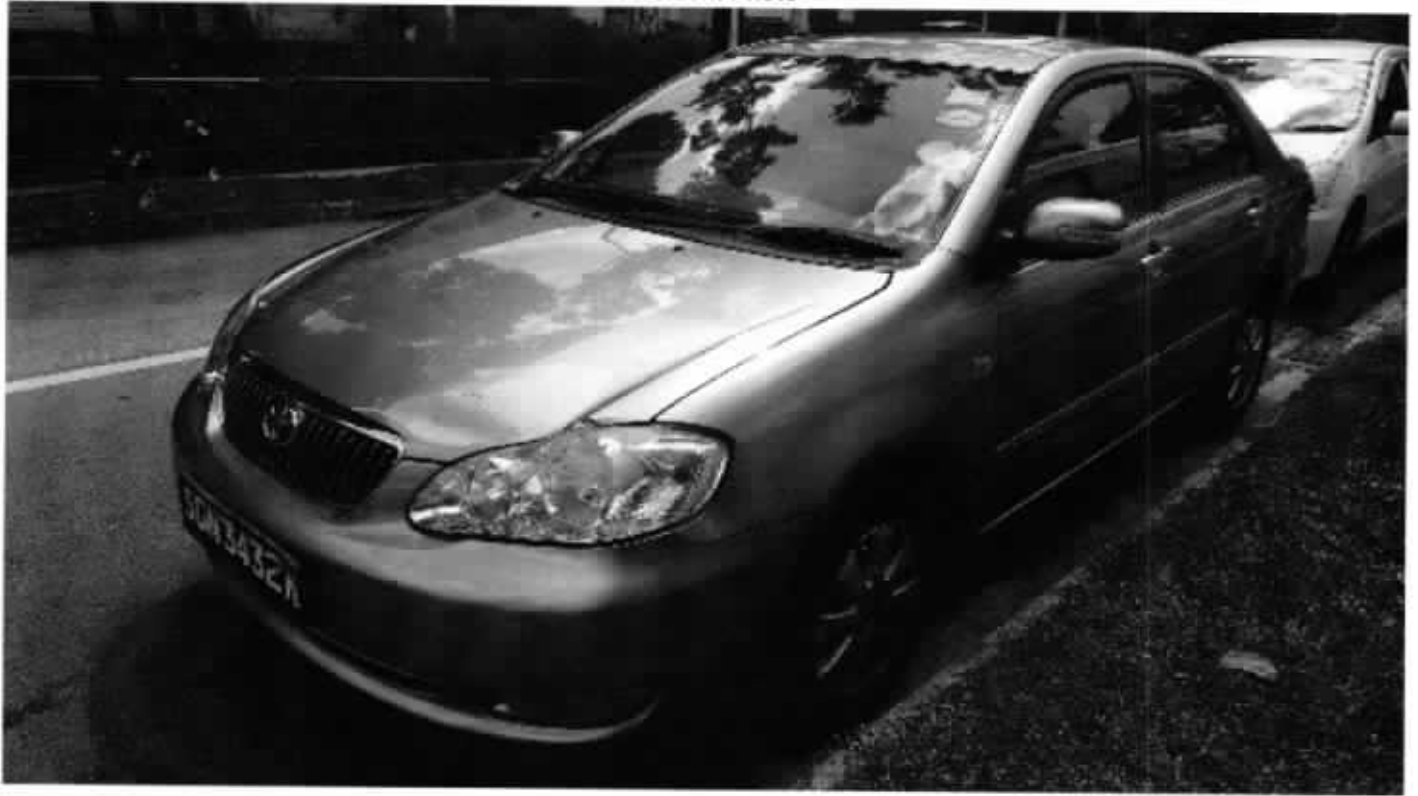
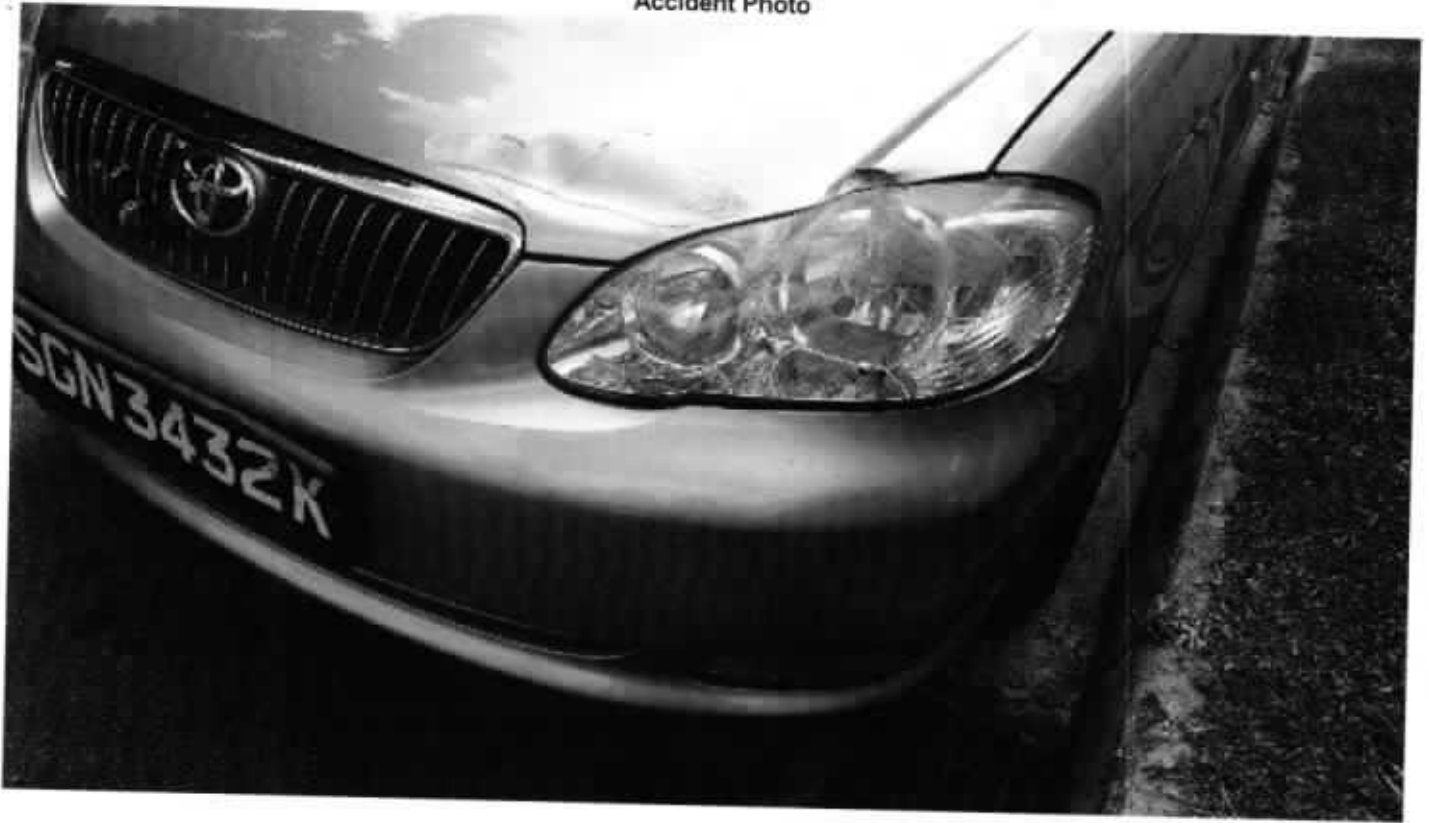
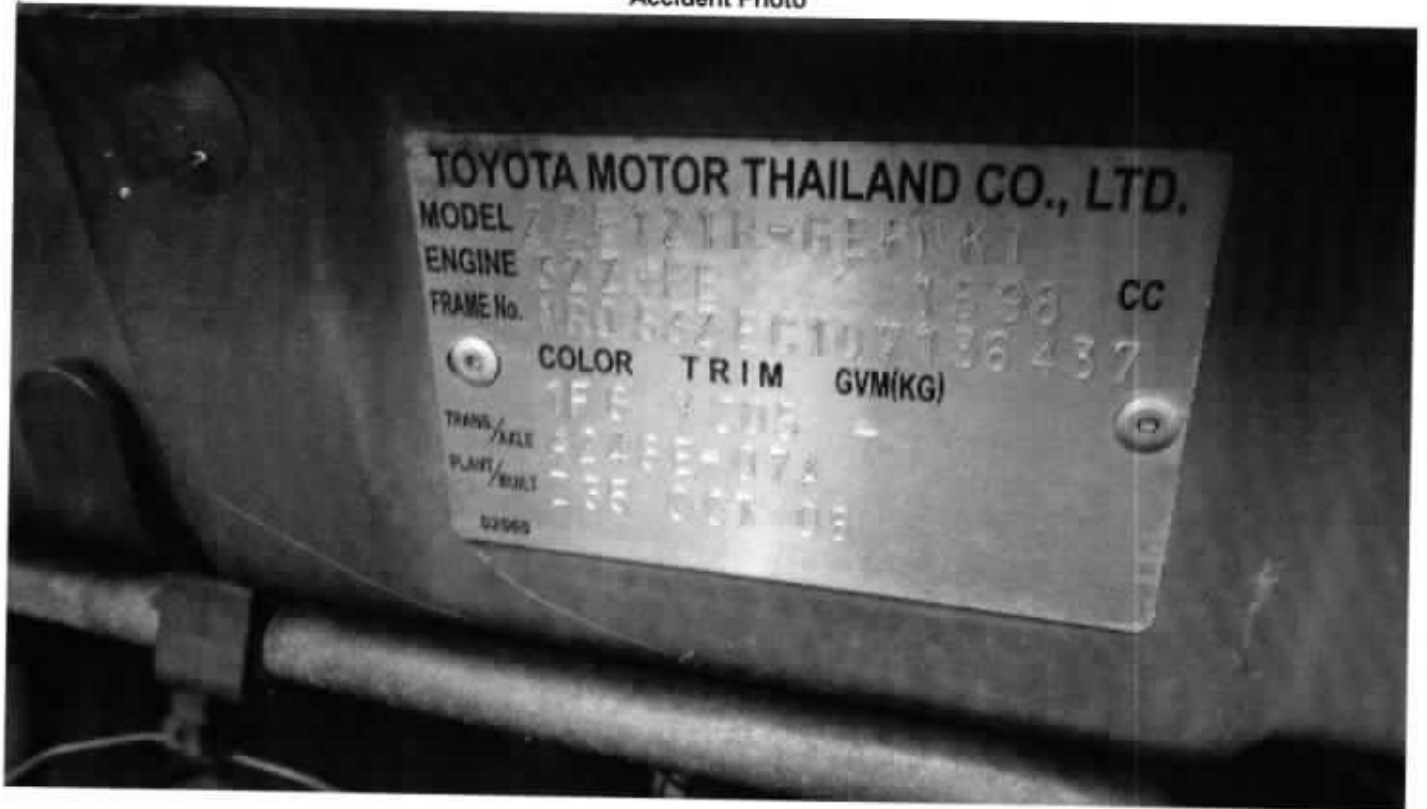
Accident Photo

At the time of inspection, we noted that the vehicle has sustained an impact damages on the Front portion(s). For more detail of the damages, please see photograph attached.
