Vehicle Inspection Report

Report No: AAS/2019/100

Registration no: SKH335L
Make/Model: Volkswagen New Beetle (A)
Year of registration: 2009
Colour: Metallic Black

VEHICLE DAMAGE INSPECTION REPORT

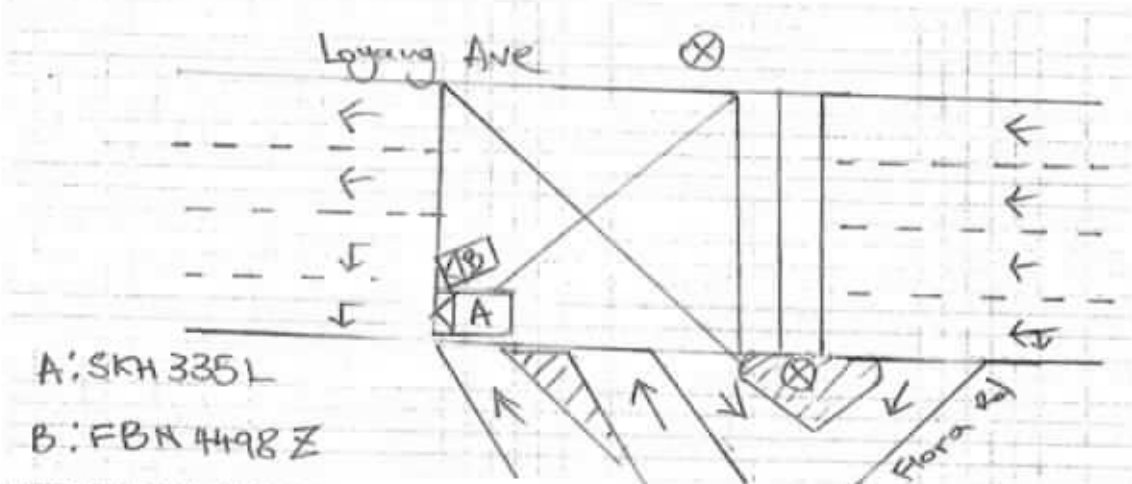
SKETCH PLAN

I was driving along Loyang Ave towards TPE (PIE) in lane 4. Approaching the above traffic junction, the traffic light was green, my lane ahead was clear and I proceeded straight. Suddenly, vehicle B changed lane in yellow box, cut into my lane and collided into the front of my vehicle.

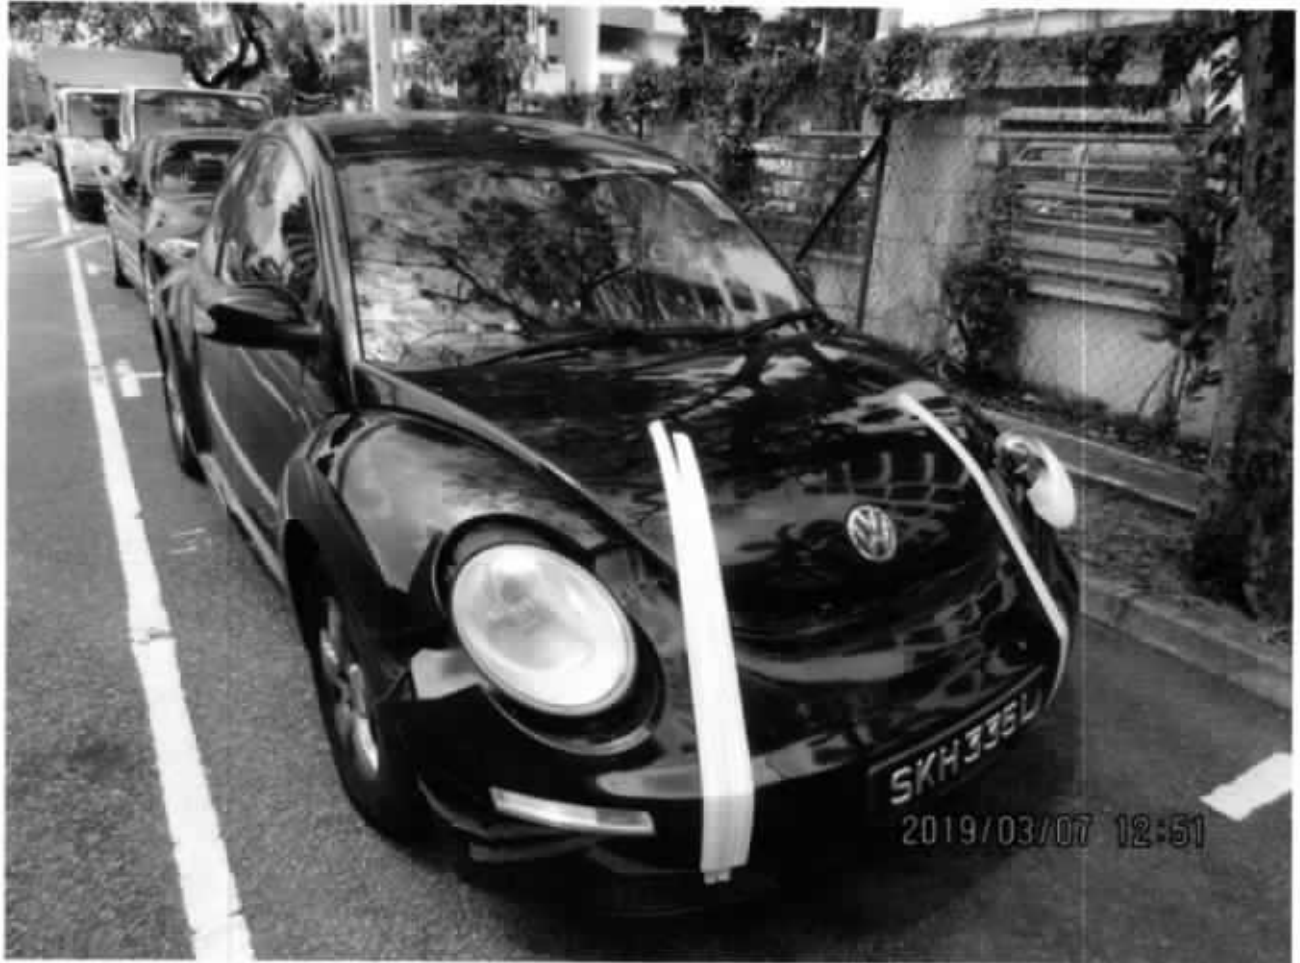
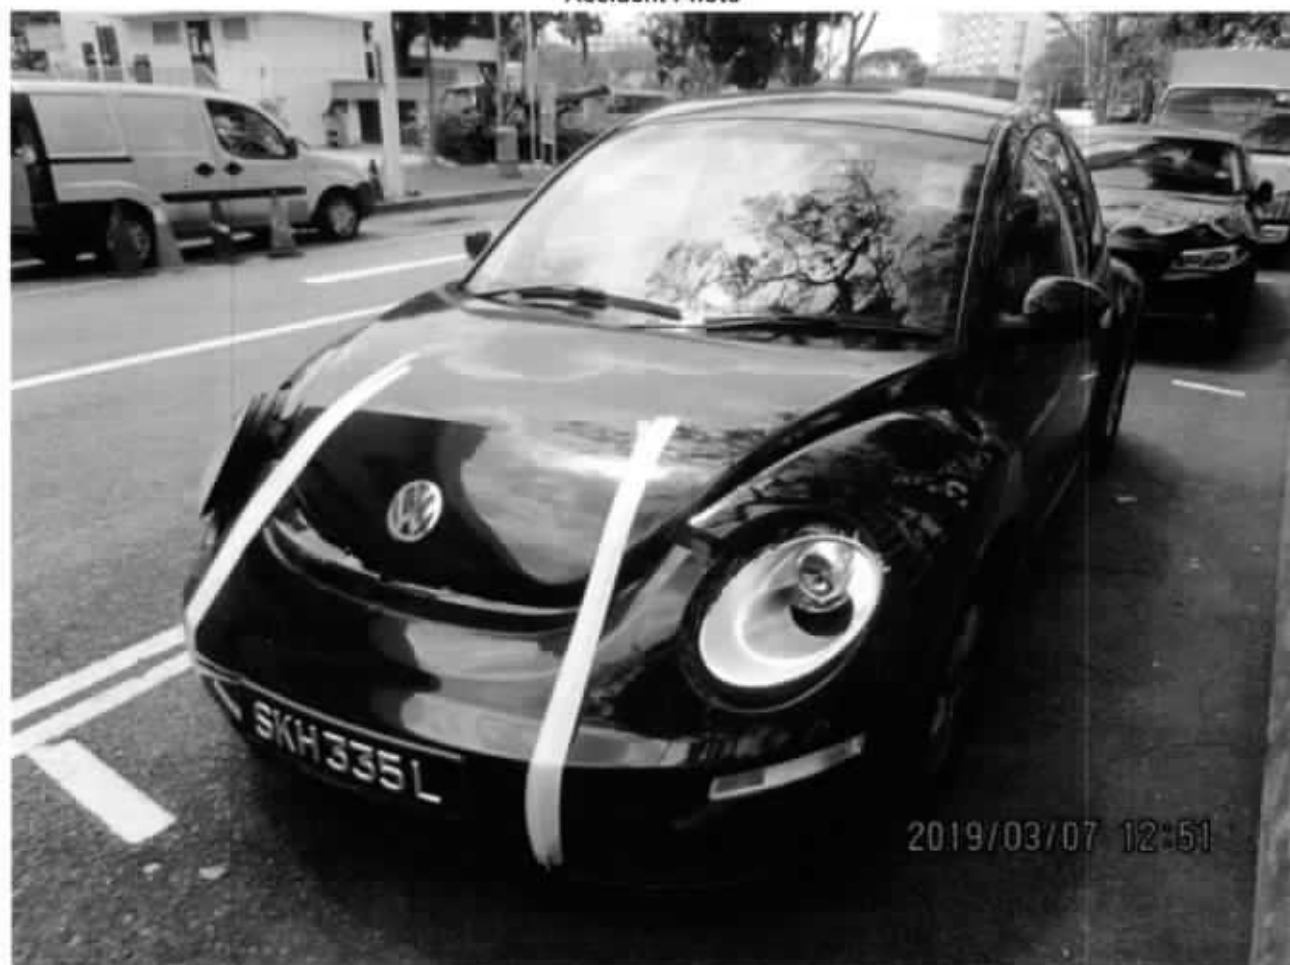
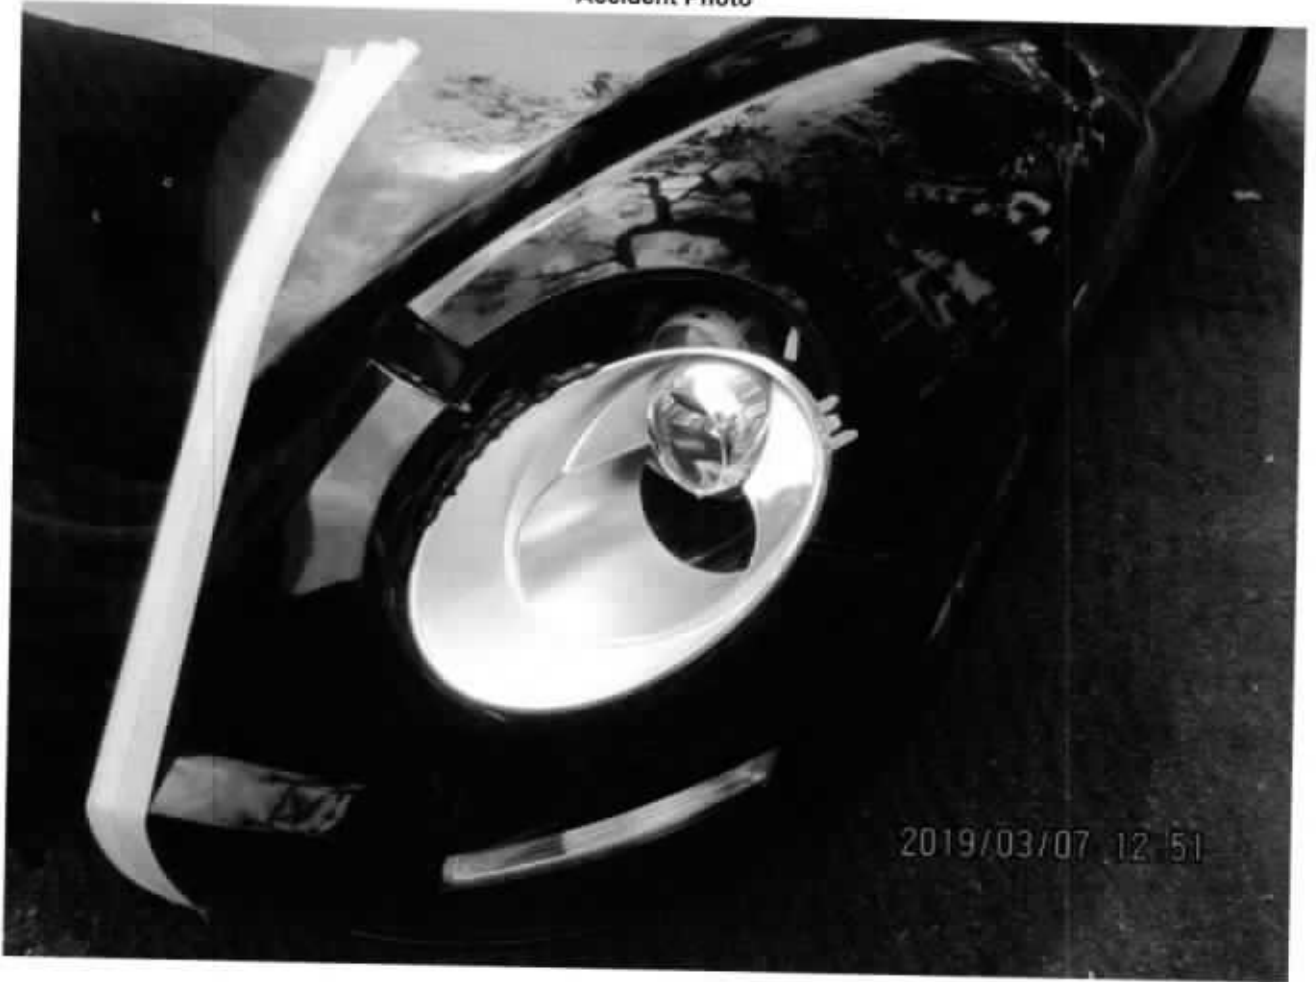
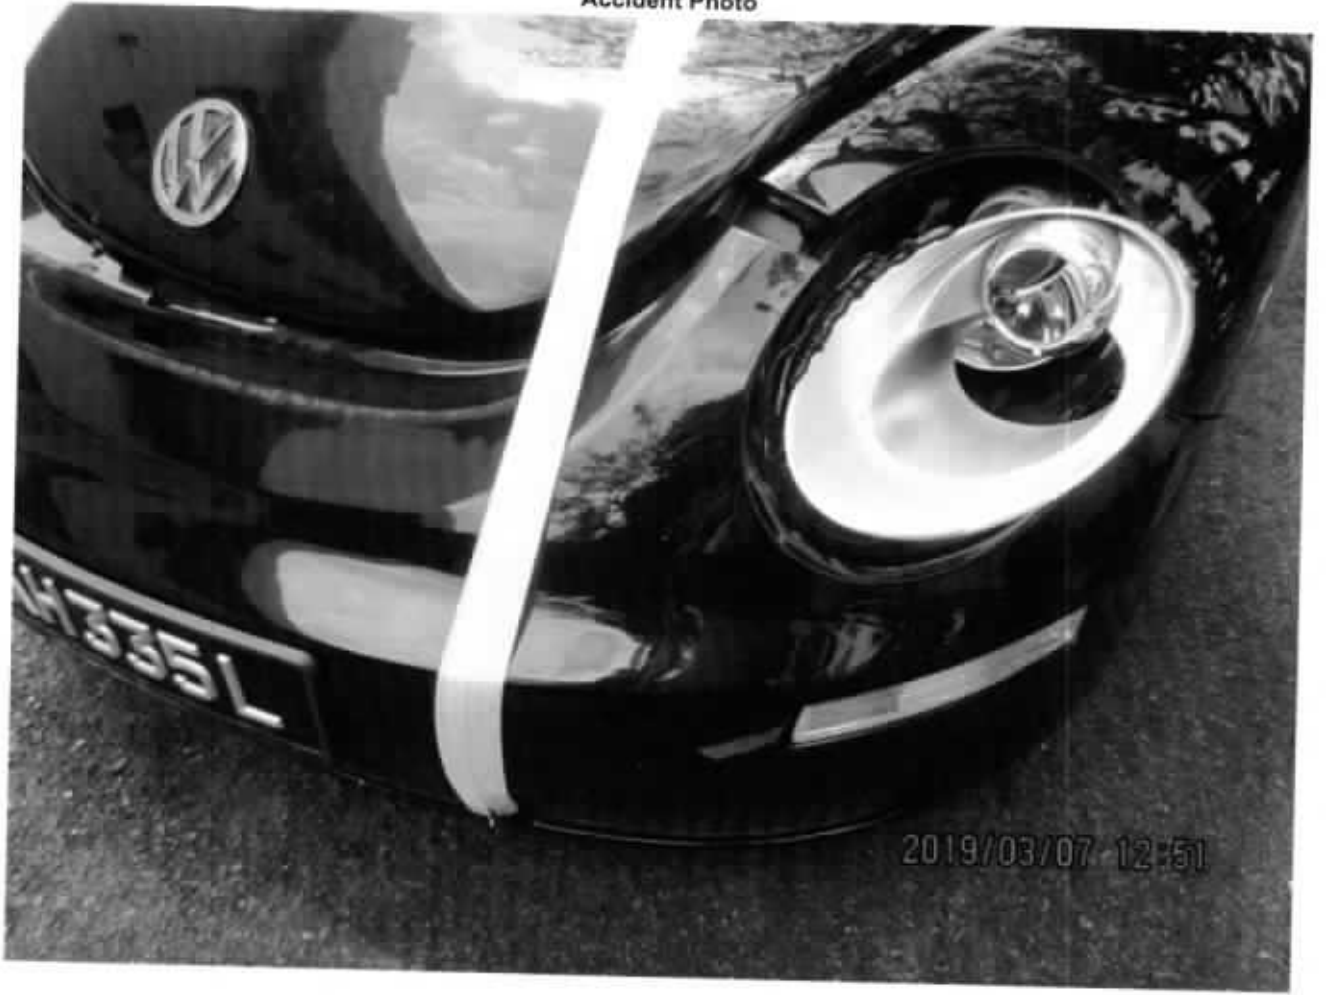
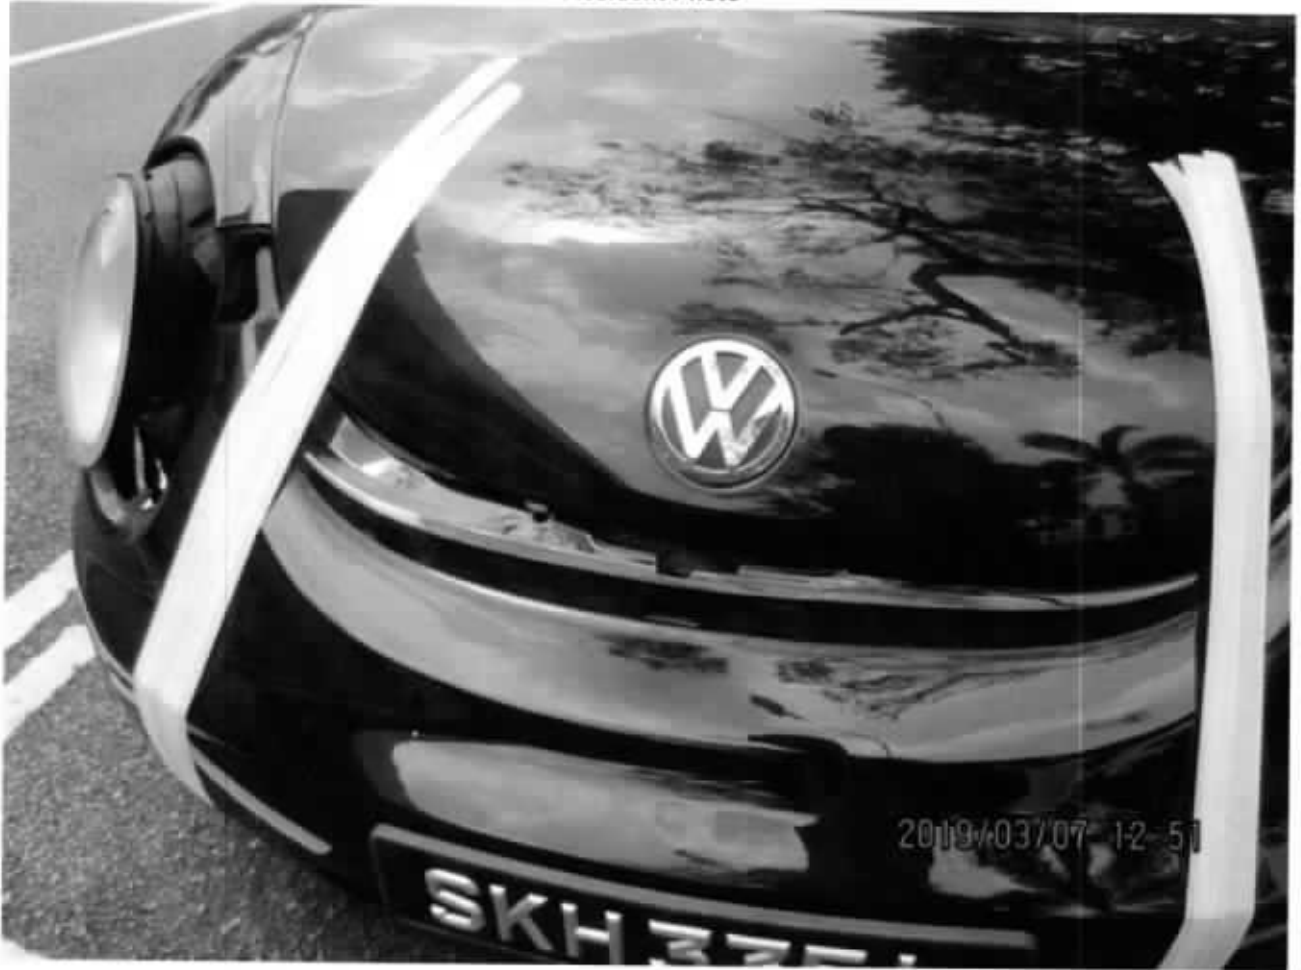
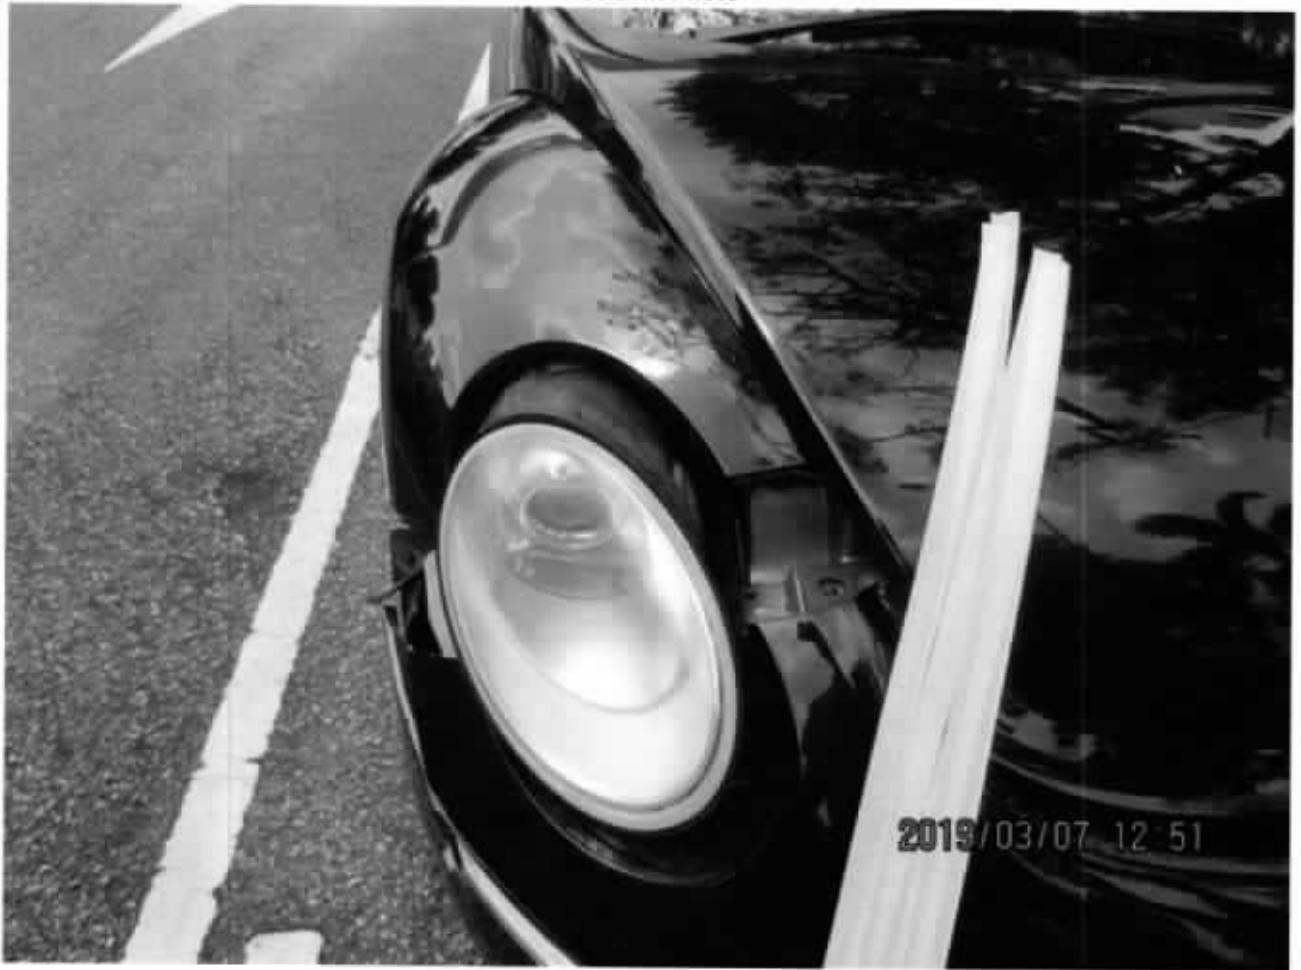
Point of impact

At the RHF portion.

General description of damages

The RHF fender, RHF road wheel, front bumper, headlamps, bonnet, lock carrier, etc.

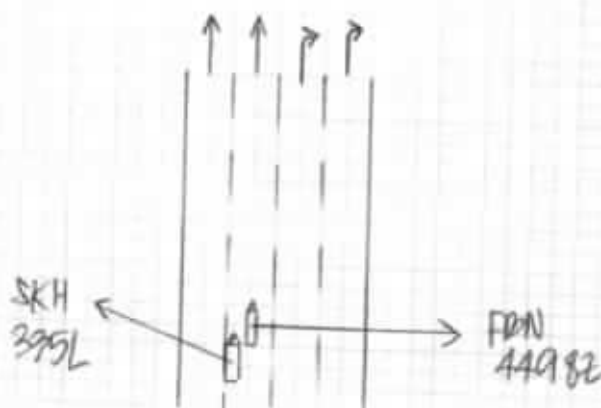
SKETCH PLAN

I was travelling along Layan Road suddenly the car (SKH 335L) was beside & near to my left leg. It does not hit my bike.
