1. Policy Particulars :- THIRD PARTY CLAIM			
Insured Veh.	GBG 8461P	Veh. Inspected	SHA 5695L
Policy No.	5096096539-01	Coverage (\$)	0.00
Claim No.	MT/1049873-001	Excess (\$)	0.00
Assign From		Assign Date	03/06/2019

4. Description of Damages			
THE VEHICLE SUSTAINED DAMAGES AT THE O/S BODY. DAMAGES SEE DETAILS.			
5. General Information			
Accident Date	30/05/2019	Inspection Date	03/06/2019
Survey held at	COMFORTDELGRO ENGINEERING PTE LTD 59 LOYANG DRIVE SINGAPORE 508969		
5a. Remarks			
A)THE INSPECTION WAS CONDUCTED ON A"WITHOUT PREJUDICE" BASIS. B)IN ACCORDANCE TO YOUR INSTRUCTIONS, WE HAVE NOT AUTHORISED REPAIRS.			
5b. Estimate Days of Repair			
ESTIMATED NORMAL PERIOD FOR REPAIR:		3 Working Days

ADJUSTMENT ON REPAIR COST FOR VEHICLE NO. SHA 5695L

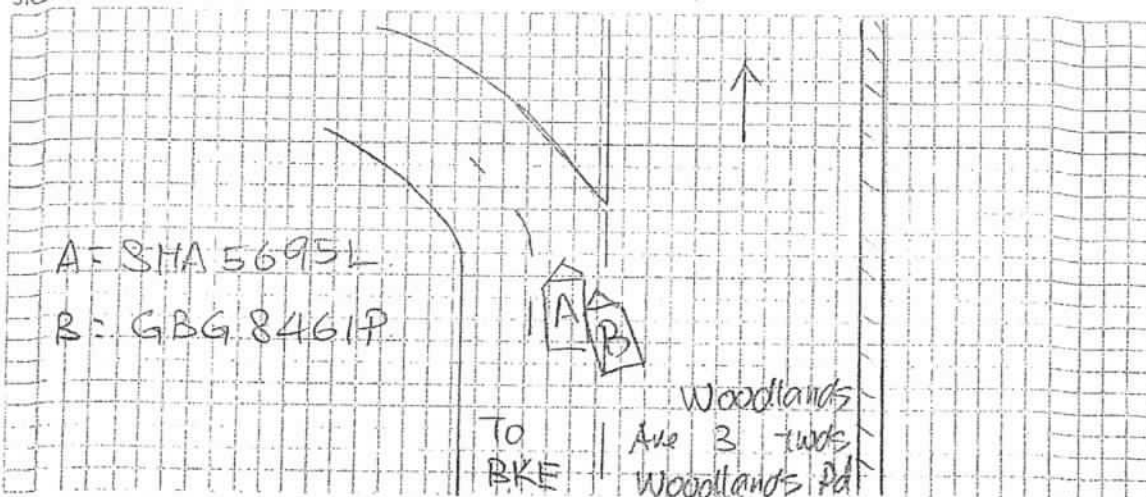
SKETCH PLAN

On 30/5/19 at about 07:40 hrs, I was driving at above said location with a female pax onboard. Suddenly I felt an impact from right hand side. Veh B encroached into my lane and it front left portion hit & grazed onto the right portion of my taxi. Both of us then alighted to take photo. No injury reported in this accident.
