**ACCIDENT INVOLVING SMA 9757 G & SML 1209 S ALONG SIMS AVENUE  
TOWARDS CHANGI INBETWEEN LORONG 9 & 11 ON 1 JUNE 2019 AT ABOUT  
1250 HOURS**

## VEHICLE DAMAGE INSPECTION REPORT

Our File No: CS3/AIG19009848/GCD3E2

Handling Insurer: AIG Asia Pacific Insurance Pte. Ltd. Policy No: 0999994322  
**Claimant Vehicle No :** SMA9757G **Insured Vehicle No :** SML1209S  
 Date of Loss: 01/06/2019 Nature of Claim: TP Claim No: 7298599023SG

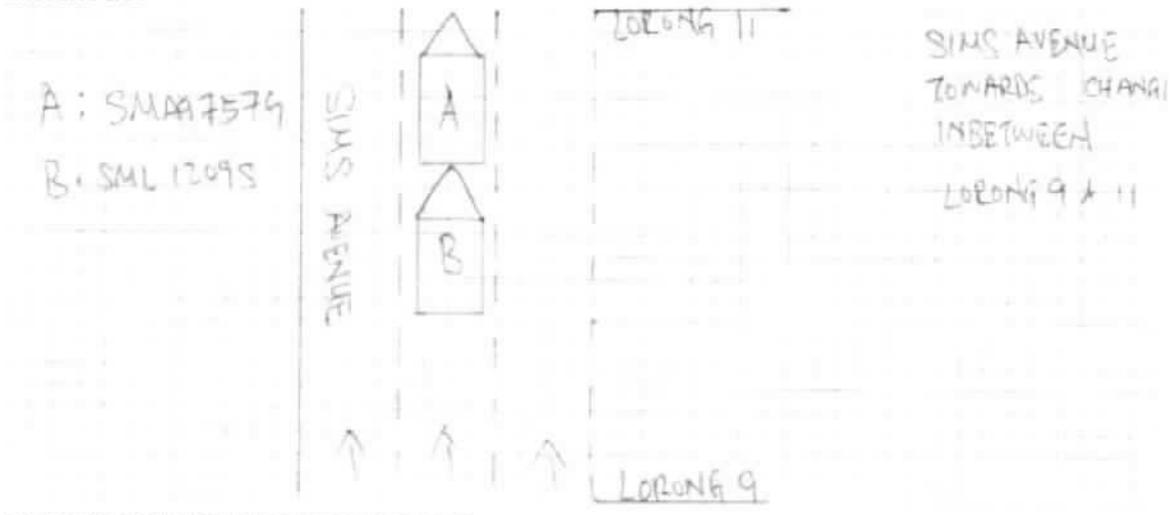
SKETCH PLAN

I WAS TRAVELLING ALONG THE STATED TIME AND LOCATION.

I noticed a vehicle on my right signalling to cut into my lane. I SLOWED DOWN AND STOPPED. SUDDENLY I FELT AN IMPACT ON MY REAR. I GOT DOWN AND INSPECT AND KNOW THAT VEHICLE 'B' HAD HIT INTO MY VEHICLE.
