To Inspect Vehicle No: SJT 2575X

HYUNDAI AVANTE

The U/C / Chassis frame / Body Structure affected due to collision.

## VEHICLE DAMAGE INSPECTION REPORT

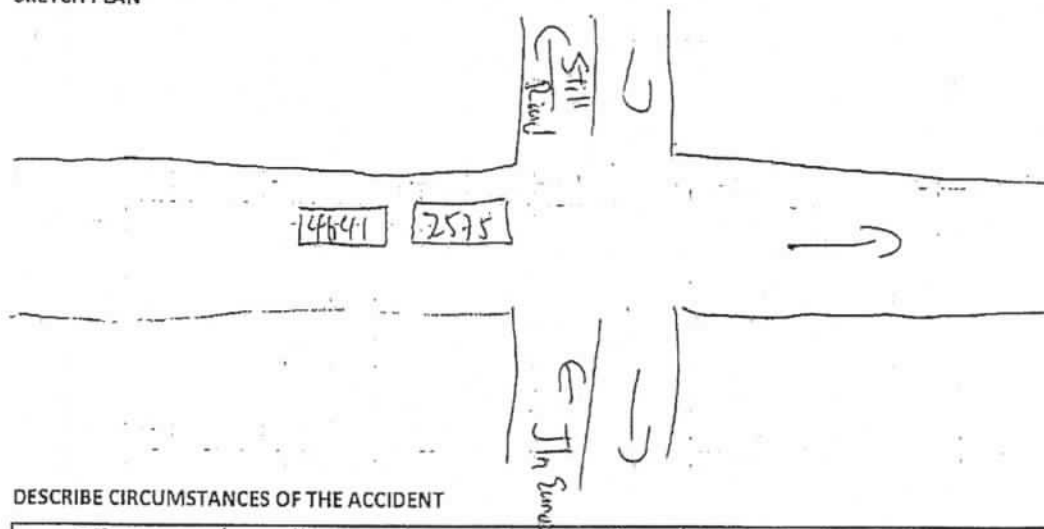
### SKETCH PLAN

I was travelling along Changi Road. I approached the traffic light junction of Changi Rd and Jalan Eunos. I saw the traffic light turn amber. The car in front of me slowed down and passed the junction. I could not pass the junction and came to a stop.

As I came to a stop, the van behind hit me straight on.  
The road was still wet and after a rest,
