REF: NS/INC19009953/KIND302

1. Policy Particulars :- THIRD PARTY CLAIM				
Insured Veh.	SKG 8820E	Veh. Inspected	SH 4374C	
Policy No.	5104288329	Coverage (\$)	0.00	
Claim No.	MT/1047514-002	Excess (\$)	0.00	
Assign From		Assign Date	04/06/2019

ADJUSTMENT ON REPAIR COST FOR VEHICLE NO. SH 4374C

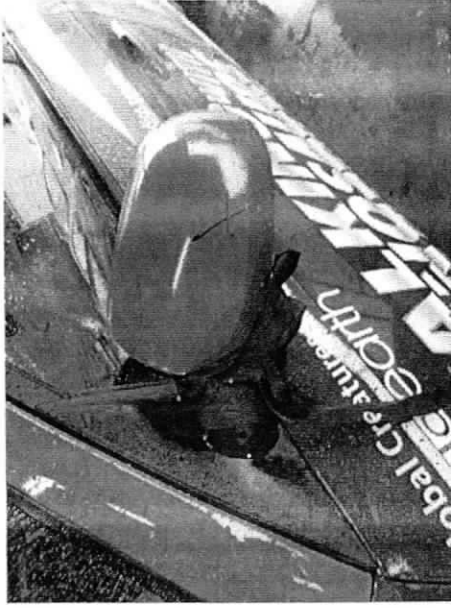
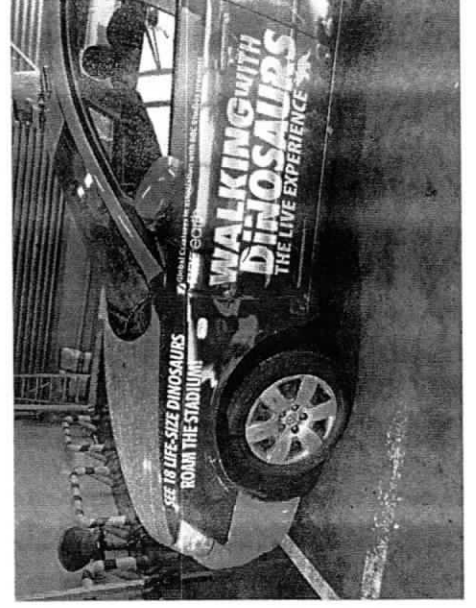
collision. As a result the said vehicle right front collided onto my left front portion of my taxi.

4. Description of Damages				
THE VEHICLE SUSTAINED DAMAGES AT THE N/S BODY. DAMAGES SEE DETAILS.				
5. General Information				
Accident Date	03/06/2019	Inspection Date	04/06/2019	
Survey held at	COMFORTDELGRO ENGINEERING PTE LTD 59 LOYANG DRIVE SINGAPORE 508969			
5a. Remarks				
A)THE INSPECTION WAS CONDUCTED ON A"WITHOUT PREJUDICE" BASIS. B)IN ACCORDANCE TO YOUR INSTRUCTIONS, WE HAVE NOT AUTHORISED REPAIRS.				
5b. Estimate Days of Repair				
ESTIMATED NORMAL PERIOD FOR REPAIR:		3 Working Days

200.00	200.00
<u>LABOUR</u>				
	PANEL BEATING. INCLUSIVE OF THE REPAIR OF FRONT BUMPER COVER, FRONT FENDER (LH) AND FRONT LH WINDSCREEN PILLAR.		800.00	400.00
	SPRAY PAINTING CHARGE.		1,000.00	850.00
	WIRING CHARGE.		50.00	20.00
	TUFF KOTE.		50.00	30.00
	TRANSFER OF DOOR.		120.00	50.00
	TOWING NORMAL.		60.00	-
			2,080.00	1,350.00

GRAND TOTAL		4,866.92	3,129.90
RECOMMENDED COST OF LUMP SUM REPAIRS (TO ITS PRE-ACCIDENT CONDITION) (CONFIRMED)			2,500.00
