1. Policy Particulars :- THIRD PARTY CLAIM

4. Description of Damages

THE VEHICLE SUSTAINED DAMAGES AT THE FRONT O/S PORTION.
DAMAGES SEE DETAILS.

ADJUSTMENT ON REPAIR COST FOR VEHICLE NO. SHD 3346S

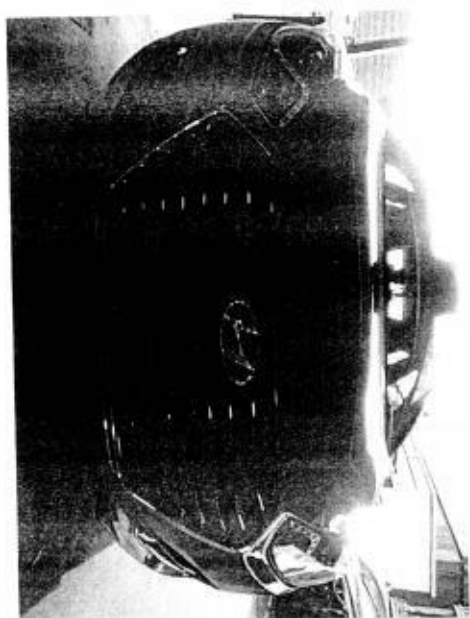
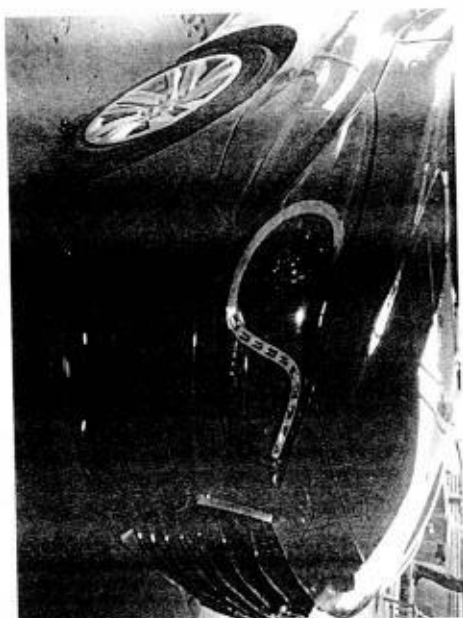
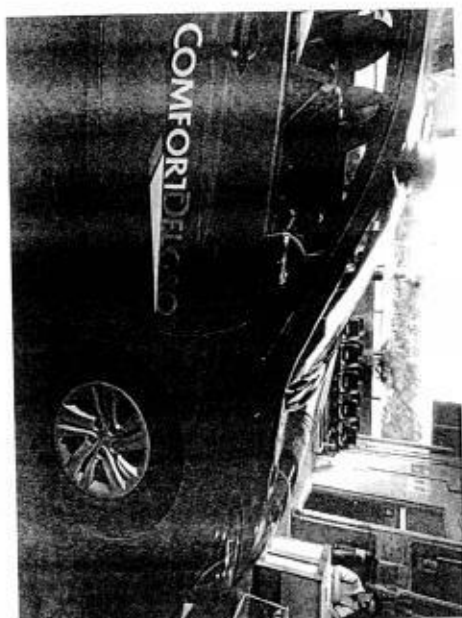
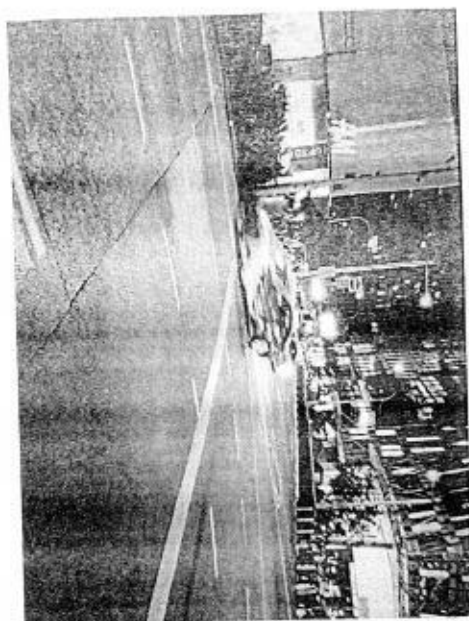
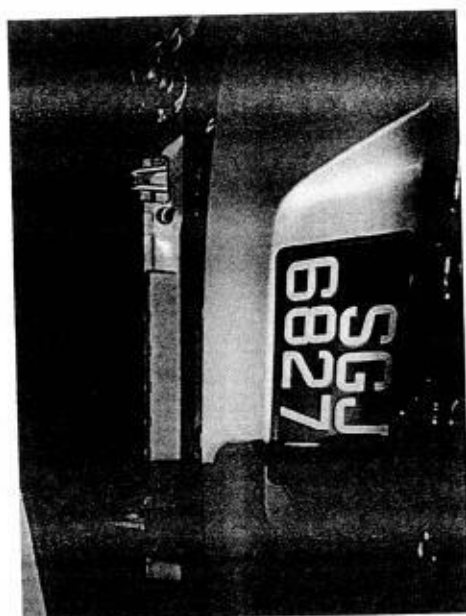
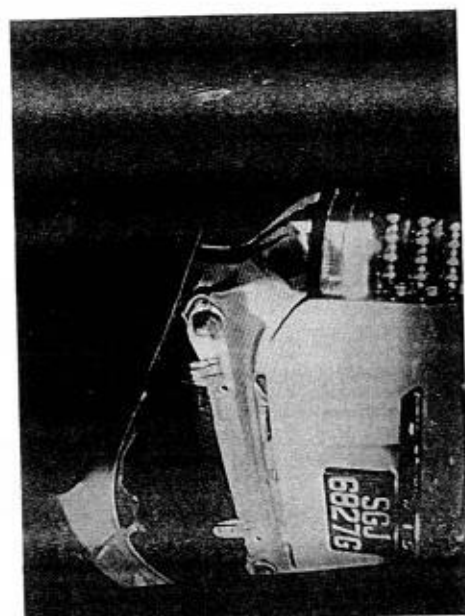
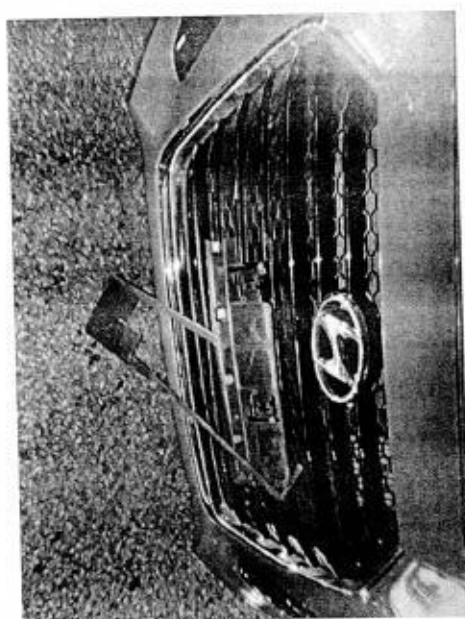
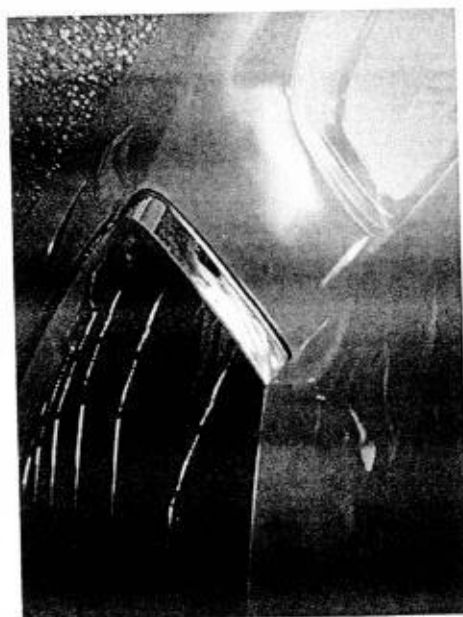
Front d/s.

The U/C / Chassis frame / Body Structure affected due to collision.

Qty	Description of Parts	Condition	Estimate By Workshop (\$)	Our Adjusted (\$)
<u>REPLACEMENT OF PARTS</u>				
1	RADIATOR GRILLE	CRACKED	1,110.10	1,110.10
1	FRONT BUMPER COVER	CUT	1,052.20	1,052.20
1	FRONT BUMPER SPONGE	SERVICEABLE	99.20	-
1	FRONT BUMPER REINFORCEMENT	SERVICEABLE	402.10	-
1	FRONT BUMPER GRILLE (RH)	SERVICEABLE	93.60	-
1	FRONT BUMPER BRACKET TOP (RH)	SERVICEABLE	22.40	-
1	FRONT BUMPER BRACKET (RH)	SERVICEABLE	24.60	-
1	HEADLAMP (LH)	GRAZED	1,388.00	1,388.00
	LESS 20% DISCOUNT		-838.44	-710.06
			3,353.76	2,840.24
<u>SPECIAL NETT ITEMS</u>				
1	FRONT NUMBER PLATE (SN)	MISSING	25.00	25.00
			25.00	25.00
<u>LABOUR</u>				
	PANEL BEATING.		400.00	200.00
	SPRAY PAINTING CHARGE.		300.00	200.00
	WIRING.		50.00	30.00
	TOWING FEE.		60.00	-
			810.00	430.00
GRAND TOTAL			4,188.76	3,295.24
RECOMMENDED COST OF LUMP SUM REPAIRS (TO ITS PRE-ACCIDENT CONDITION) (CONFIRMED)				2,650.00
