SH 622 6J

1. Policy Particulars :- THIRD PARTY CLAIM

THE VEHICLE SUSTAINED DAMAGES AT THE FRONT N/S PORTION. DAMAGES SEE DETAILS.

ADJUSTMENT ON REPAIR COST FOR VEHICLE NO. SH 6226J

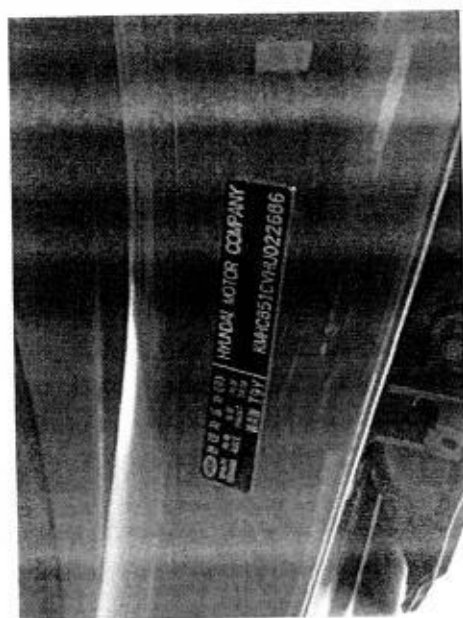
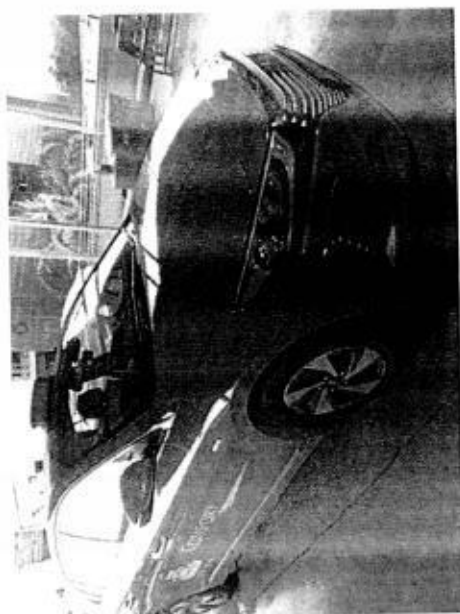
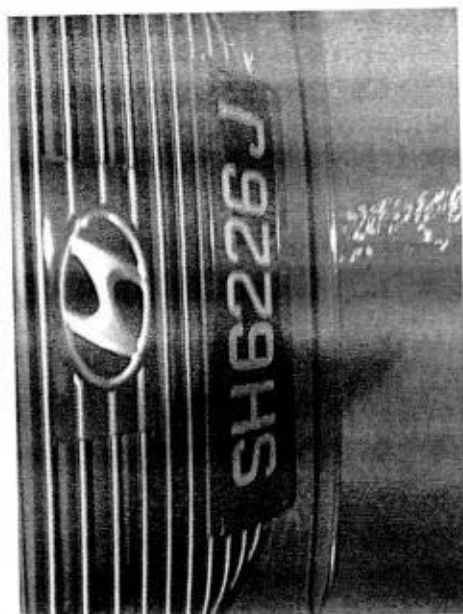
The U/C / Chassis frame / Body Structure affected due to collision.

Qty	Description of Parts	Condition	Estimate By Workshop (\$)	Our Adjusted (\$)
REPLACEMENT OF PARTS				
1	FRONT BUMPER COVER	TO REPAIR SEE LABOUR	418.30	-
10	FRONT BUMPER CLIPS @\$2.20	NOT NECESSARY	22.00	-
10	FRONT BUMPER CLIPS @\$2.20	NOT NECESSARY	22.00	-
1	FRONT BUMPER UPPER MOULDING	CRACKED	108.50	108.50
1	HEADLAMP - LH	CRACKED	1,198.80	1,198.80
1	RADIATOR GRILLE	CRACKED	1,227.50	1,227.50
	LESS 20% DISCOUNT		-599.42	-506.96
			2,397.68	2,027.84
LABOUR				
	PANEL BEATING. INCLUSIVE OF THE REPAIR OF FRONT BUMPER COVER.		400.00	200.00
	SPRAY PAINTING CHARGE.		300.00	200.00
	WIRING CHARGE.		50.00	20.00
			750.00	420.00
GRAND TOTAL			3,147.68	2,447.84
RECOMMENDED COST OF LUMP SUM REPAIRS (TO ITS PRE-ACCIDENT CONDITION) (CONFIRMED)				1,950.00
