To Inspect Vehicle No: SMK 5742Yat Workshop m/s Topmaxof Blk 3007 Ubi Rd 1 #01-410

Veh No: SMK 5742YYr Regn: 2016 AprilType: M. Car / M. Cycle / Bus / Van / Lorry / Taxi / Prime Mover /

Make: Toyota Harrier Premium c.c 1986Colour: BlackA/C: Insured / Std / NI / NASp. Reading: 47250T/Radio: Insured / Std / NI / NA

## VEHICLE DAMAGE INSPECTION REPORT

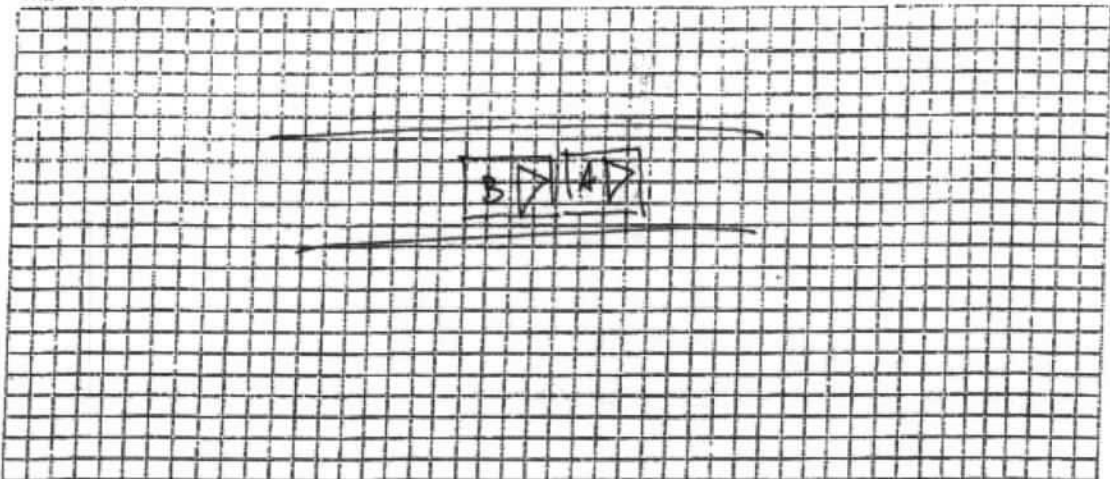
Sketch Plan #2

Type Of Accident	COLLISION - HEAD TO REAR
Weather Conditions	CLEAR
Road Surface	DRY

A - SM1K5742Y  
B - 86Y 2669X
