Your Ref: F/IP/03085/2018  
Our Ref: CI/SPF19010230/D

**Ang Mo Kio Division**  
Singapore Police Force  
51 Ang Mo Kio Avenue 9  
Singapore 569784

### **MECHANICAL INSPECTION REPORT OF AN ELECTRIC SCOOTER**

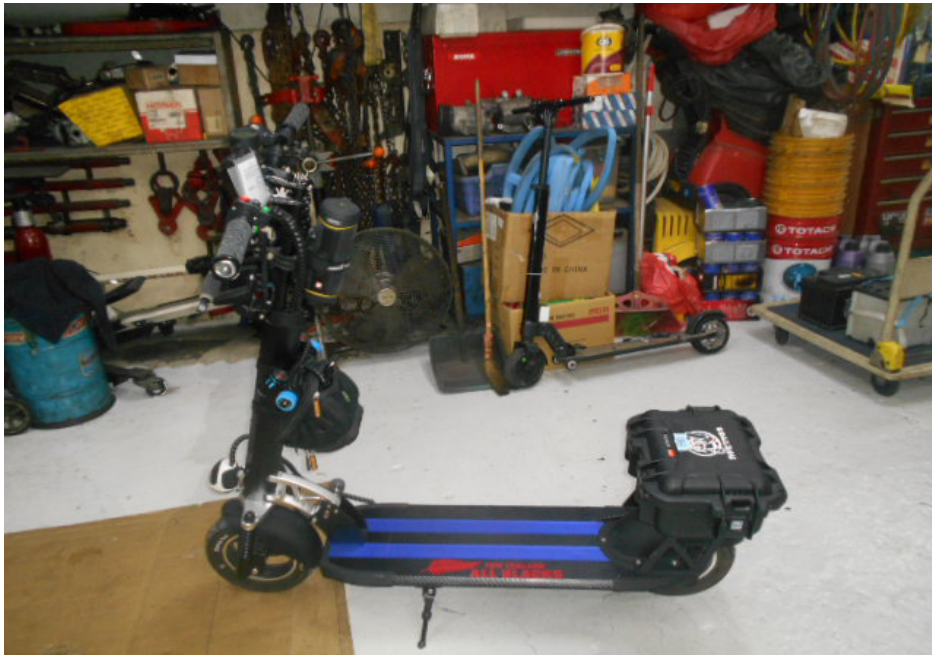
**Photo 1** shows a general view of the electric scooter that I had inspected. The electric scooter was observed to be without any physical damage.

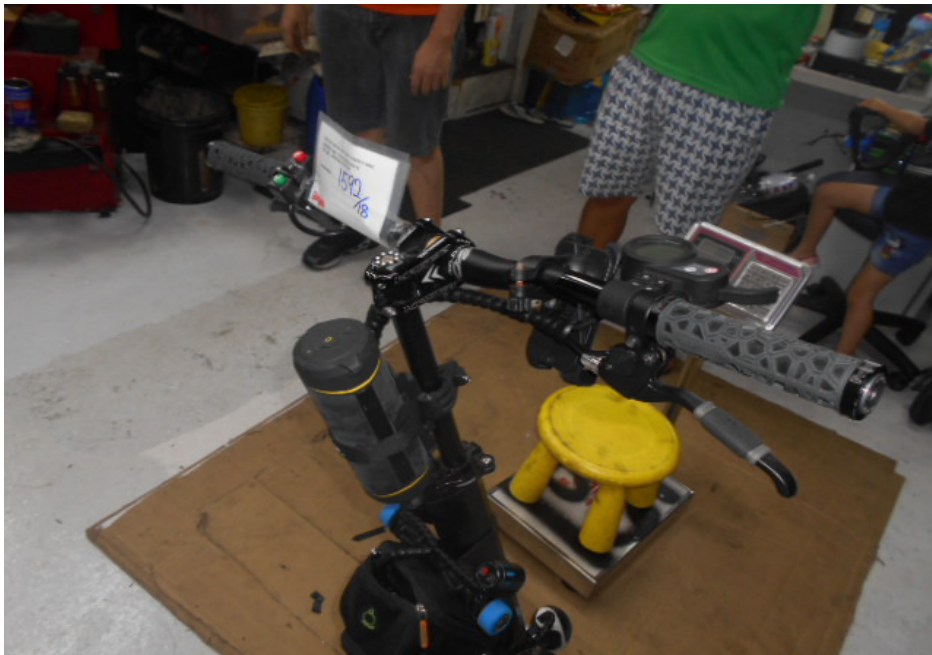
**Photo 2** shows a general view of the handle bar of the electric scooter.

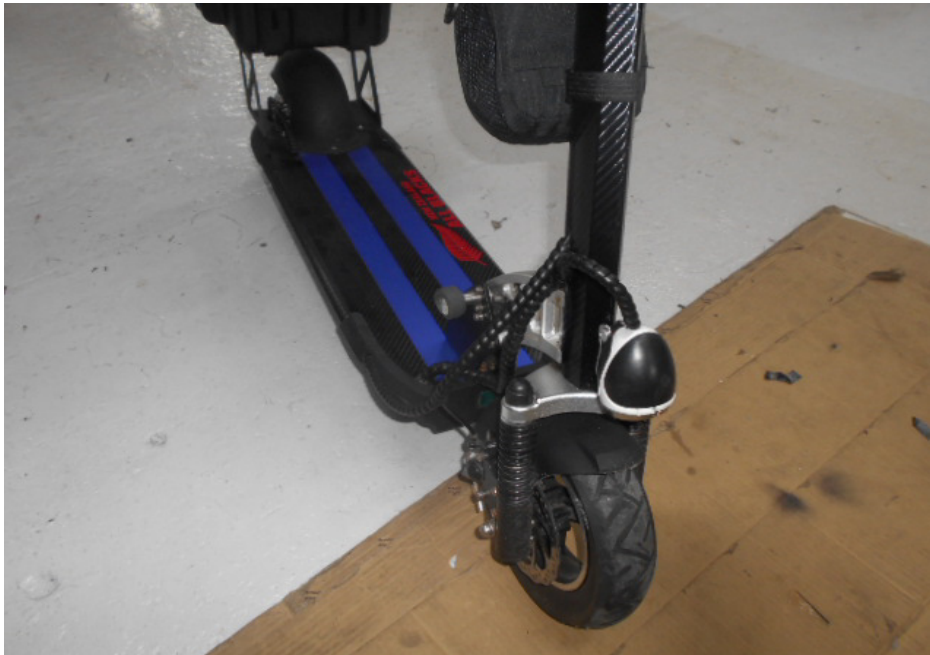
**Photo 3** shows a general view of the frontal body and front tyre of the electric scooter. The front tyre fitted on the electric scooter was observed to be of serviceable condition with the tread pattern clearly visible.

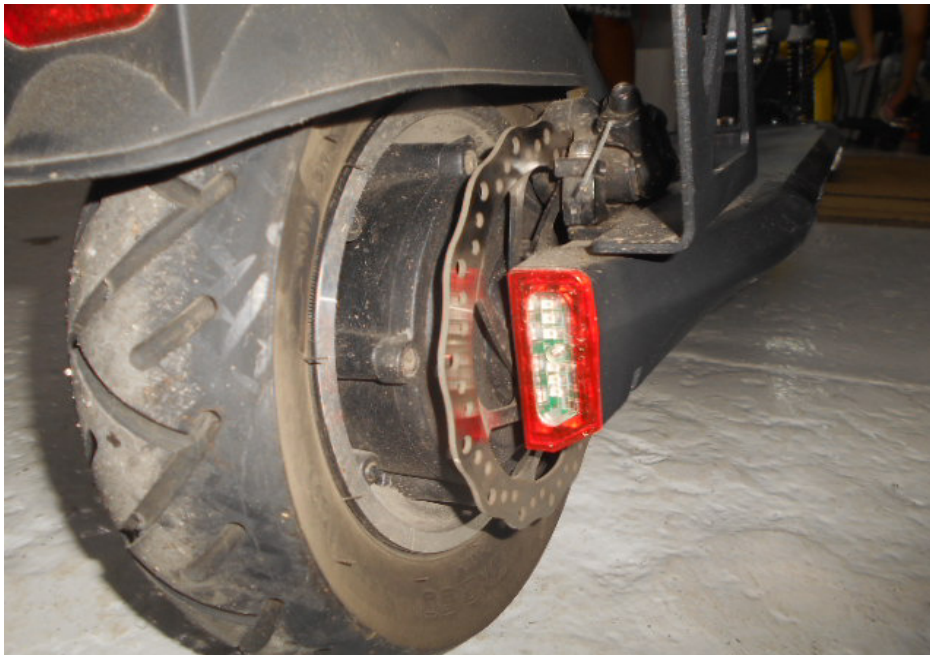
**Photo 4** shows the rear tyre that was fitted on the electric scooter. The rear tyre was observed to be of serviceable condition with the tread pattern clearly visible.

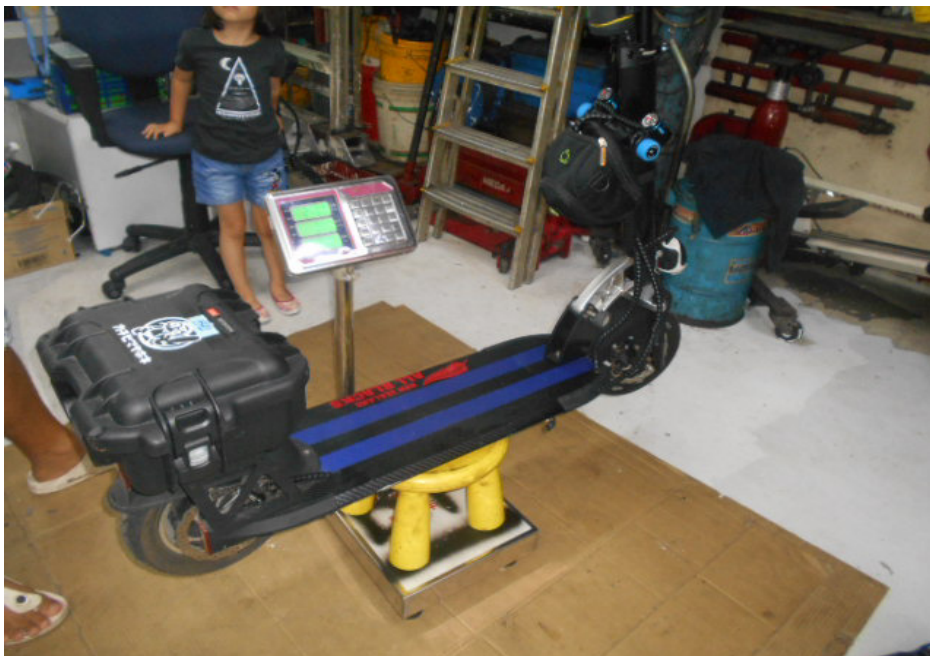
**Photo 6** shows the electric scooter being weighed on a digital weighing scale. The yellow plastic chair supporting the electric scooter on the weighing scale was to prevent the tyres of the electric scooter from touching the ground during the weighing. The digital weighing scale was first calibrated to zero when the yellow plastic chair was placed on the scale.

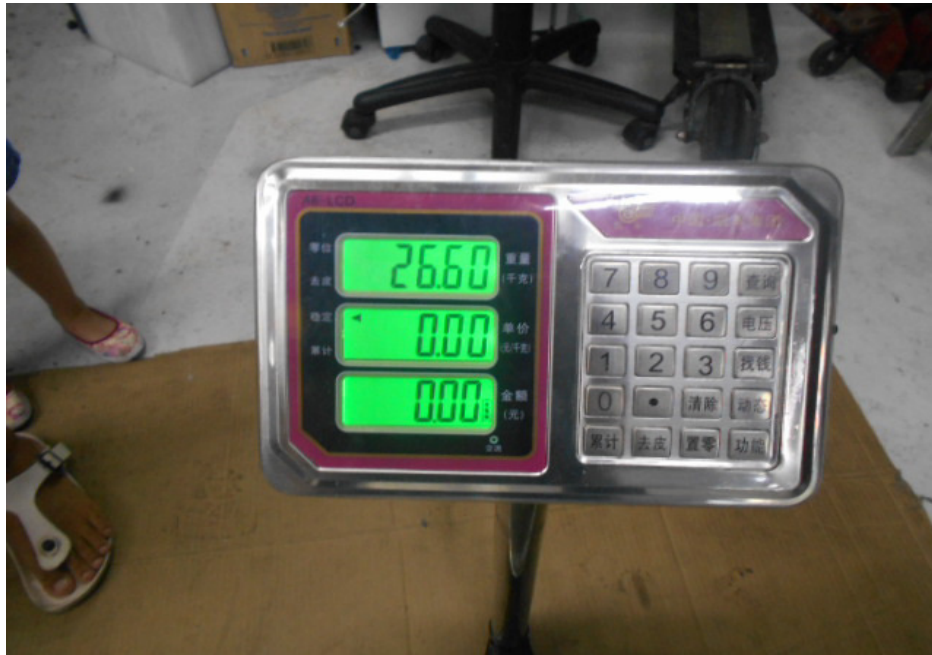
**Photo 7** shows the weight of the electric scooter that was recorded by the digital weighing scale. The weight recorded was 26.60kg.

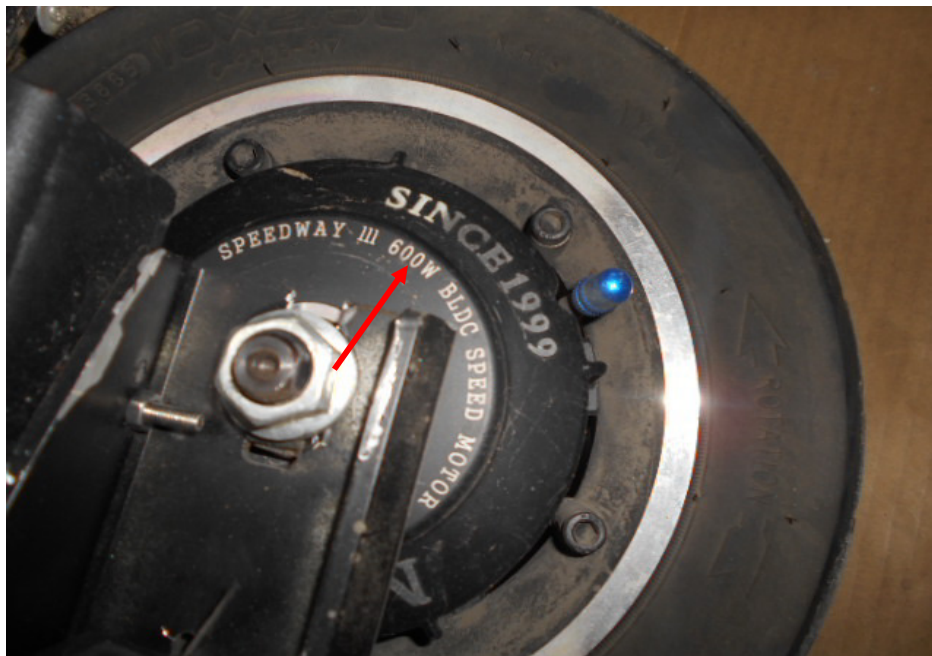
**Photo 8** shows the electric motor that was fitted on the rear wheel of the electric scooter. The power rating of the electric motor was observed to be 600 Watt (arrowed). The motor in this electric motor turns/rotates when electric power is supplied from the battery of the electric scooter.

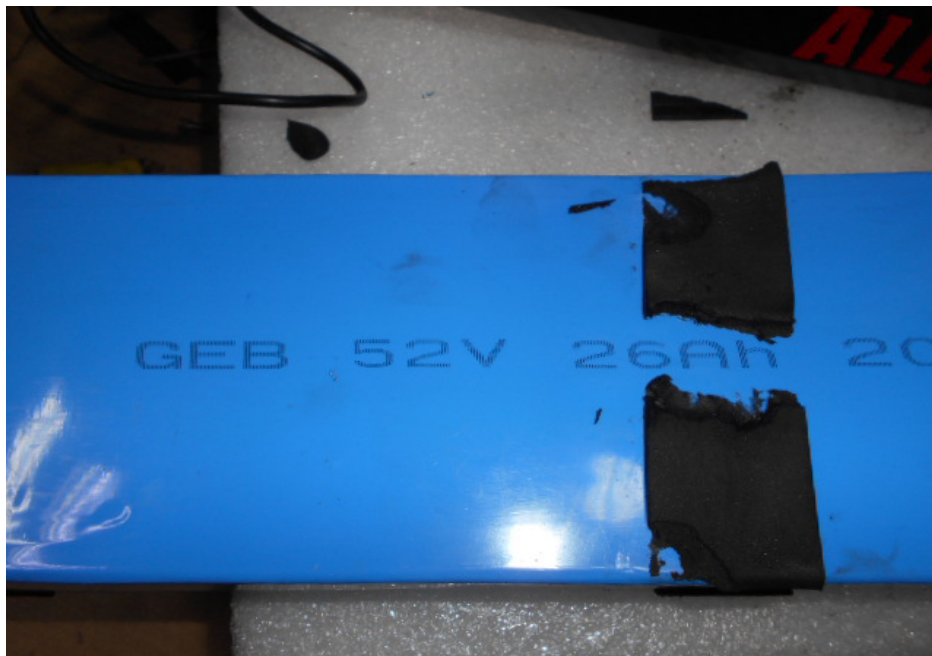
**Photo 10** shows the battery fitted on the electric scooter was a 52 Volt with 26 Ampere/hour battery. This battery supplies the electric power to the electric motor in order for the electric scooter to accelerate/move.

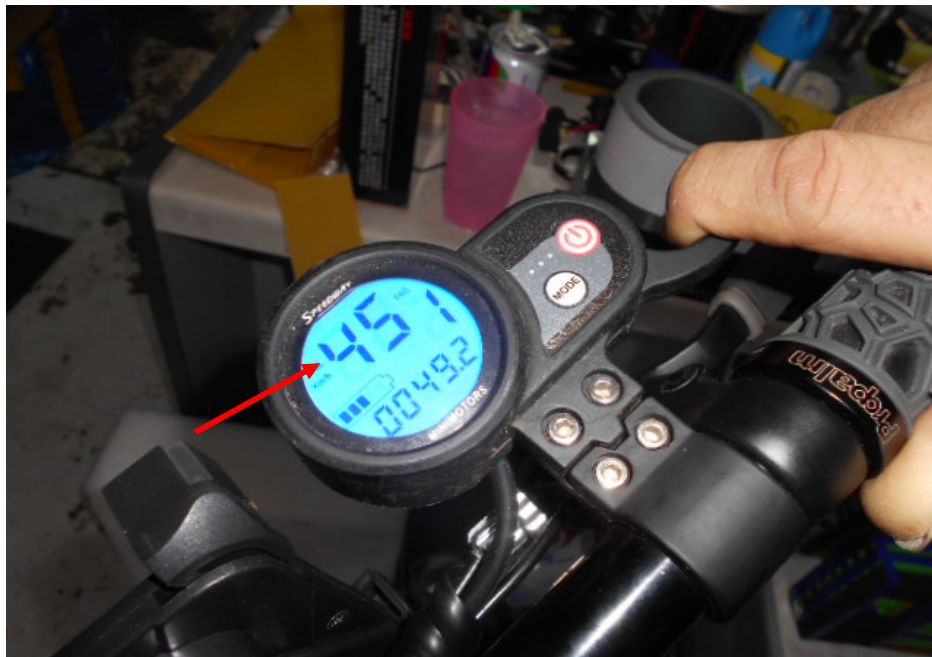
**Photo 12** shows the lever (arrowed) for the acceleration/movement function of the electric scooter being depressed with the speed (arrowed) of the electric scooter displayed on the digital meter. To maintain acceleration/movement, the lever will have to be continuously depressed.

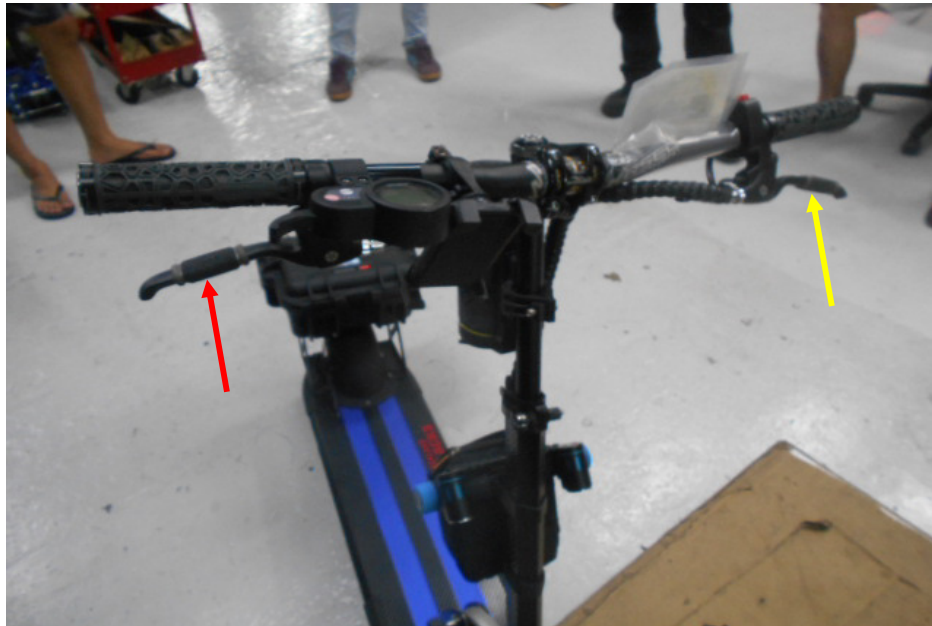
**Photo 13** shows the levers that operates the braking function of the electric scooter. The lever (red arrow) at the right side of the handle bar operates the brake for the front wheel while the lever (yellow arrow) at the left side of the handle bar operates the brake for the rear wheel. The levers can be simultaneously depressed or individual depressed.

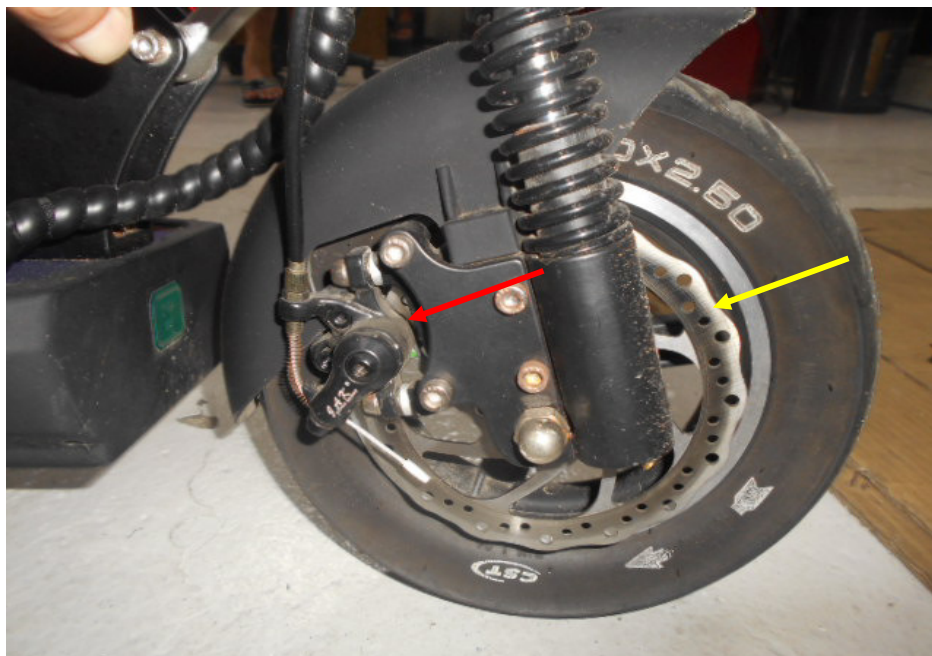
**Photo 14** shows the braking components at the front wheel of the electric scooter. When the front brake lever of the electric scooter is depressed, the brake pad (red arrow) is pushed towards the brake disc (yellow arrow) via cable and spring. The brake pad clamps against the brake disc providing the frictional resistance to reduce the rotation of the front wheel, hence creating the braking effect for the electric scooter.

14. For the static test, the electric scooter was suspended from the ground ie wheels not touching ground. The throttle lever was depressed causing the front wheel and the rear wheel to rotate, simulating movement of the electric scooter. I then depressed the front brake lever only and it was observed that the front wheel stopped rotating almost instantaneously. The front brake lever did not require to be fully depressed for the front wheel to stop rotating. The front brake of the electric scooter was in serviceable condition.

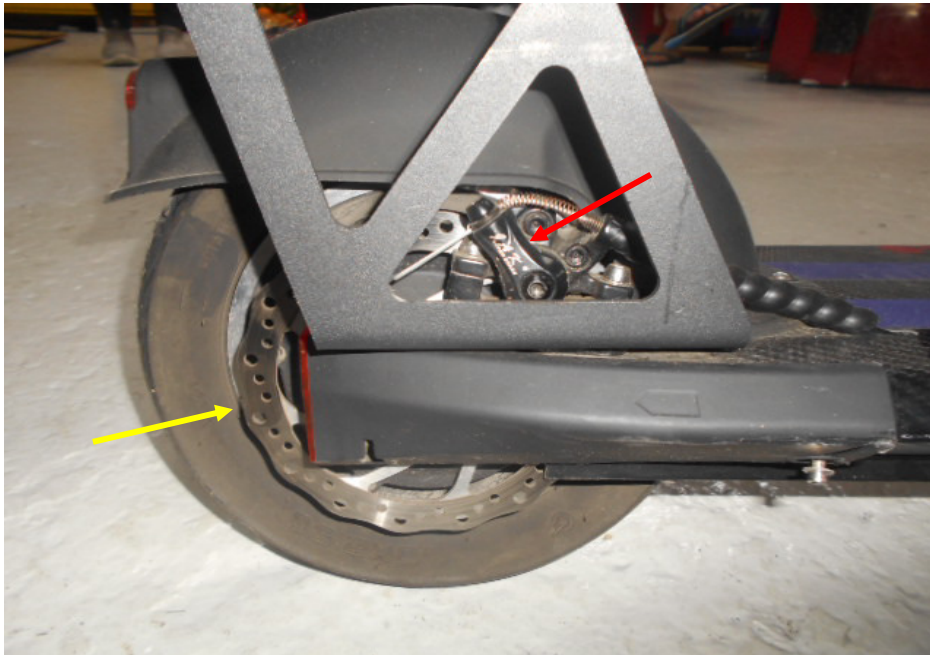
**Photo 15** shows the braking components at the rear wheel of the electric scooter. When the rear brake lever of the electric scooter is depressed, the brake pad (red arrow) clamps against the brake disc (yellow arrow), via cable and spring, hence providing the frictional resistance to reduce the rotation of the rear wheel.

15. With regard to the rear brake, a slightly more effort was required to stop the rotation of the rear wheel. It was noted that the rear brake lever had to be fully depressed in order for the rear wheel to stop rotating. Note that fully depressed refers to the rear brake lever almost touching the handle bar. This is an indication that the rear brake of the electric scooter needs to be adjusted/serviced due to normal deterioration of the rear brake pad.

16. Like with all motor vehicles, motorcycles and bicycles, the brake pad of an electric scooter will progressively wear off from usage over a period of time. When this happens, the gap between the brake pad and the brake disc becomes wider. Due to this wider gap, the brake pad needs to move further to clamp onto the brake disc, and correspondingly more effort is required by the operator to activate the brake in order to compensate for the wider gap.

17. For this case, although a slightly more effort was required, the rear brake of the electric scooter was still able to stop the rotation of the rear wheel during my static test. It will however translate to an overall increase in the stopping distance for the electric scooter when the brake is applied by the operator whilst riding the electric scooter. Simply put, the additional time needed (wider gap) for the rear brake pad to clamp onto the brake disc causes the electric scooter to travel more distance before the rear brake becomes engaged.

18. From the observations gathered during my physical inspection of the electric scooter, its steering system and its 2 tyres were of serviceable condition.
19. The front brake of the electric scooter was found to be in serviceable condition. The rear brake was however found to be in a condition that requires adjustment/servicing. I had found that engaging of the rear brake required slightly more effort by the operator. This would lead to a slightly longer stopping distance.
