Your Ref: E/IP/00505/2019
Our Ref: CI/SPF19010231/D

Tanglin Division

MECHANICAL INSPECTION REPORT OF AN ELECTRIC SCOOTER

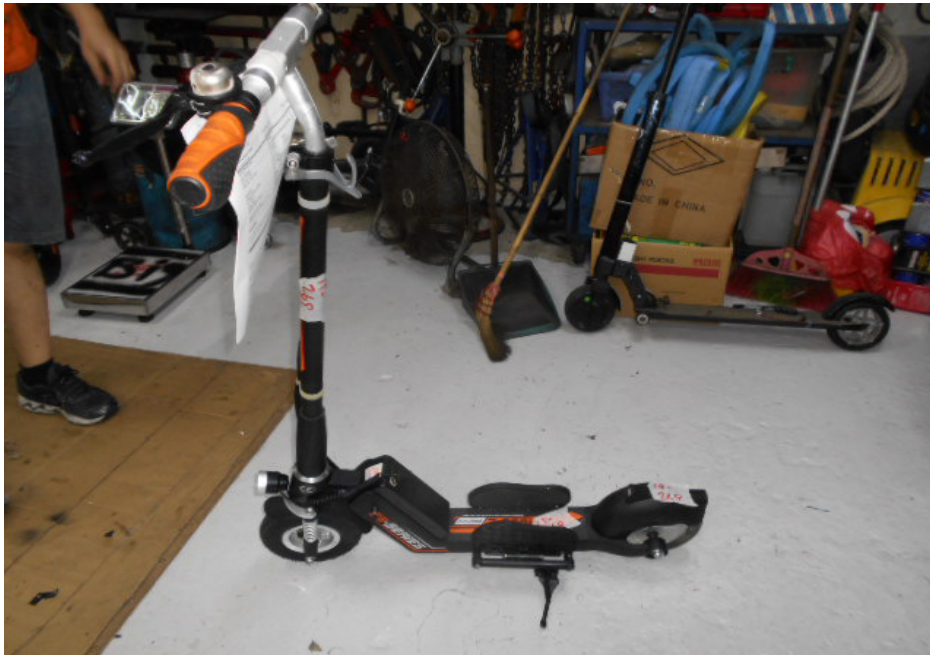
Photo 1 shows a general view of the electric scooter that I had inspected. The electric scooter was observed to be without any physical damage.

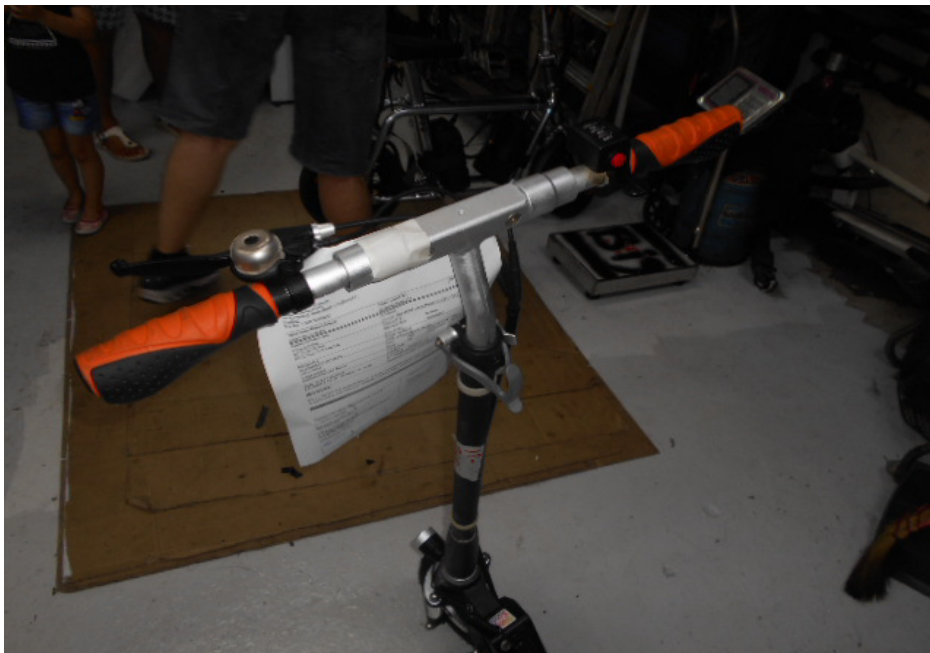
Photo 2 shows a general view of the handle bar of the electric scooter. The width of the electric scooter was measured to be approximately 58cm. This was the length of the handle bar from one side to the other side, which typically represents the width of an electric scooter given that the handle bar extends laterally out from the body of an electric scooter.

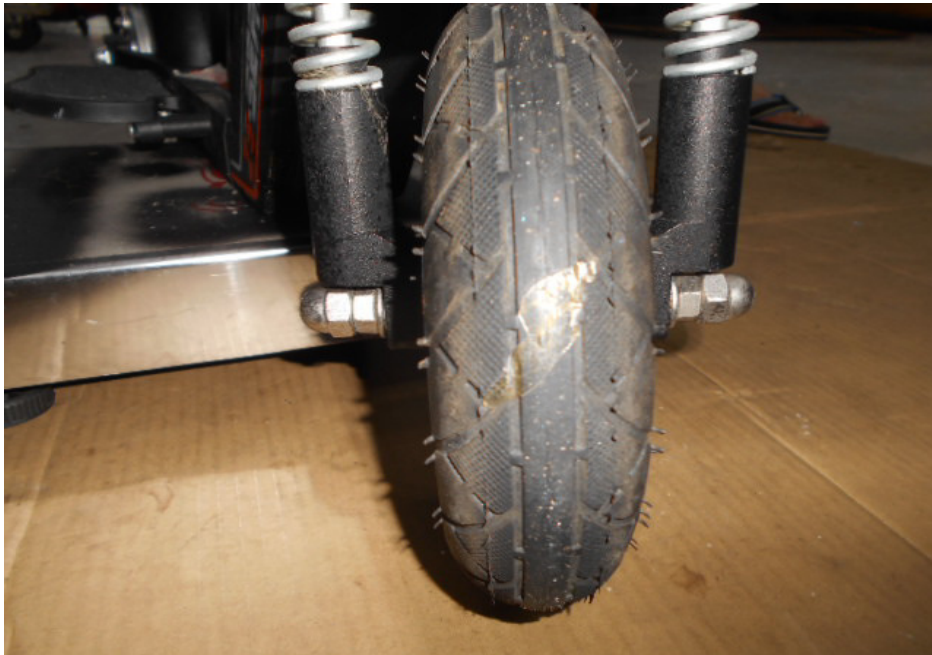
Photo 3 shows a general view of the front tyre of the electric scooter. The front tyre fitted on the electric scooter was observed to be of serviceable condition with the tread pattern clearly visible. It was also sufficiently inflated for operation.

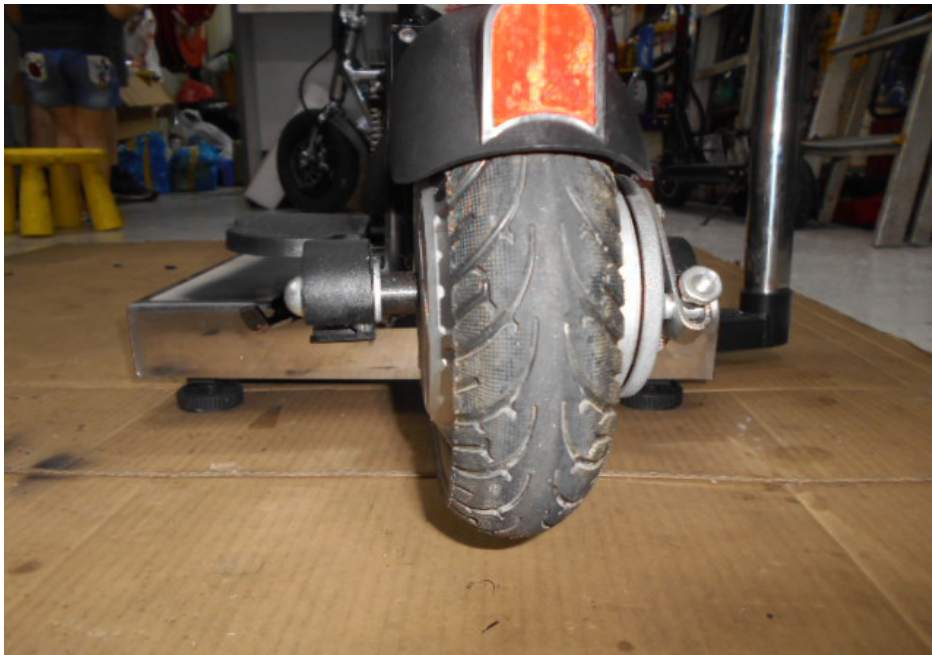
Photo 4 shows the rear tyre that was fitted on the electric scooter. The rear tyre was observed to be of serviceable condition with the tread pattern clearly visible. Similar to the front tyre, the rear tyre of the electric scooter was sufficiently inflated for operation.

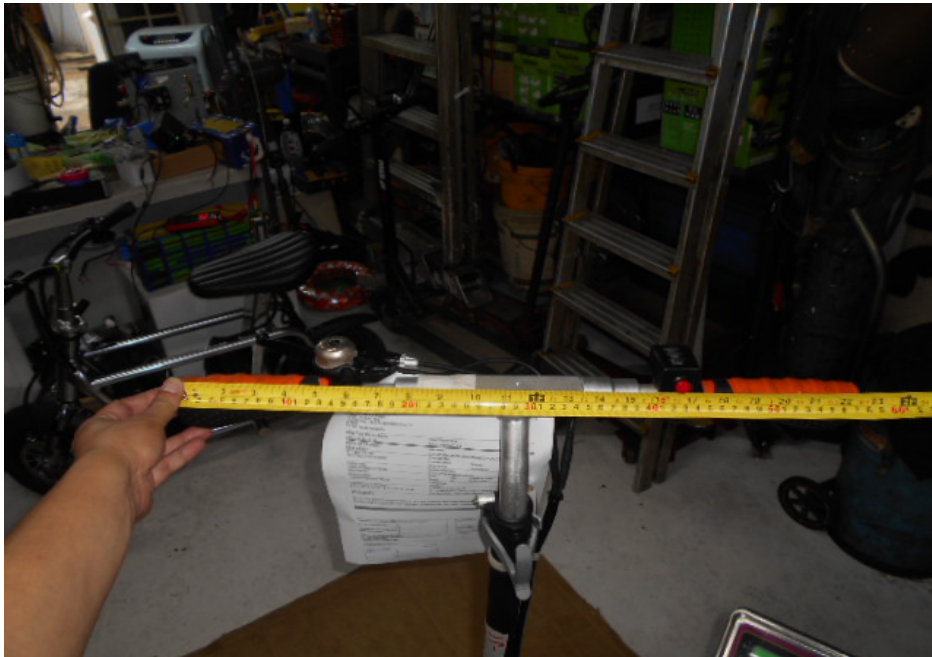
Photo 5 shows measurements being carried out to the electric scooter. The length of the electric scooter (leading edge of front tyre to trailing edge of rear tyre) was measured to be approximately 80cm while the width of the electric scooter was measured to be approximately 58cm.

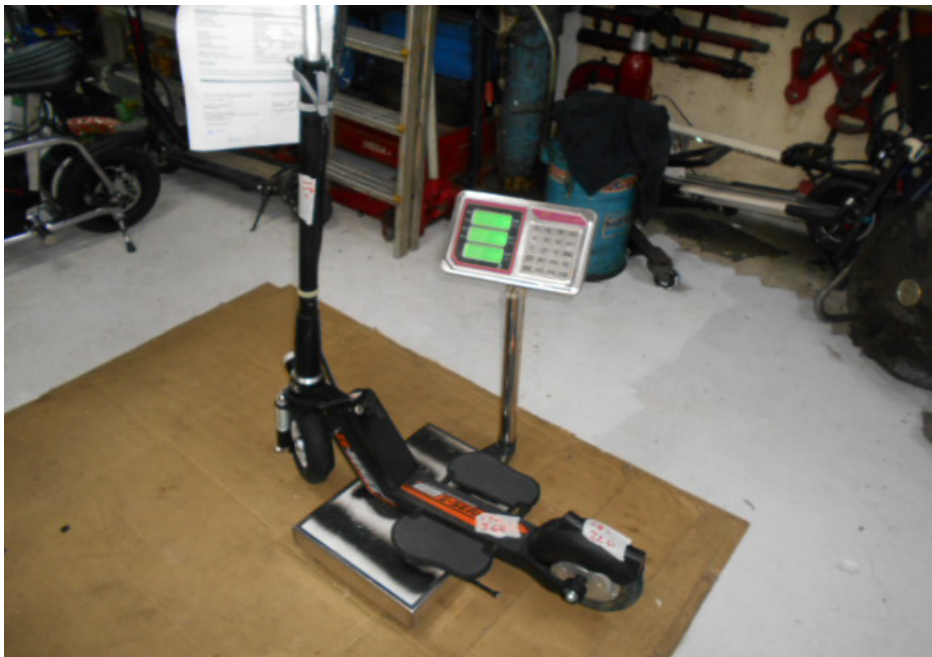
Photo 6 shows the electric scooter being weighed on a digital weighing scale. The digital weighing scale was first calibrated to zero prior to the weighing.

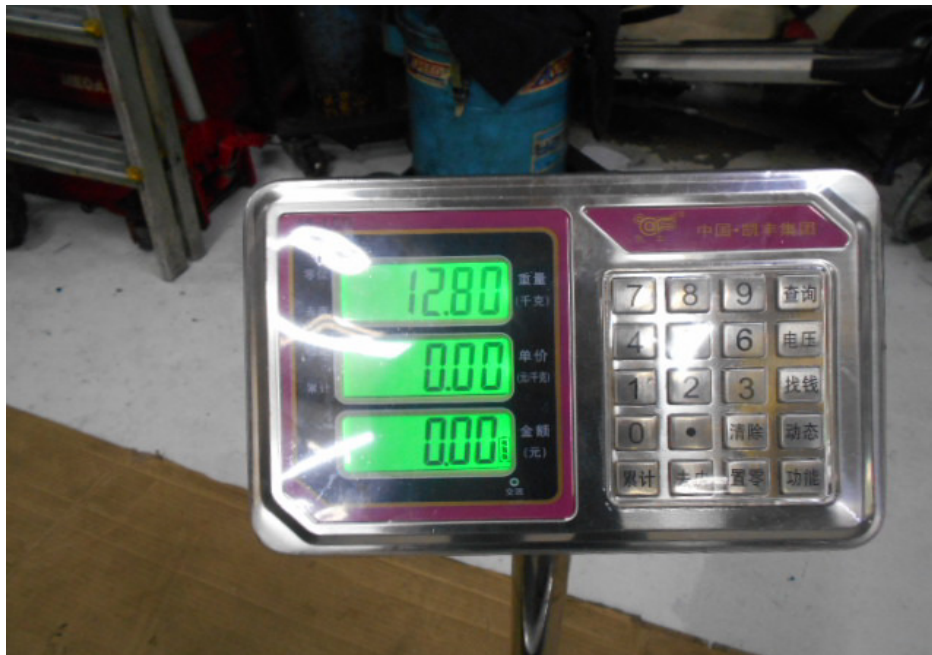
Photo 7 shows the weight of the electric scooter that was recorded by the digital weighing scale. The weight recorded was 12.80kg.

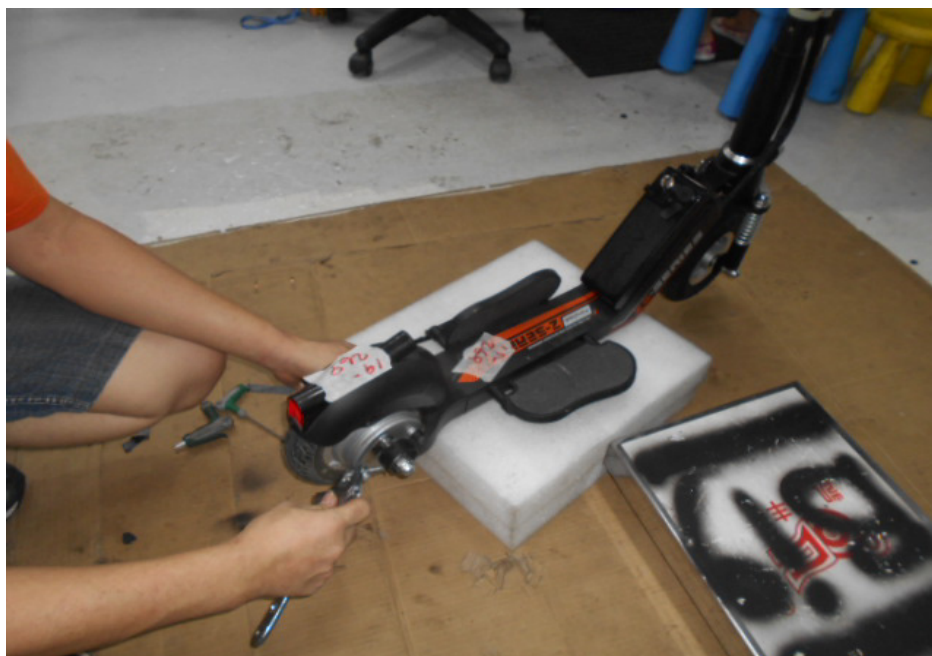
Photo 8 shows dismantling of the rear wheel being carried out to check on the electric motor and rear brake of the electric scooter.

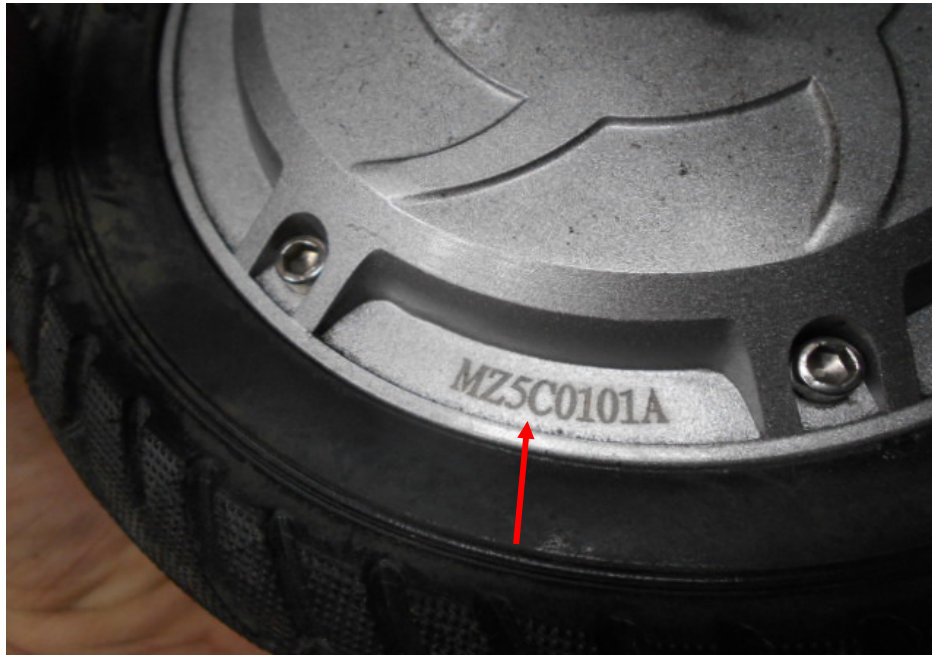
Photo 9 shows the electric motor that was fitted on the rear wheel of the electric scooter. The motor in this electric motor turns/rotates when electric power is supplied from the battery of the electric scooter. From the serial number (arrowed) engraved on the electric motor, the electric motor fitted was a standard original electric motor.

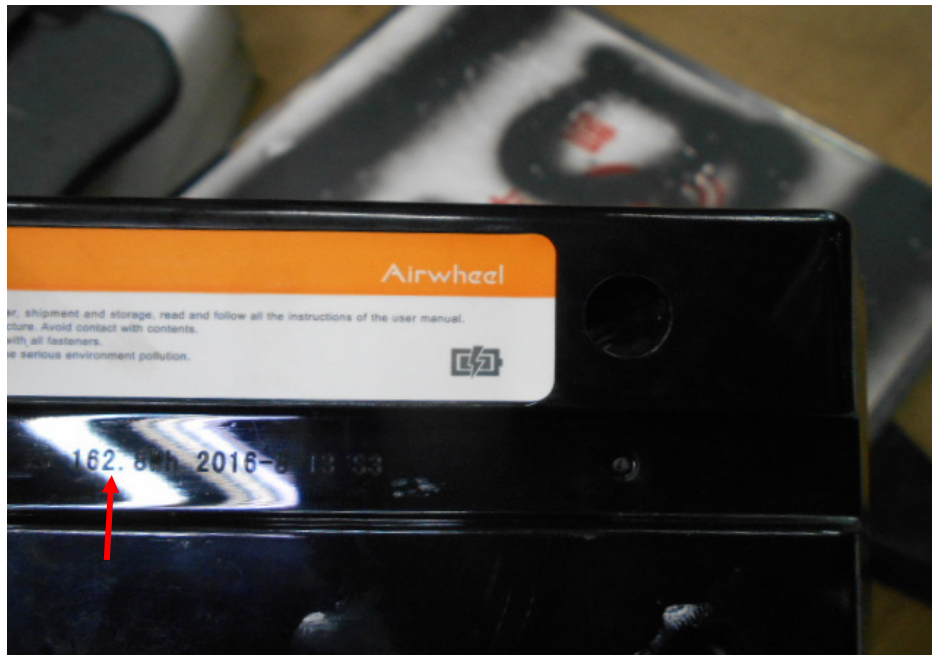
Photo 11 shows the battery that was fitted on the electric scooter. This battery supplies the electric power to the electric motor in order for the electric scooter to accelerate/move. The capacity of the battery was indicated as 162.8 Watt/hour (arrowed), a standard original battery for the electric scooter.

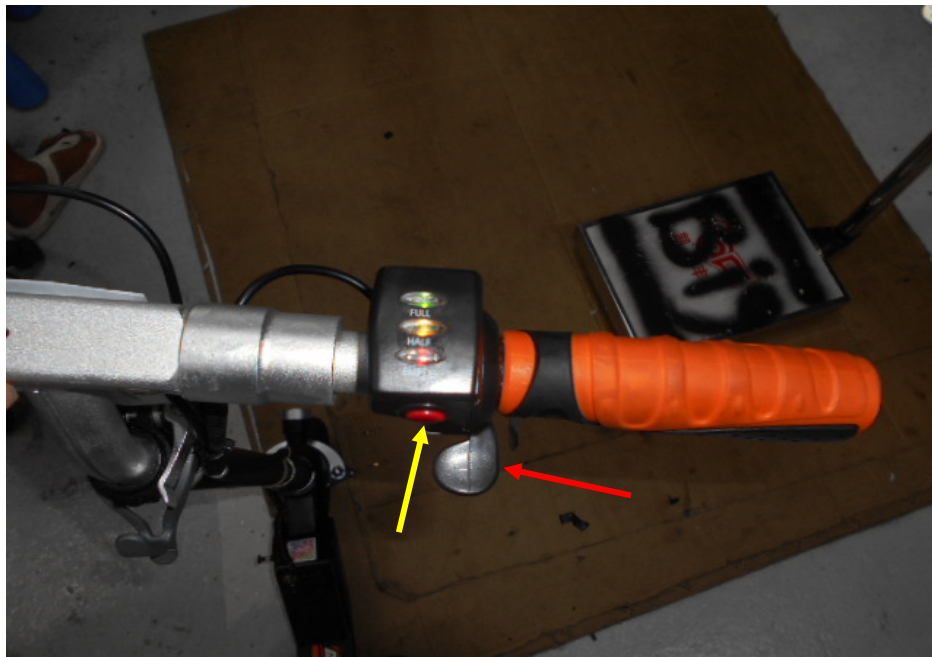
8. The acceleration/movement function of the electric scooter is via a lever which acts as a throttle. This lever is located towards the right side of the handle bar, just below the on/off power button of the electric scooter. When the lever is manually depressed, the electric scooter will accelerate/move. To maintain acceleration/movement, the lever will have to be continuously depressed.
9. When this lever is depressed, electric power from the battery of the electric scooter is supplied to the electric motor that is fitted at the rear wheel. The motor in the electric motor then turns/rotates, resulting in the rear wheel of the electric scooter to also turn/rotate. This allows the electric scooter to accelerate/move. See photo 12 below.

Photo 12 shows the lever (red arrow) for the acceleration/movement function of the electric scooter. When this lever is depressed, electric power from the battery of the electric scooter is supplied to the electric motor that is fitted at the rear wheel. The motor in the electric motor then turns/rotates, resulting in the rear wheel of the electric scooter to also turn/rotate. This allows the electric scooter to accelerate/move. To maintain acceleration/movement, the lever will have to be continuously depressed. The on/off power button of the electric scooter is shown by the yellow arrow.

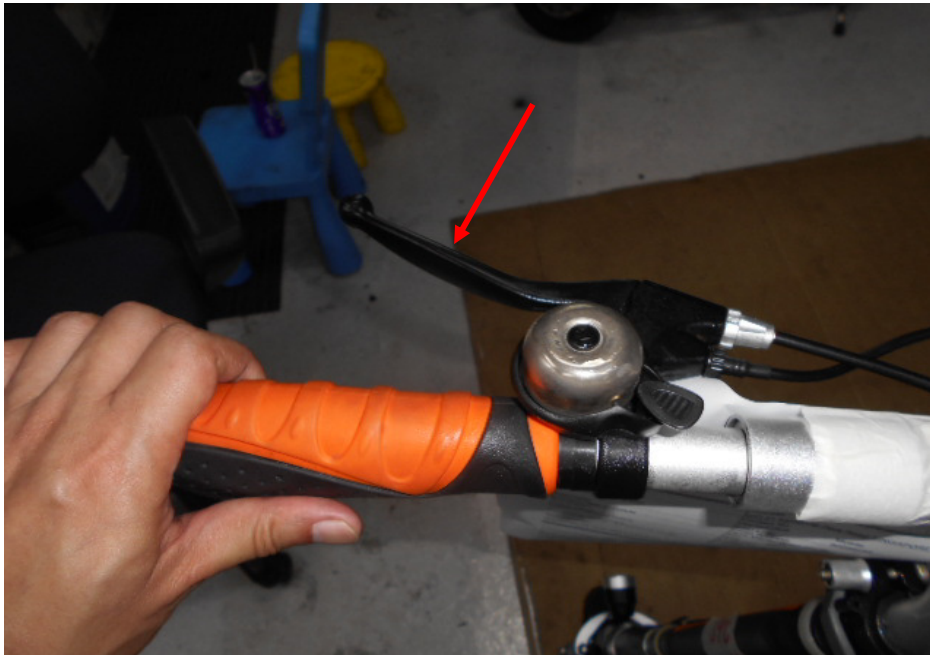
10. The stopping function of the electric scooter is via a lever that is located at the left side of the handle bar. The lever is operated manually. When depressed, the brake is activated by cable and spring pushing the brake shoe outwards to clamp onto the brake drum at the rear wheel of the electric scooter. Frictional resistance from this clamping action reduces the rotation of the rear wheel, hence creating the braking effect for the electric scooter.
11. I note that the braking system of the electric scooter was only to its rear wheel. There was no brake component(s) fitted onto its front wheel. Hence the braking function of the entire electric scooter is dependent on the reduction in rotation of its rear wheel. See photo 13 & 14 below.

Photo 13 shows the lever (arrowed) that operates the braking function of the electric scooter. The lever is operated manually. When depressed, the brake is activated by cable and spring pushing the brake shoe outwards to clamp onto the brake drum at the rear wheel of the electric scooter. Frictional resistance from this clamping action reduces the rotation of the rear wheel, hence creating the braking effect for the electric scooter.

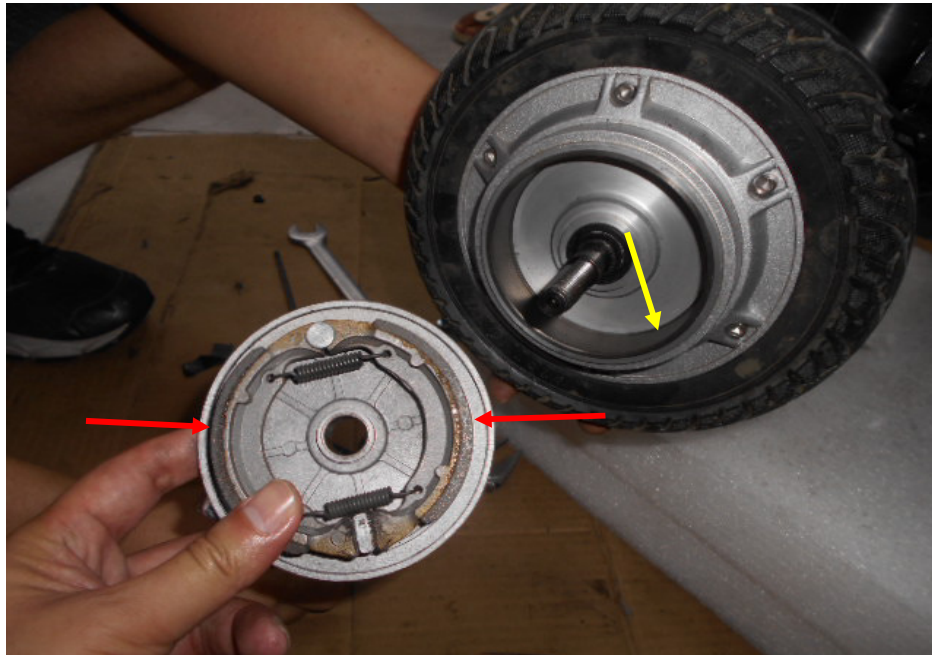
15. The rear brake of the electric scooter was then dismantled for my further examination. Upon touching the frictional material of the brake shoe and the inner surfaces of the brake drum, dust had accumulated on my finger. This dust is commonly referred to as brake dust and is a normal phenomenon caused by the grinding of the frictional material of the brake shoe against the inner surfaces of the brake drum. Periodic cleaning to remove brake dust is required to maintain optimal braking efficiency, especially for brake drum type of braking system where the brake shoe is housed within a closed brake drum.

16. If brake dust is allowed to accumulate within the brake drum, the brake dust could form a layer between the frictional material of the brake shoe and inner surface of the brake drum, preventing the frictional material from coming into contact directly with the inner surface of the brake drum. More effort would then be needed to press the brake shoe outwards against the inner surface of the drum. This was the case for the electric scooter that I had inspected where a slightly more effort was required to stop the rotation of the rear wheel. See photo 15 & 16 below.

Photo 15 shows the rear brake of the electric scooter after it was dismantled. When the brake is activated, cable and spring actions pushes the brake shoe (red arrow) outwards to clamp onto the inner surface (yellow arrow) of the brake drum. Frictional resistance from this clamping action reduces the rotation of the rear wheel, hence creating the braking effect for the electric scooter.

18. From the observations gathered during my physical inspection of the electric scooter, its steering system and its 2 tyres were of serviceable condition.
19. The braking system of the electric scooter was found to be in a condition that requires adjustment/servicing. Accumulation of brake dust within the brake drum of the electric scooter had affected its braking efficiency. Notwithstanding this, an operator riding the electric scooter will still be able to bring the electric scooter to a complete stop with a slightly more effort when depressing the brake lever. The slightly more effort needed would however lead to a slightly longer stopping distance.
