REF: NS/INC 19010454/ K19d352

NTUC INCOME INSURANCE CO-OPERATIVE LTD Ref: NS/INC19010454/K1qd3s2

4. Description of Damages

ADJUSTMENT ON REPAIR COST FOR VEHICLE NO. SHC 2434H

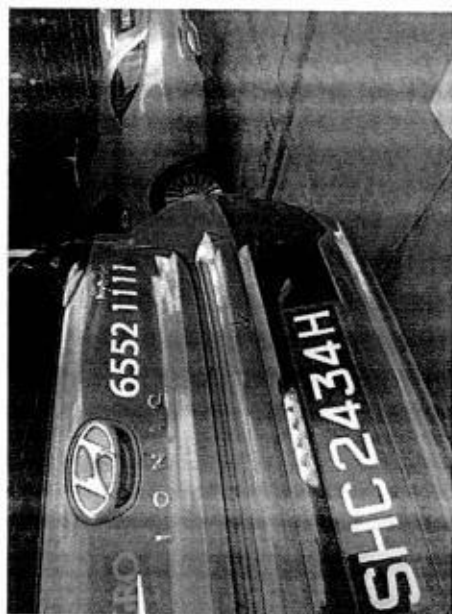
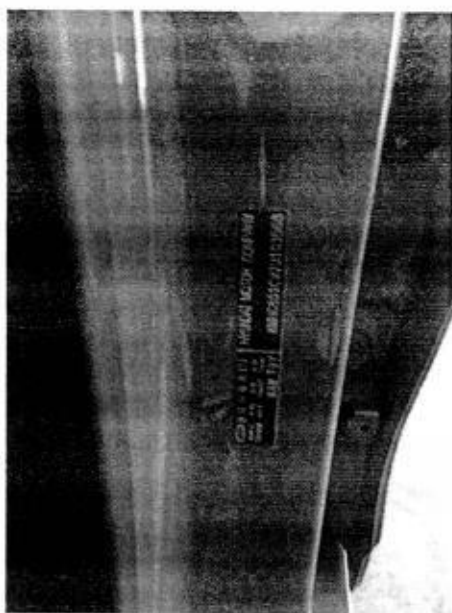
Rear o/s

I then check and found that my rear bumper dented in. I had suffered some neck and back injuries as such I had went to Y M Chan Clinic & Surgery and received 3 days of MC.

THE VEHICLE SUSTAINED DAMAGES AT THE REAR O/S PORTION. DAMAGES SEE DETAILS.
--

Qty	Description of Parts	Condition	Estimate By Workshop (\$)	Our Adjusted (\$)
<u>REPLACEMENT OF PARTS</u>				
1	REAR BUMPER	TO REPAIR SEE LABOUR	459.40	-
1	REAR BUMPER CENTRE MOULDING ASSY	CRACKED	451.25	451.25
10	REAR BUMPER COVER CLIPS	NECESSARY	22.00	22.00
	LESS 20% DISCOUNT		-186.53	-94.65

746.12	378.60
<u>NETT ITEMS</u>				
1	REAR NO. PLATE (N)	CRACKED	25.00	25.00
	LESS 10% DISCOUNT		-	-2.50
			25.00	22.50
<u>SPECIAL NETT ITEMS</u>				
1	REAR NO. PLATE TRIM COVER (SN)	SERVICEABLE	30.00	-
1	REAR BUMPER REVERSE SENSOR (SN)	SERVICEABLE	135.70	-
1	REAR BUMPER RUBBER MAT (SN)	NOT NECESSARY	50.00	-

215.70	-
<u>LABOUR</u>				
	PANEL BEATING. INCLUSIVE OF THE REPAIR OF REAR BUMPER.		350.00	200.00
	SPRAY PAINTING CHARGE.		250.00	200.00
	WIRING CHARGE.	NOT NECESSARY	50.00	-
	REMOVE / REFIX REVERSE SENSOR.	NOT NECESSARY	120.00	-

770.00	400.00
GRAND TOTAL			1,756.82	801.10
RECOMMENDED COST OF REPAIRS (CONFIRMED)				801.10
