To Inspect Vehicle No: SBS 3370M

Subject: FINALISATION ACCIDENT INVOLVING SBS3370M & XD8613Z ON 12/06/2019 @ 12:50HRS ALONG JUNCTION BUKIT BATOK WEST AVE 3 & AVE 8

Preliminary Advice

VEHICLE DAMAGE INSPECTION REPORT

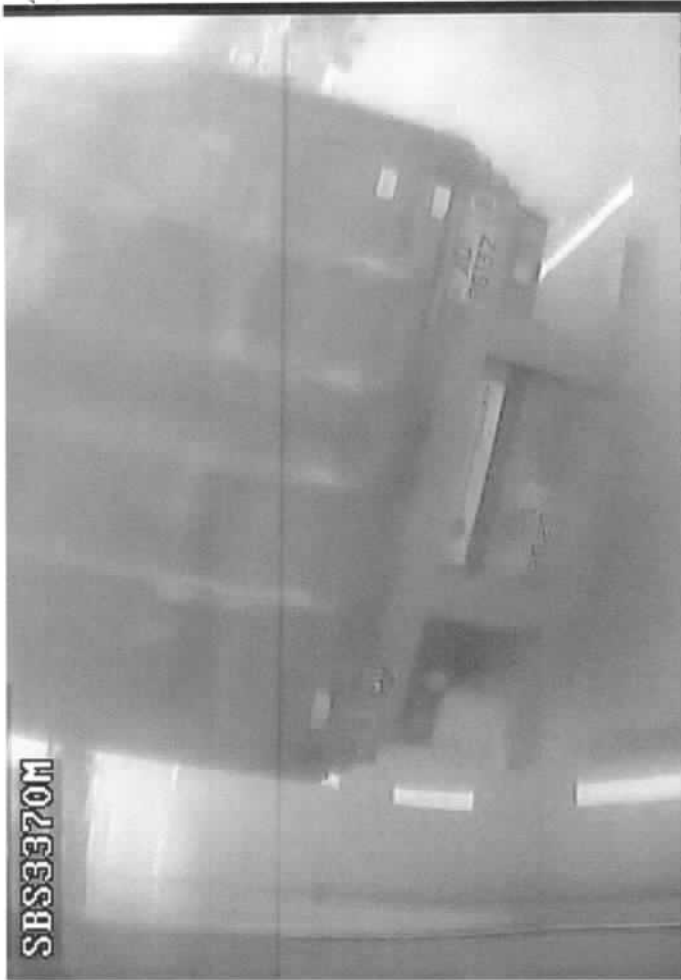
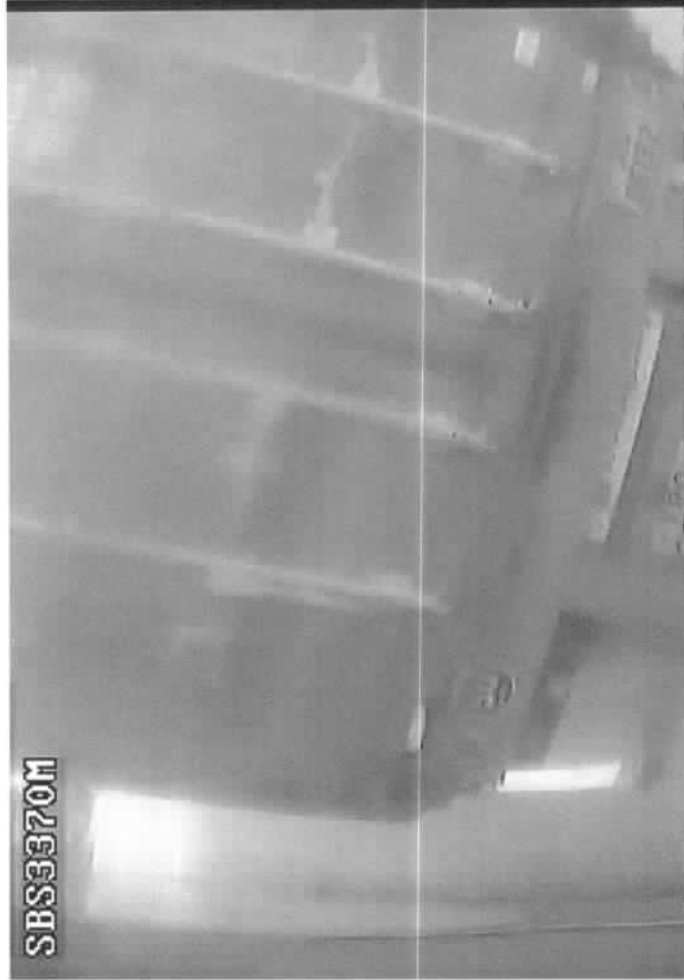
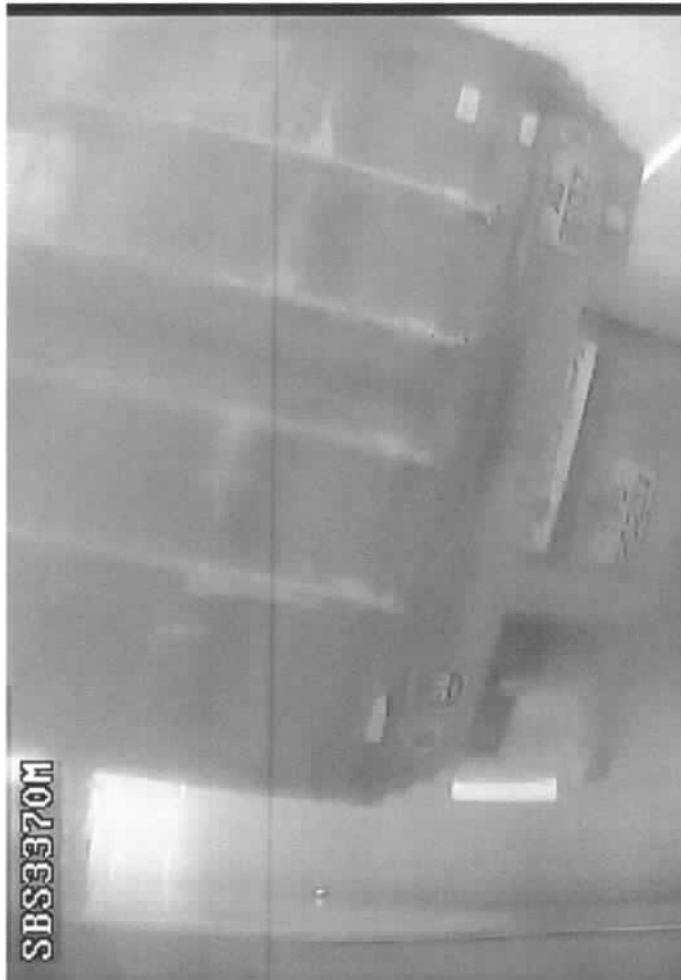
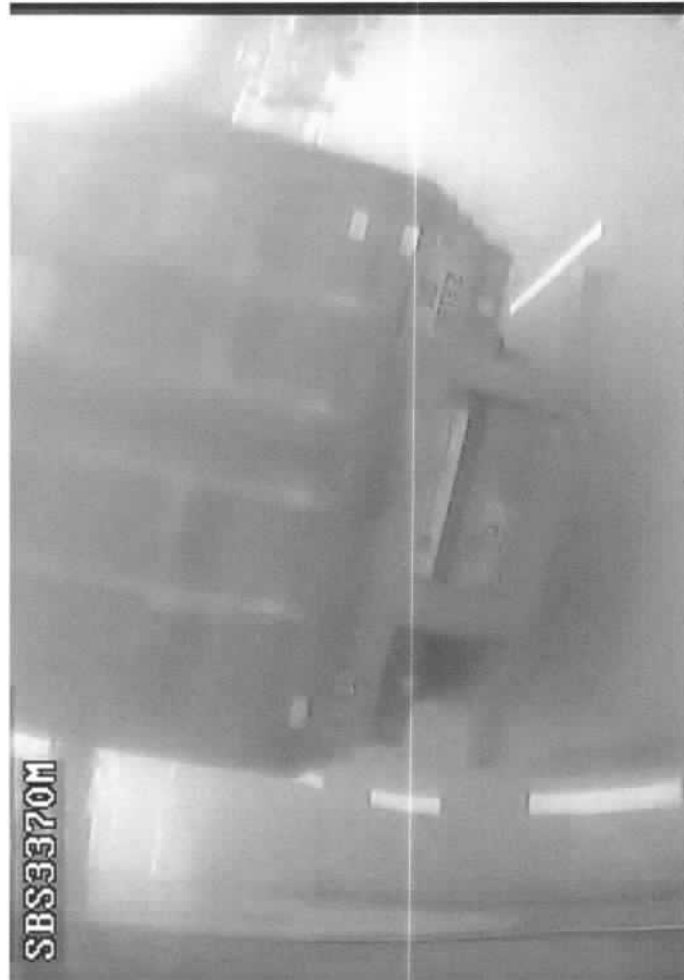
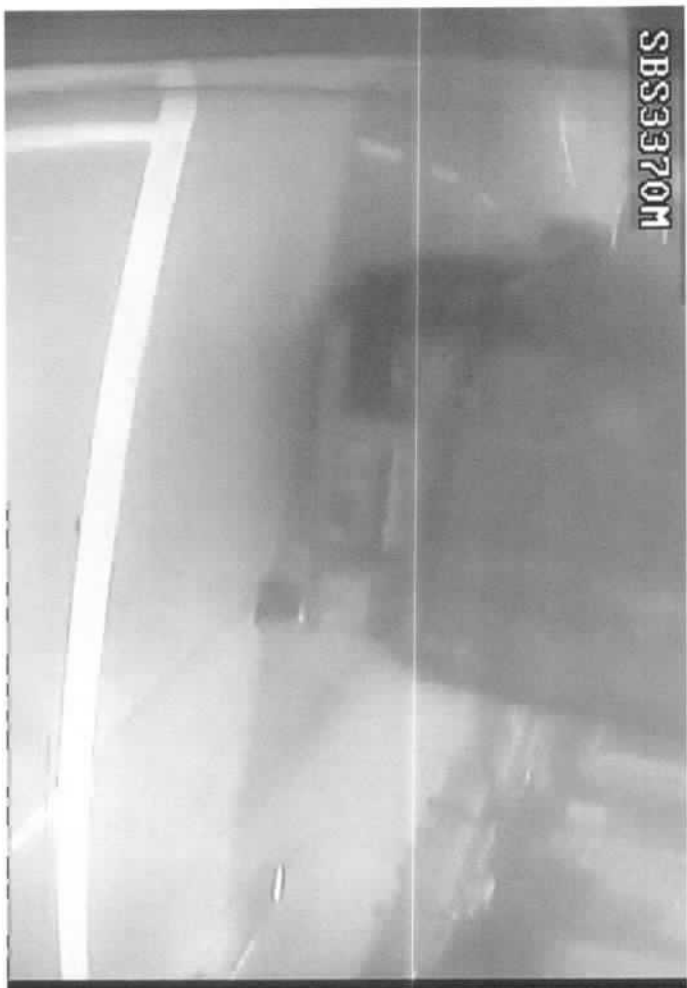
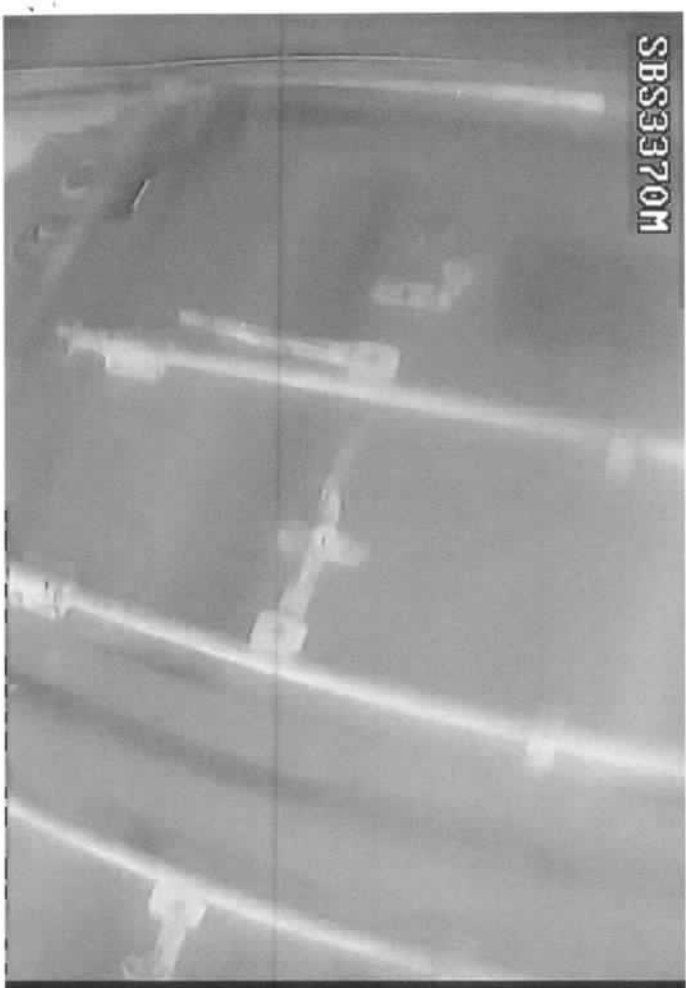
SBS33370M

The **U/C / Chassis frame / Body Structure** affected due to collision.

The vehicle sustained impact / damages o/s portion and parts claimed are consistent to the accident.

No.	Qty	Part No.	Particulars	Condition	Repairer's	Amount
1	1		*BRONZE BODY GLASS	Broken	1,118.28 FS	*1,118.28 FS
2	1		*BRONZE BODY GLASS 4MM	Broken	215.86 FS	*215.86 FS
3	8		*SIKAFLEX BLACK	Necessary	256.00 FS	*256.00 FS
4	1		*BRONZE BODY FRAME	Bent	1,000.00 FS	*1,000.00 FS
Total Parts (S\$)					2,590.14	2,590.14

No	Particulars	Lab.Type	Repairer's	Amount
Labour Items				
1	TO REPLACE ALL DAMAGED PARTS	New	2,250.00	2,250.00
2	ADVERTISEMENT REPAIR COST	New	1,400.00	1,400.00
Gross Labour Cost (S\$)			3,650.00	3,650.00
