**CLAIMANT: Q LEASING
ACCIDENT INVOLVING SBA555L & SKV7672T ON 08 APRIL 2019 ALONG SINGAPORE PAYA LEBAR CARPARK AT ABOUT 1400 HOURS**

Final Repair Bill for Vehicle no. SBA555L

Report Reference : TP / 04-19020/DY / 2019

THIRD PARTY SURVEY

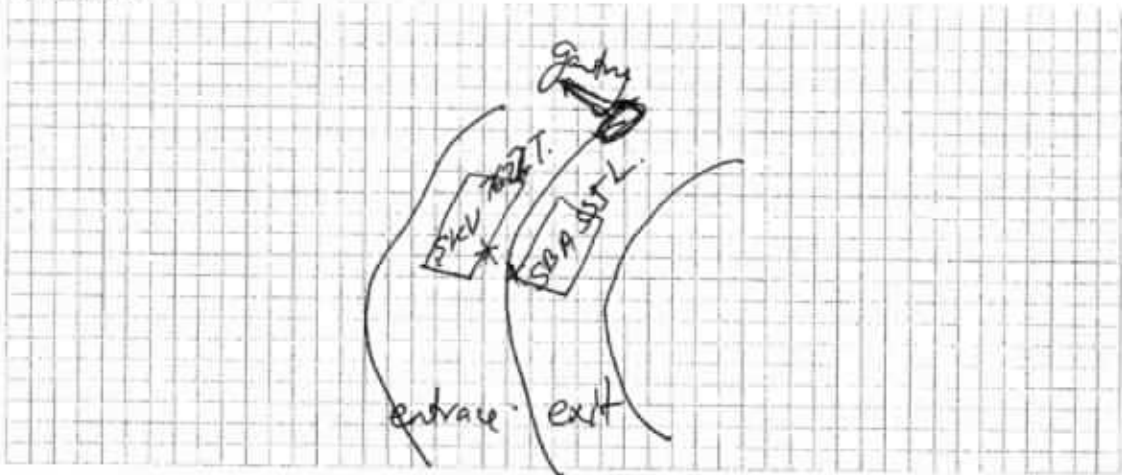
SKETCH PLAN

As I was entering the carpark at airport, Andrew
 amount 1400 hrs, on the oncoming side, exiting my car park
 against me. There was scratches on
 my car and the other.

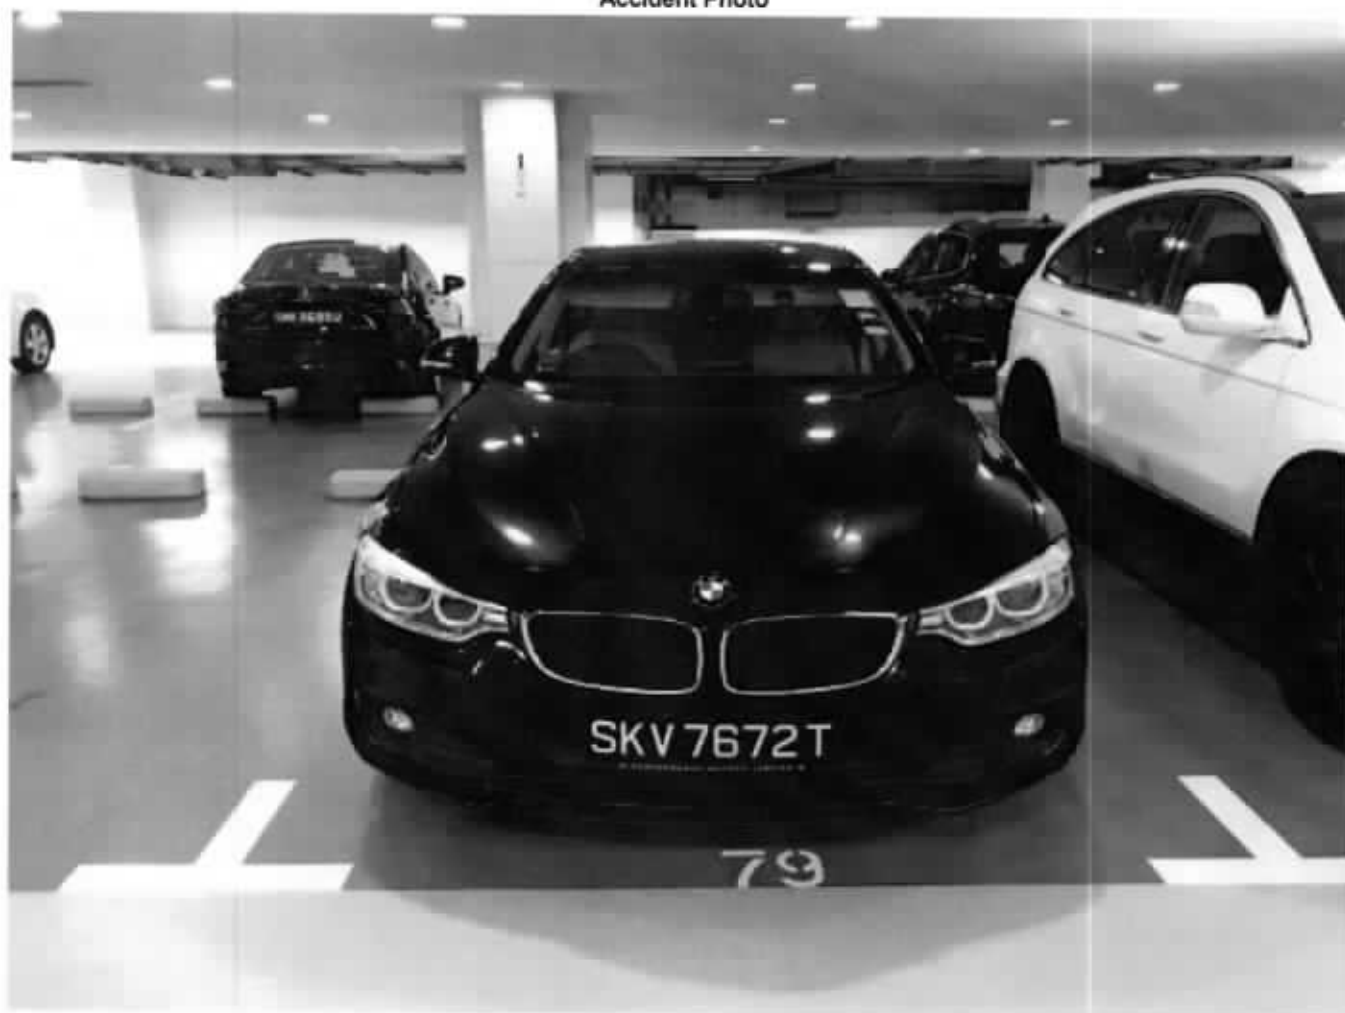
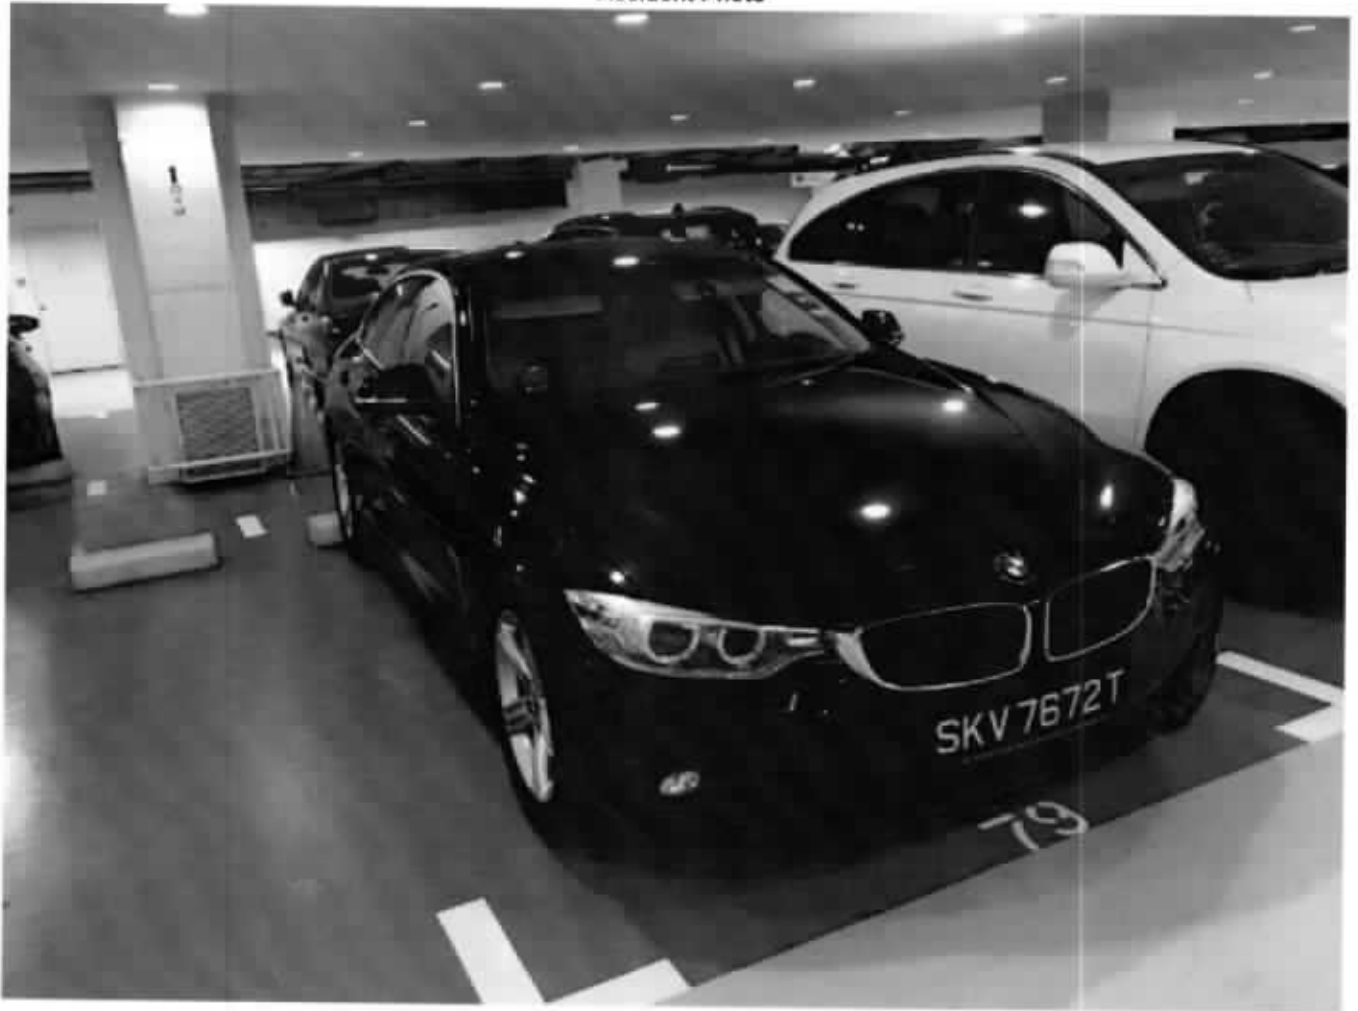
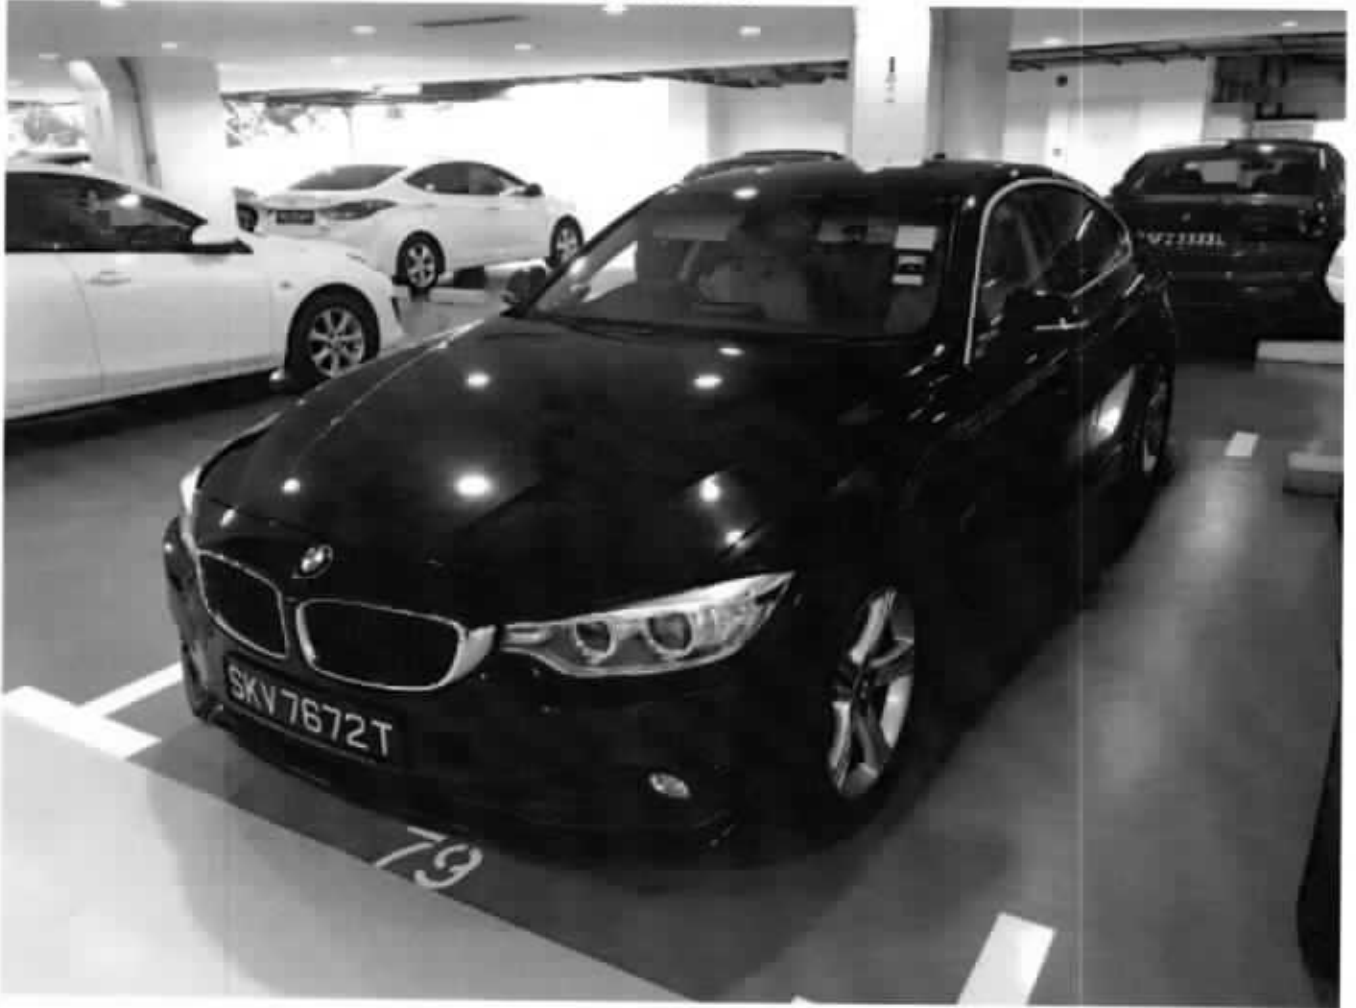
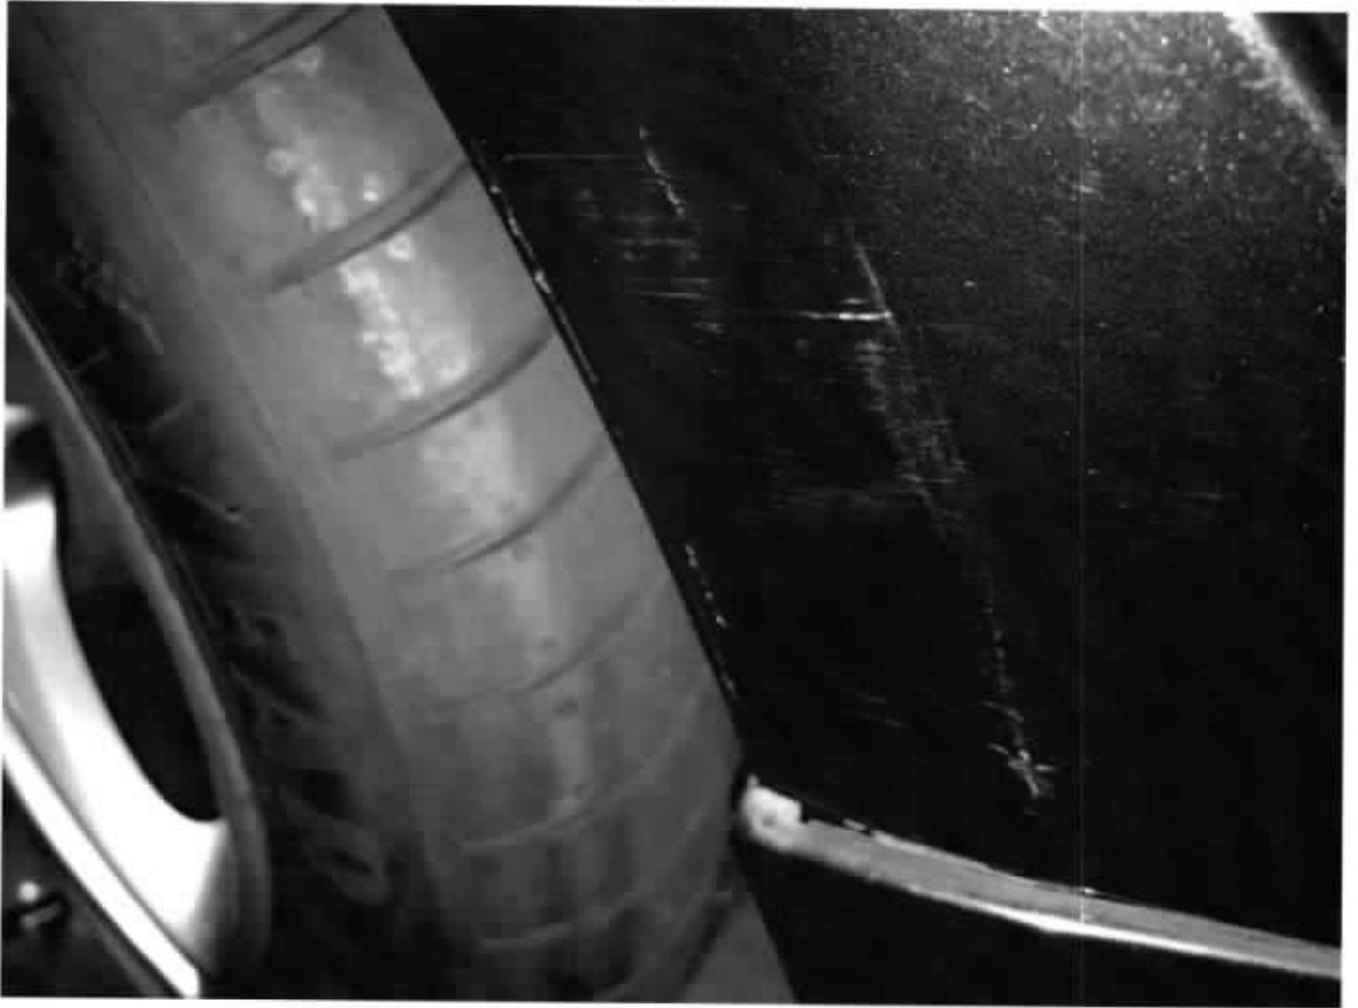
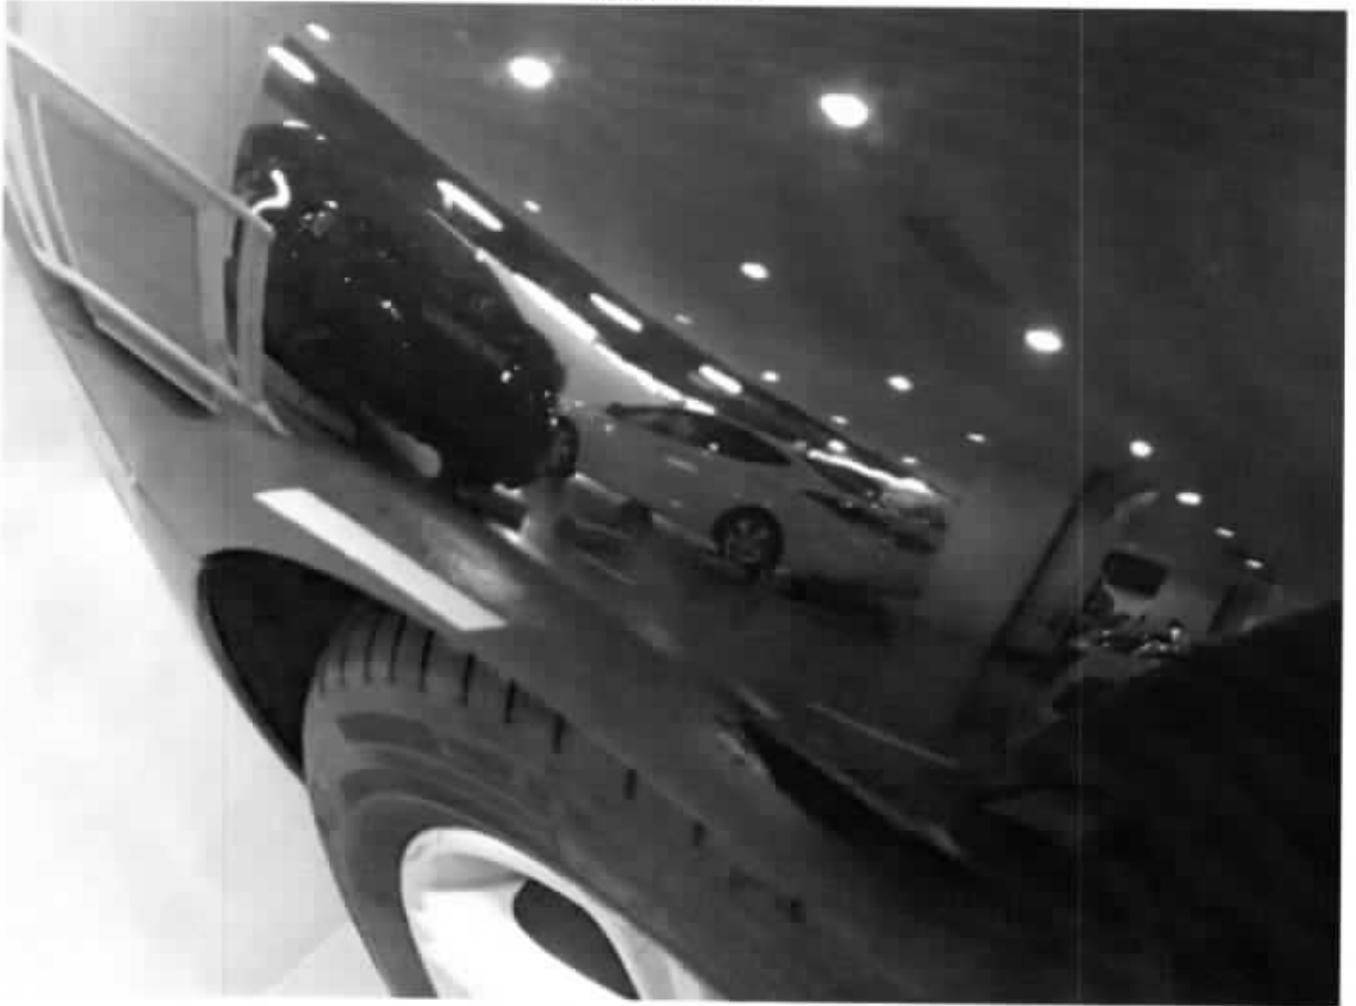
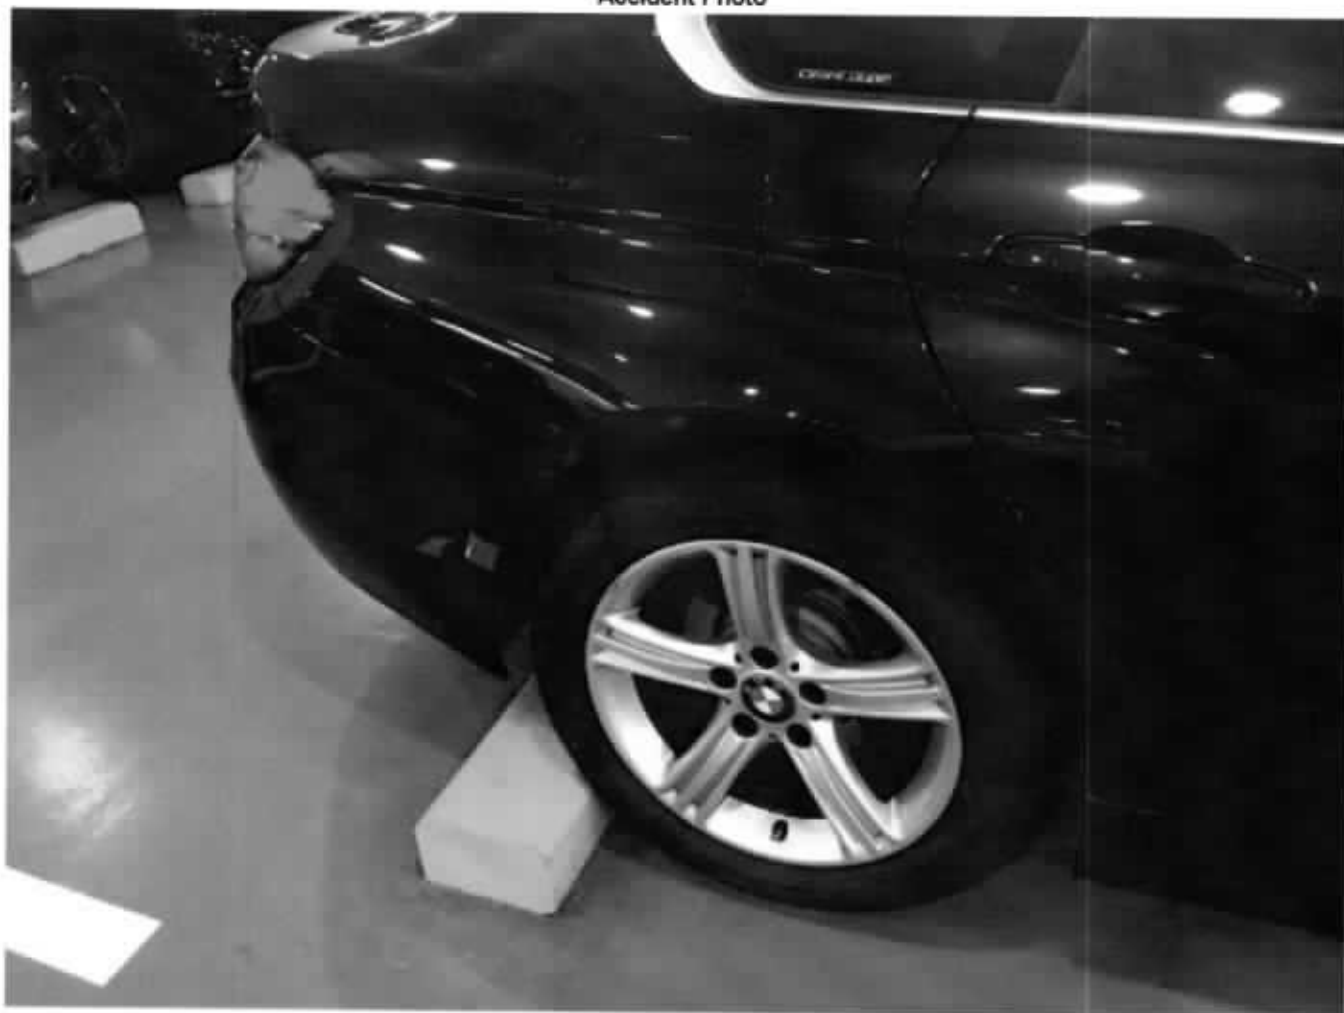
Accident Photo

At the time of inspection, we noted that the vehicle has sustained an impact damages on the front portion(s). For more detail of the damages, please see photograph attached.
