Report No: 0039-19-EMAm

ACCIDENT VEHICLE SURVEY REPORT

Vehicle Reg No.:	SGT9196X	Odometer:	260938km
Make & Model:	Toyota Picnic Auto	Colour:	Blue
Chassis number:	JTEGH23B800023151	Date of accident:	11/01/2019
Year of Regn.:	26/04/2007	Date inspected:	15/01/2019
Repairer at:	EM Solution Pte Ltd	Date inspected (After Repair):	18/01/2019
	160 Sin Ming Drive #03-19 Sin Ming Autocity		
	Singapore 575722

ADJUSTMENT ON REPAIR COST FOR VEHICLE NO. SGT 9196X

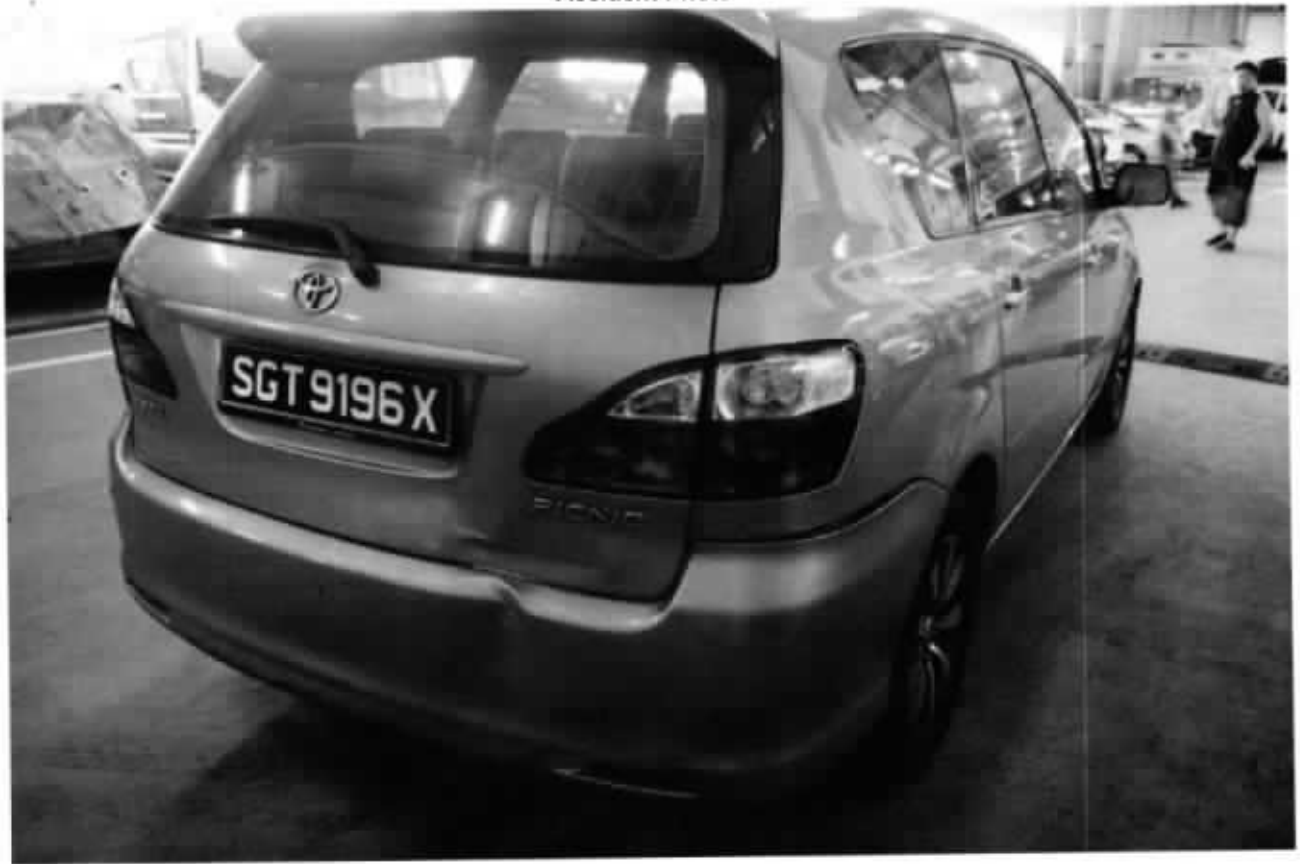
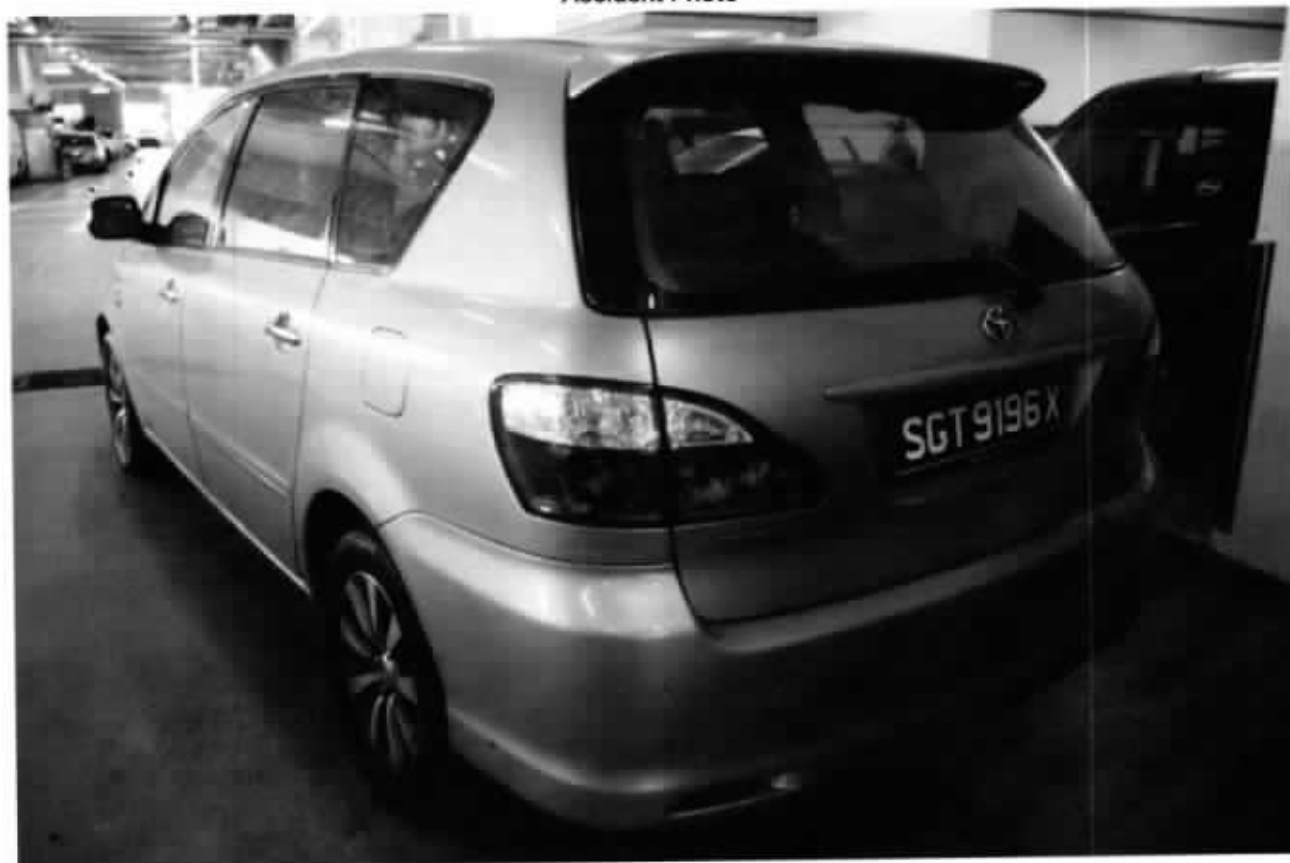
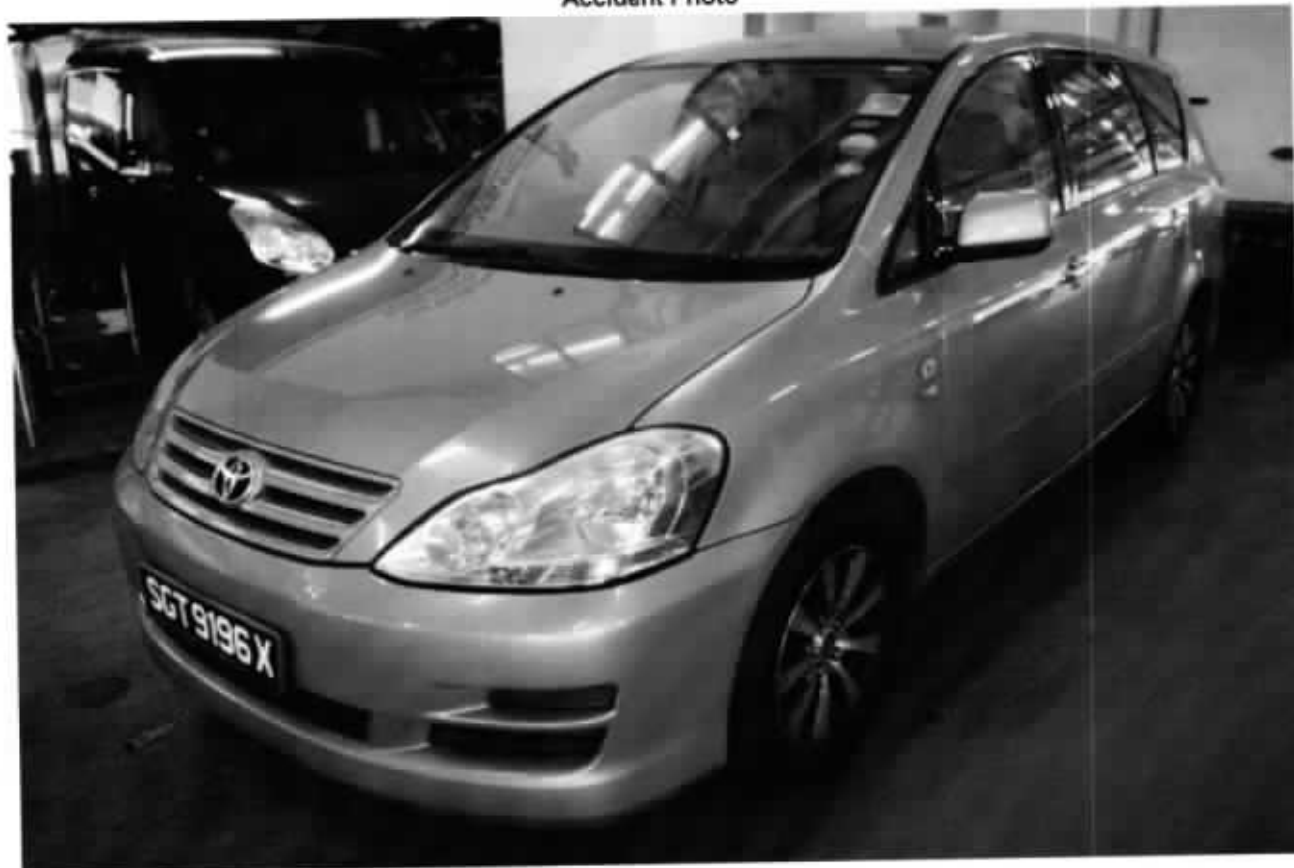
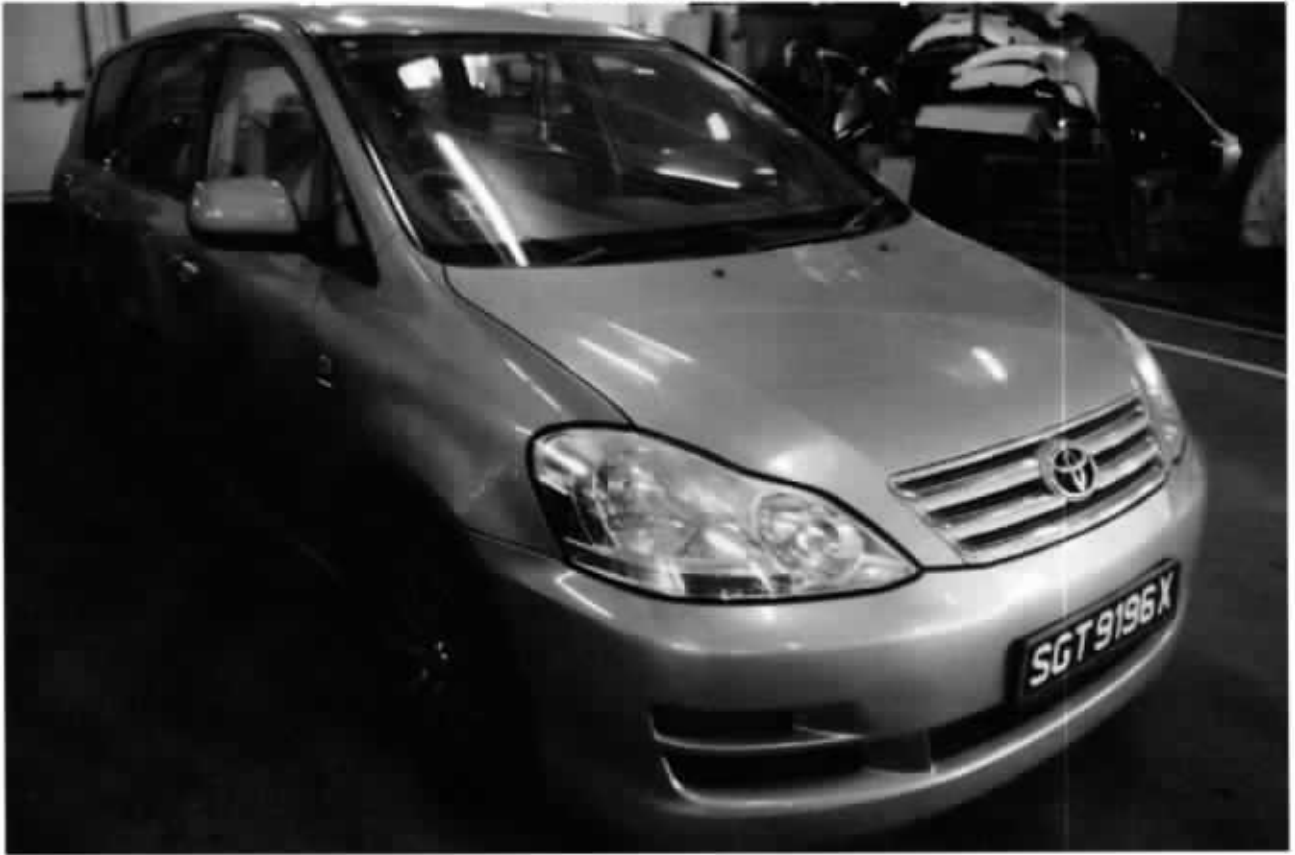
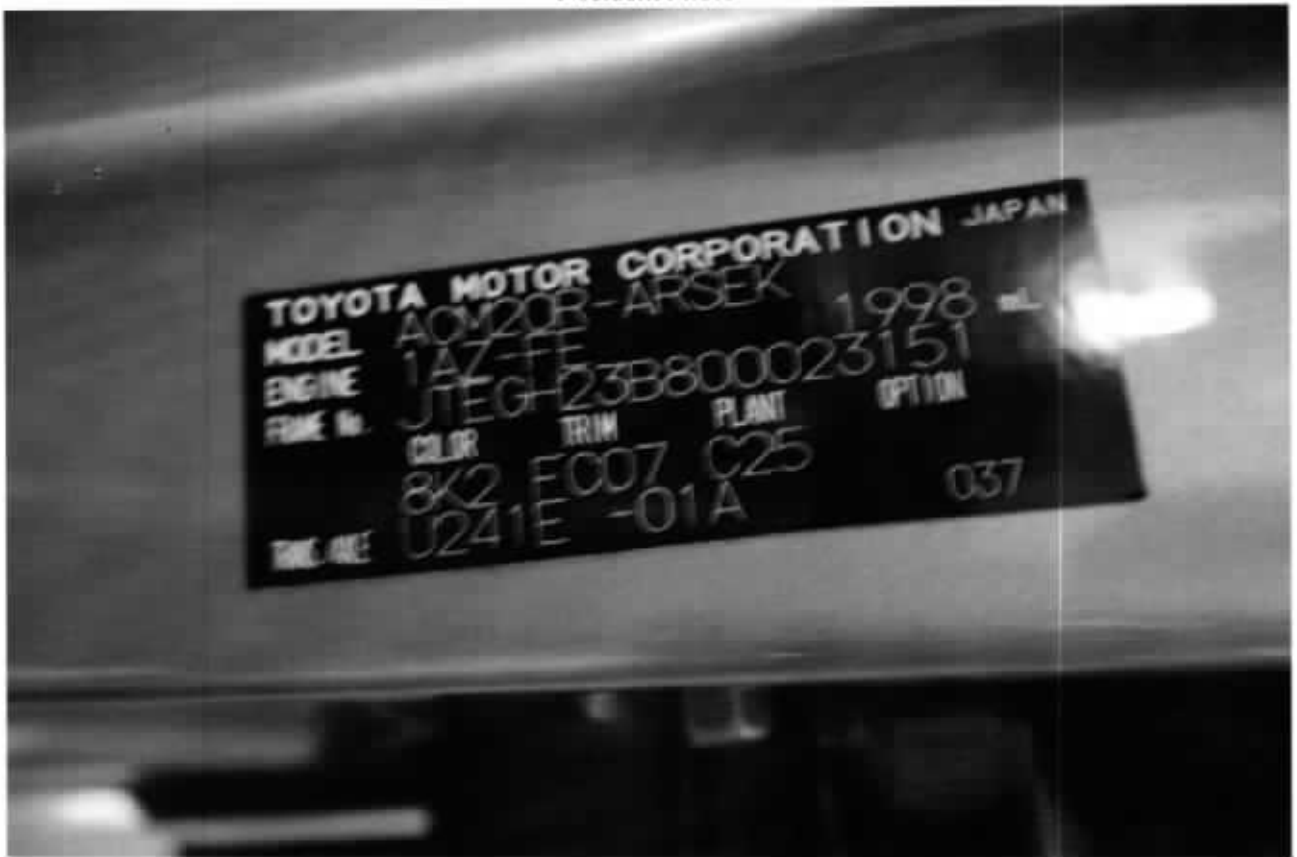
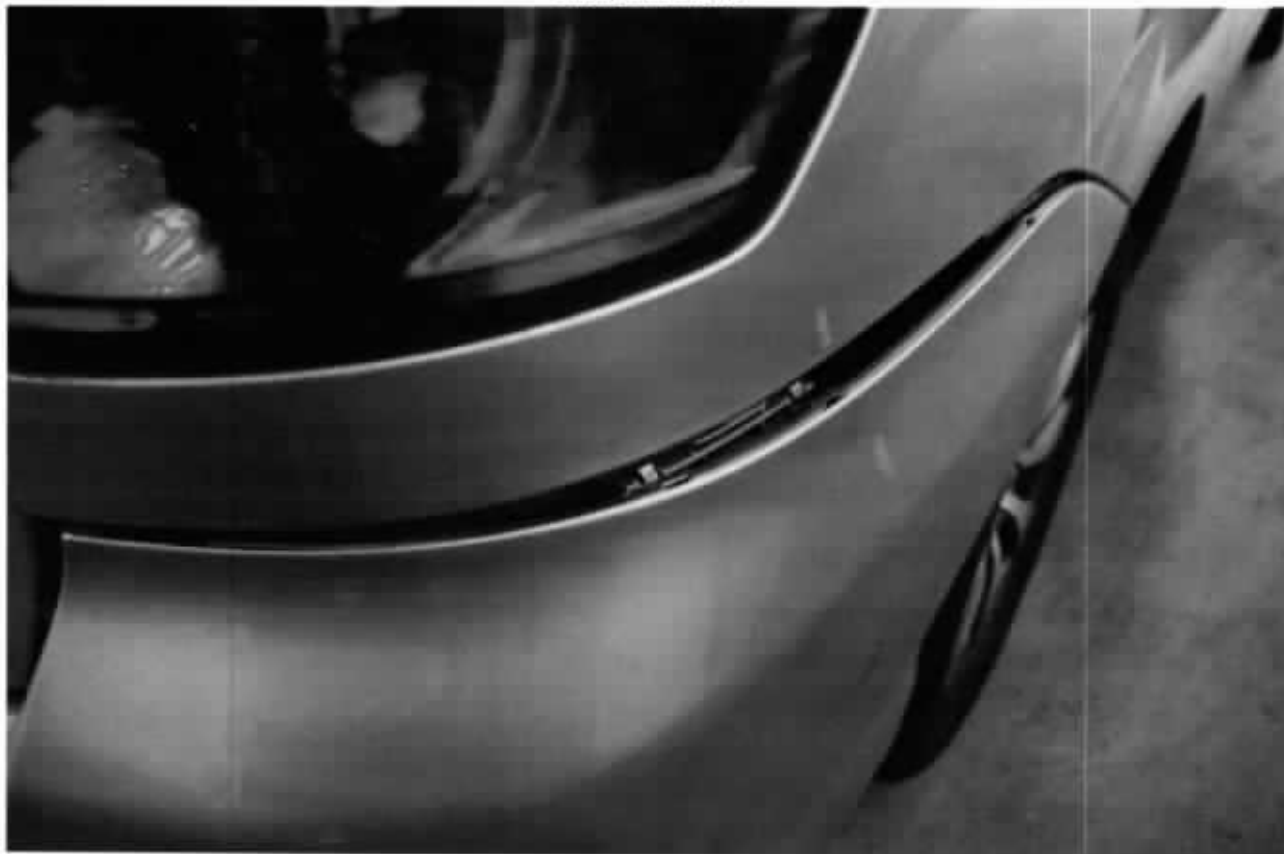
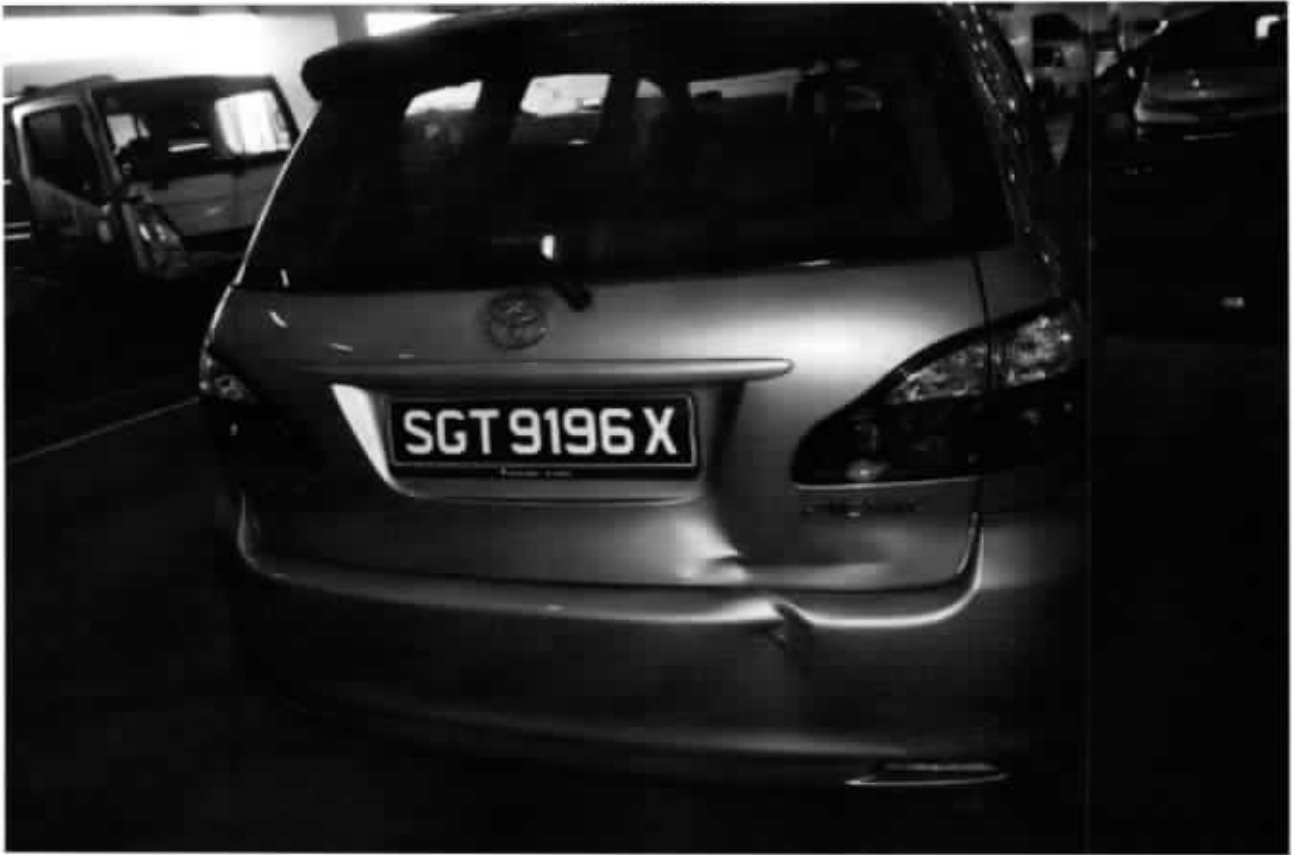
Accident Photo

The U/C / Chassis frame / Body Structure affected due to collision.

Impact on the rear portion.
Please see details as described in the Annex for parts and labour.

Hence, the recommended cost of repairs based on LUMP SUM repairs is : **\$7,900.00**
and the recommended number of working days for the repairs is : **9**
