To Inspect Vehicle No: SJT 6712R Insured: SML 8333U

VEHICLE DAMAGE INSPECTION REPORT

Our Ref: 309/TP/2019

Reg No:	SJT6712R	Make &	Toyota
Reg date:	26/10/2009	Model	Corolla Altis 1.6 Auto
Colour:	Beige	Engine No:	3ZZ4940786
Type:	Motor Car	Chassis No:	MR053ZEE106157734
Type of Claims:	Third Party	Odometer No:	108621km
		Engine Cap:	1598cc

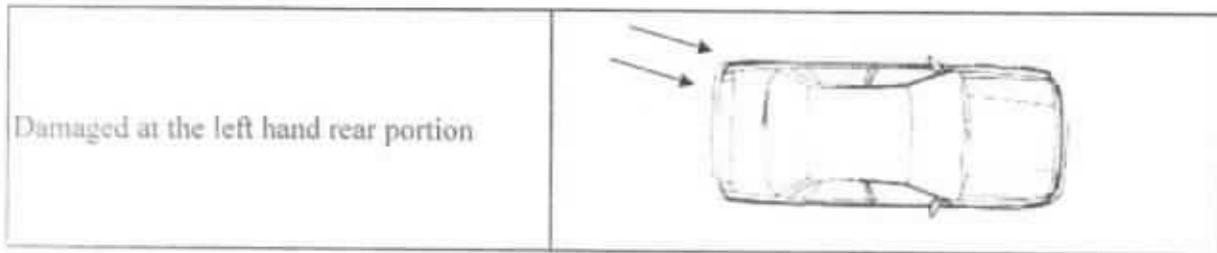
POINT OF IMPACT

Our visual inspection of the vehicle revealed that the damages noted are at the left hand rear portion.

We have inspected the actual damages found on the vehicle and recommend the replacement of parts and repairs accordingly. The estimated repair cost is \$5,706.18. The repairer has agreed to undertake the repairs at our adjusted lump sum amount of \$3,000.00.

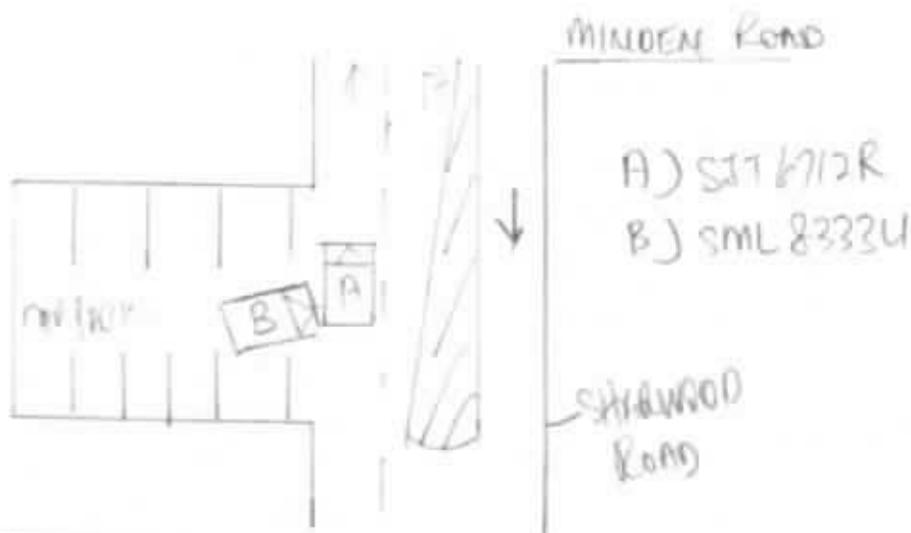
Sketch Plan #2

ON 24 OF APRIL 2019 AT ABOUT 1620PM WHILE I WAS TRAVELLING ALONG SHERWOOD ROAD BEFORE MINDEN ROAD. A CAR DROVE OUT FROM CARPARK ON THE LEFT CAR NUMBER SML 8333U SPUN OUT TO THE RIGHT LEFT OF MY CAR & MY KIM THAT ALL.
