TP Claims against NTUC Income: Follow-Through Survey

NTU	C INCOME INSUR	ANCE CO-OPERATIVE LTD	Ref:	NS/INC1901075	0/Nvd3e2				
		D UNION HOUSESINGAPORE	Date:	12-07-2019 INC4					
1.		Policy Particulars							
•••	Insured Veh.	SDV 5569E	_	nspected	SHC 3928T				
	Policy No.	5101791614	_	age (\$)	0.00				
	Claim No.	MT/1051614-001	Excess (\$)		0.00				
	Assign From		Assig	n Date	17/06/2019

ADJUSTMENT ON REPAIR COST FOR VEHICLE NO. SHC 3928T

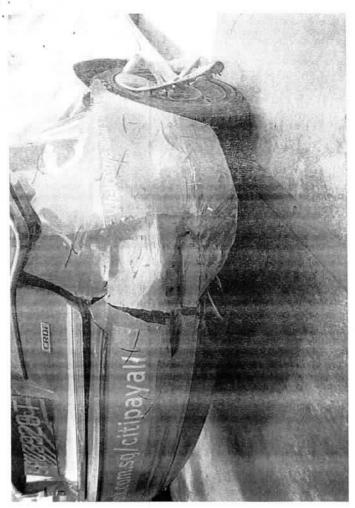
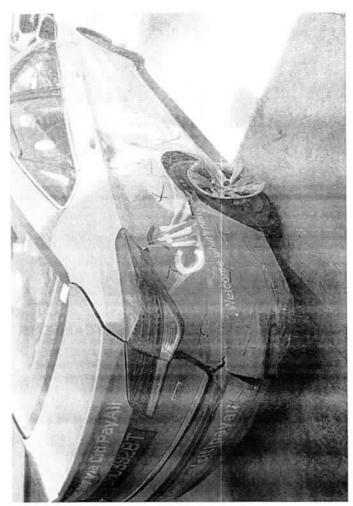
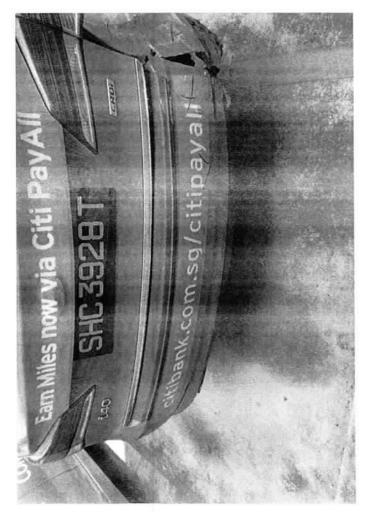
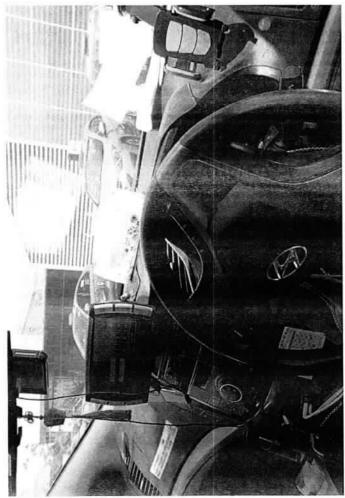
4.		Description	AND DESCRIPTION OF THE PERSON NAMED IN COLUMN						
	THE VEHICLE SU	STAINED DAMAGES AT THE RE	AR O/S	PORTION.					
	DAMAGES SEE D	ETAILS.

Qty	Description of Parts	Condition	Estimate By Workshop (\$)	Our Adjusted (\$)
	REPLACEMENT OF PARTS			
1	BOOT LID	TO REPAIR SEE LABOUR	2,174.90	2
1	BOOT LID LOCK UPPER	SERVICEABLE	102.60	5
1	BOOT LID LOCK LOWER	SERVICEABLE	31.70	
1	BOOT LID 'H' EMBLEM	NECESSARY	28.70	28.70
1	BOOT LID CRDI PLATE	NECESSARY	27.90	27.90
1	REAR BUMPER	CRACKED	553.00	553.00
1	REAR BUMPER REINFORCEMENT	DEFORMED	428.40	428.40
2	REAR BUMPER REINFORCEMENT BRACKET (LH/RH) @\$80.30	O/S BENT	160.60	80.30
10	REAR BUMPER CLIP	NECESSARY	22.00	22.00
2	REAR BUMPER BRACKET @\$35.60	SERVICEABLE	71.20	-
1	REAR BUMPER SPONGE	CRACKED	103.50	103.50
1	REAR BUMPER UNDER COVER	DEFORMED	228.00	228.00
1	REAR BUMPER REFLECTOR LAMP, RH	MISSING	30.60	30.60
1	TAIL LAMP (RH)	CRACKED	697.80	697.80
1	REAR PANEL	SERVICEABLE	526.70	-
1	REAR PANEL GARNISH	SERVICEABLE	57.70	-
1	REAR PANEL LOWER PANEL	SERVICEABLE	89.40	-
1	REAR FENDER (RH)	DEFORMED	2,171.40	2,171.40

1	REAR FENDER INNER LINING (RH)	SERVICEABLE	169.30	-
1	REAR WINDSCREEN MOULDING	NECESSARY	28.30	28.30
1	EXHAUST PIPE INSULATOR, RH	SERVICEABLE	58.55	-
1	EXHAUST SILENCER, RH	DENTED	967.70	967.70
1	EXHAUST PIPE HANGER, RH	SERVICEABLE	58.55	-
1	EXHAUST PIPE CENTRE	BENT	730.10	730.10
1	REAR TYRE RIM (RH)	SCRATCHED	325.30	325.30
1	REAR WHEEL HUP-CAP (RH)	CRACKED	107.10	107.10
	LESS 20% DISCOUNT		-1,990.20	-1,306.02
			7,960.80	5,224.08

RECOMMENDED COST OF LUMP SUM REPAIRS	5,550.00
(TO ITS PRE-ACCIDENT CONDITION) (CONFIRMED)
