NTUC INCOME INSURANCE CO-OPERATIVE LTD Ref: NS/INC19010825/K1sd3n2

1. Policy Particulars :- THIRD PARTY CLAIM

Insured Veh.	YL 6351M	Veh. Inspected	SHD 3005B
Policy No.	5108006832	Coverage (\$)	0.00
Claim No.	MT/1049874-001	Excess (\$)	0.00
Assign From		Assign Date	18/06/2019

ADJUSTMENT ON REPAIR COST FOR VEHICLE NO. SHD 3005B

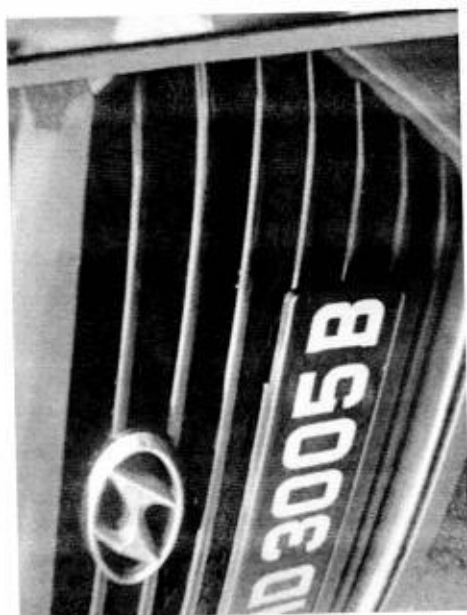
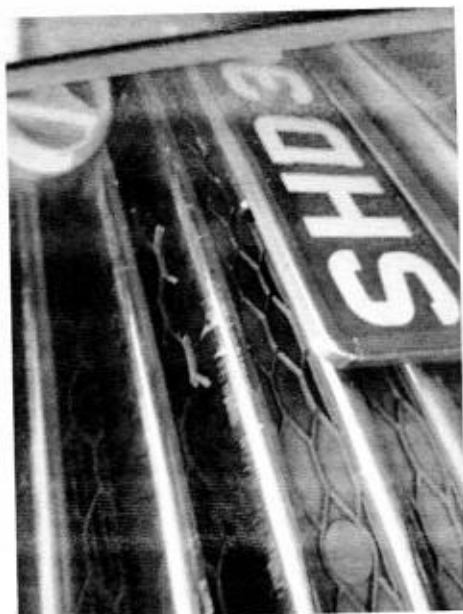
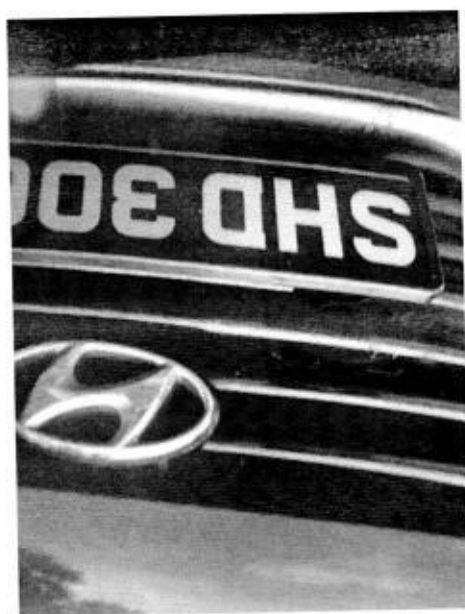
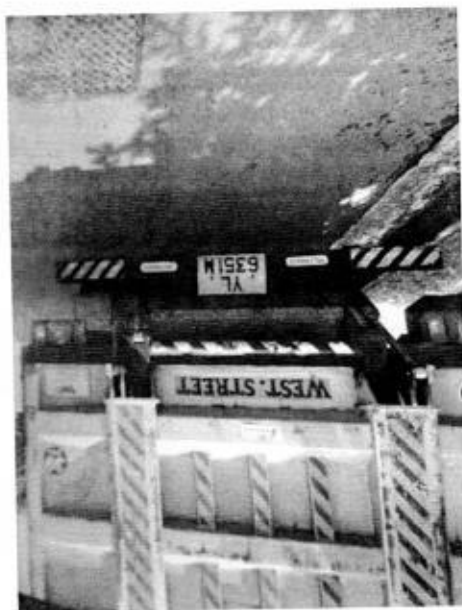
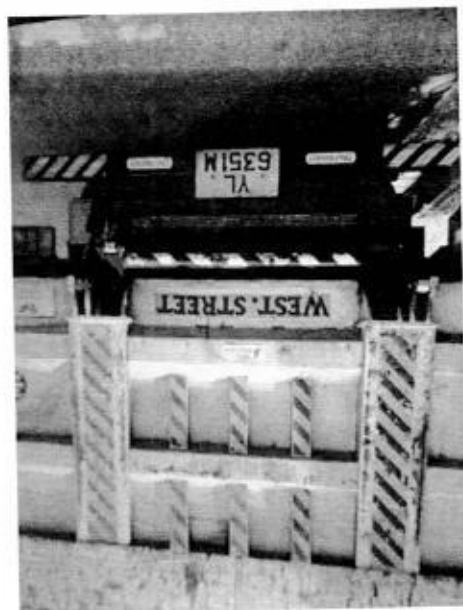
THE VEHICLE SUSTAINED DAMAGES AT THE FRONT PORTION. DAMAGES SEE DETAILS.

Qty	Description of Parts	Condition	Estimate By Workshop (\$)	Our Adjusted (\$)
REPLACEMENT OF PARTS				
1	RADIATOR GRILLE	CRACKED	1,110.10	1,110.10
1	FRONT BUMPER COVER	CRACKED	1,052.20	1,052.20
2	FRONT BUMPER BRACKET TOP (LH/RH) @\$22.40	SERVICEABLE	44.80	-
2	FRONT BUMPER BRACKET (LH/RH) @\$24.60	SERVICEABLE	49.20	-
	LESS 20% DISCOUNT		-451.26	-432.46
			1,805.04	1,729.84
LABOUR				
	PANEL BEATING.		400.00	200.00
	SPRAY PAINTING CHARGE.		300.00	200.00
			700.00	400.00
			2,505.04	2,129.84
GRAND TOTAL				
RECOMMENDED COST OF LUMP SUM REPAIRS (TO ITS PRE-ACCIDENT CONDITION) (CONFIRMED)				1,700.00
