Survey held at CPGE (Loyang)

1. Policy Particulars :- THIRD PARTY CLAIM			
Insured Veh.	SGU 1719K	Veh. Inspected	SHC 2261P
Policy No.	5094576865-01	Coverage (\$)	0.00
Claim No.	MT/1050747-001	Excess (\$)	0.00
Assign From		Assign Date	19/06/2019

4. Description of Damages			
THE VEHICLE SUSTAINED DAMAGES AT THE N/S FRONT PORTION. DAMAGES SEE DETAILS.			
5. General Information			
Accident Date	18/06/2019	Inspection Date	19/06/2019
Survey held at	COMFORTDELGRO ENGINEERING PTE LTD 59 LOYANG DRIVE SINGAPORE 508969		
5a. Remarks			
A)THE INSPECTION WAS CONDUCTED ON A"WITHOUT PREJUDICE" BASIS. B)IN ACCORDANCE TO YOUR INSTRUCTIONS, WE HAVE NOT AUTHORISED REPAIRS.			
5b. Estimate Days of Repair			
ESTIMATED NORMAL PERIOD FOR REPAIR:		3 Working Days

ADJUSTMENT ON REPAIR COST FOR VEHICLE NO. SHC 2261P

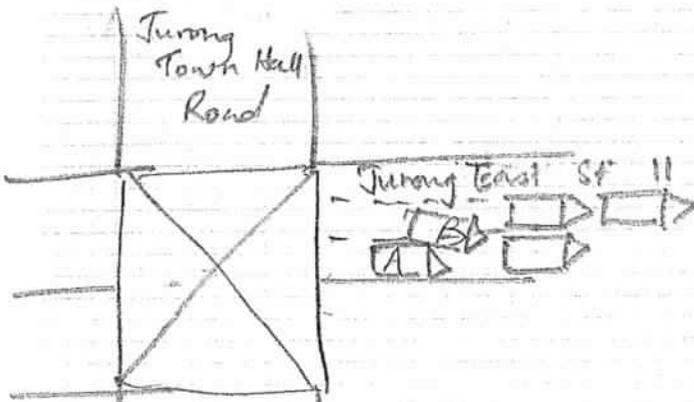
SKETCH PLAN

A) SHC2261P
 B) SGU1719K

On 18/6/19 at about 1630hrs when I Veh A was travelling along JE St 11 after passing the junction, Veh B from the left lane filtered into my lane suddenly and collided on the left front portion of my vehicle. Veh B sustained damages on the right rear portion. I felt some pain on my shoulder and abdomen areas. I will be consulting the doctor subsequently.

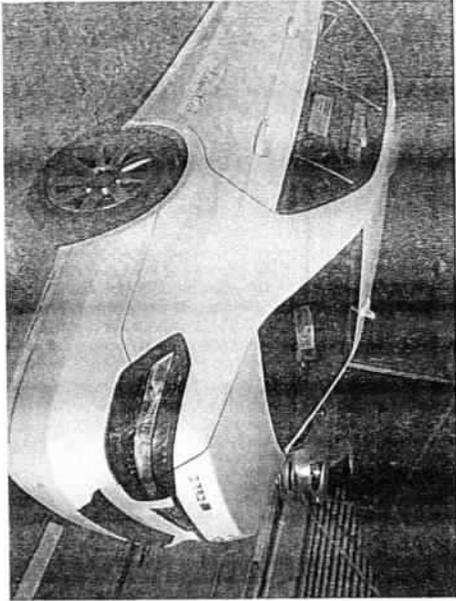
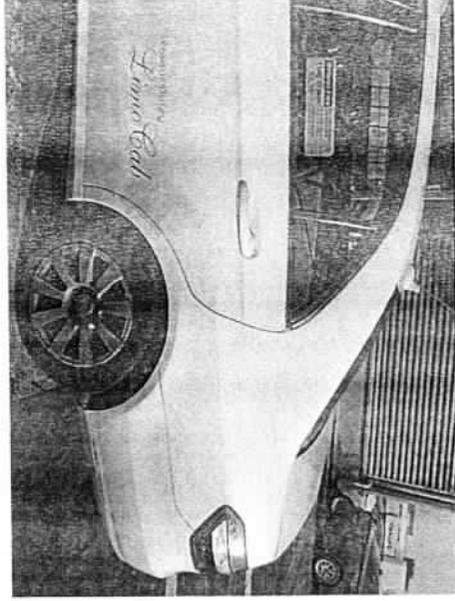
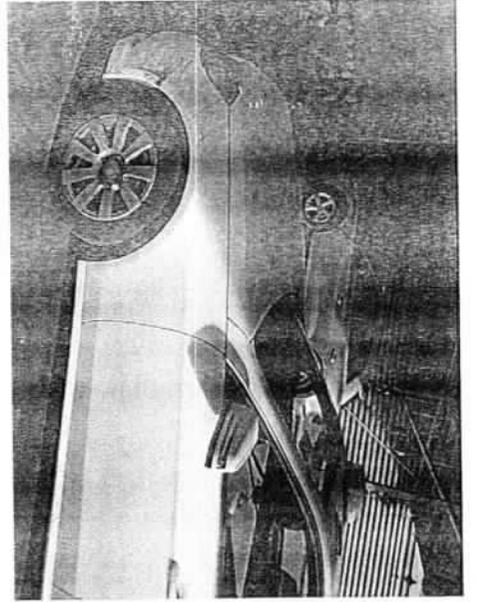
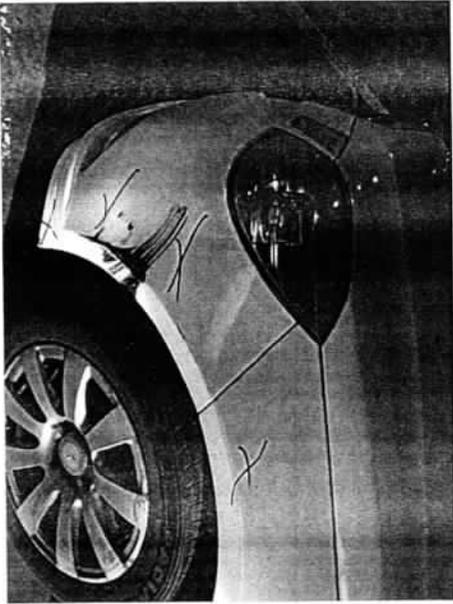
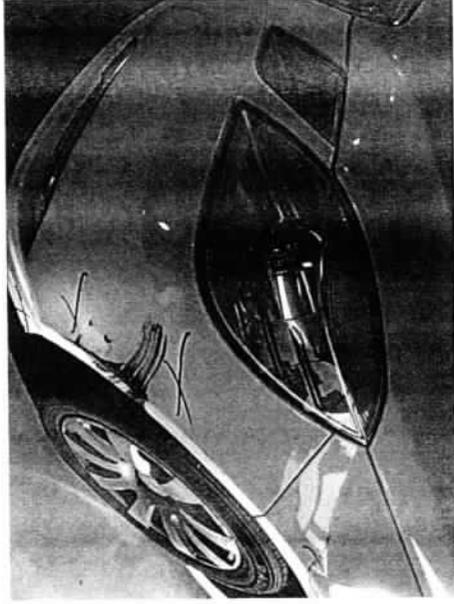
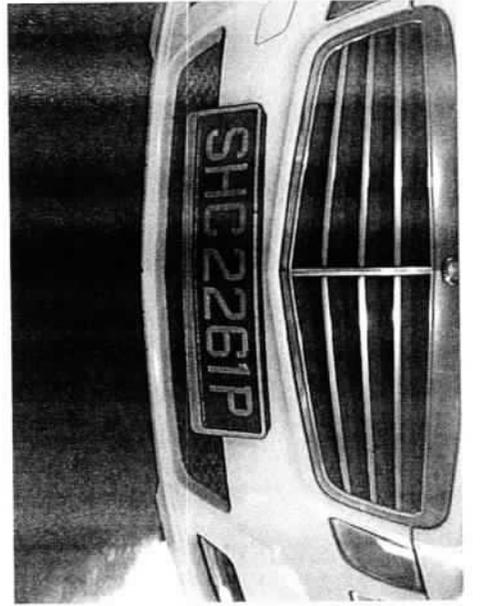
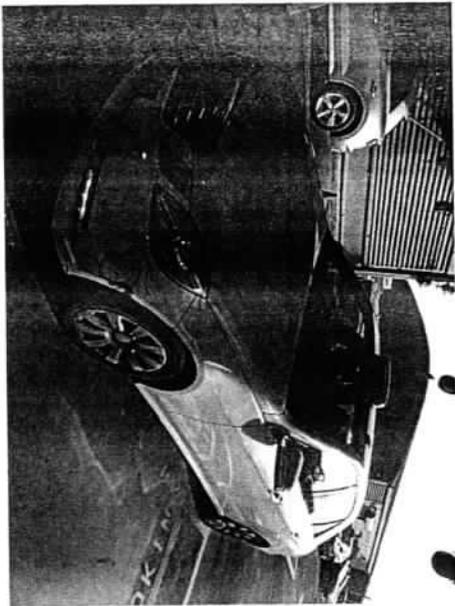
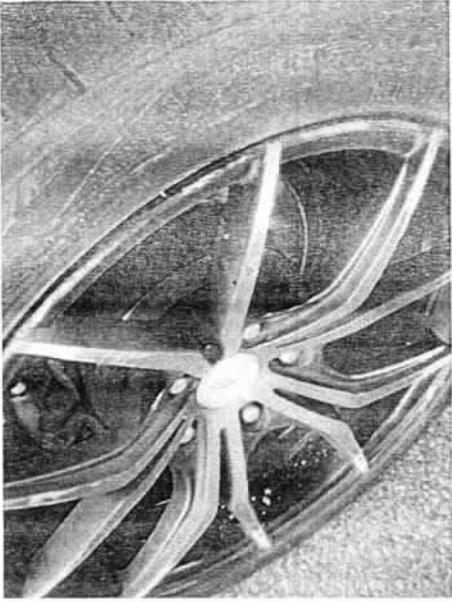
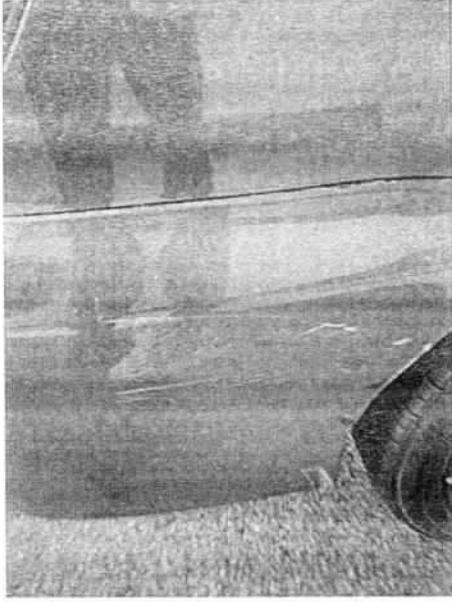
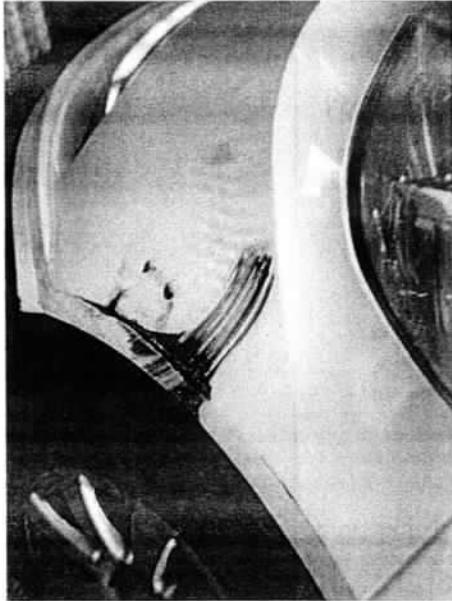
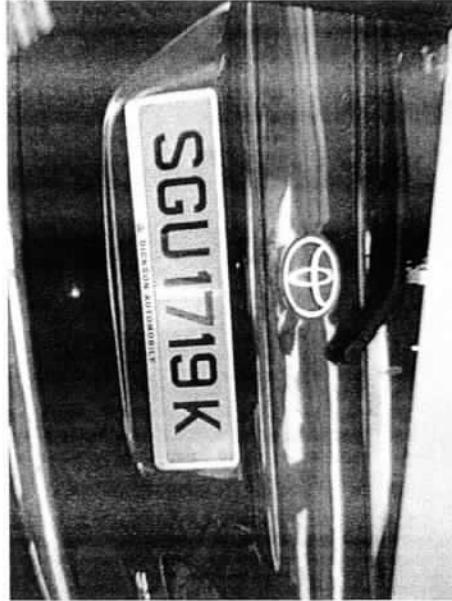
n/s front

The U/C / Chassis frame / Body Structure affected due to collision.

Qty	Description of Parts	Condition	Estimate By Workshop (\$)	Our Adjusted (\$)
REPLACEMENT OF PARTS				
1	BUMPER ASSY,FRT	CUT	1,890.50	1,890.50
1	BUMPER BRACKET,FRT/LH	SERVICEABLE	95.00	-
1	HEAD LAMP ASSY (LH)	GRAZED	2,380.00	2,380.00
1	WHEEL RIM,LH	SERVICEABLE	1,250.00	-
1	FRONT LH FENDER (NPA)	TO REPAIR SEE LABOUR	-	-
	LESS 20% DISCOUNT		-1,123.10	-854.10
			4,492.40	3,416.40
LABOUR				
	PANEL BEATING.INCLUSIVE OF THE REPAIR OF FRONT LH FENDER.		400.00	200.00
	SPRAY PAINTING CHARGE.		600.00	400.00
	WIRING CHARGE.		30.00	20.00
	TUFF KOTE.	NOT NECESSARY	50.00	-
	FRT WHEEL ALIGNMENT.	NOT NECESSARY	120.00	-
			1,200.00	620.00
GRAND TOTAL			5,692.40	4,036.40
RECOMMENDED COST OF LUMP SUM REPAIRS (TO ITS PRE-ACCIDENT CONDITION) (CONFIRMED)				3,200.00
