NTUC INCOME INSURANCE CO-OPERATIVE LTD Ref: NS/INC19010955/K1vd3n2

### 1. Policy Particulars :- THIRD PARTY CLAIM

### 4. Description of Damages

**ADJUSTMENT ON REPAIR COST FOR VEHICLE NO. SHC 789Y**

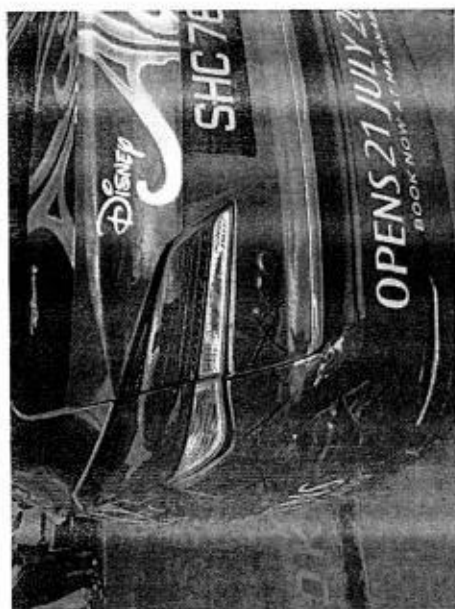
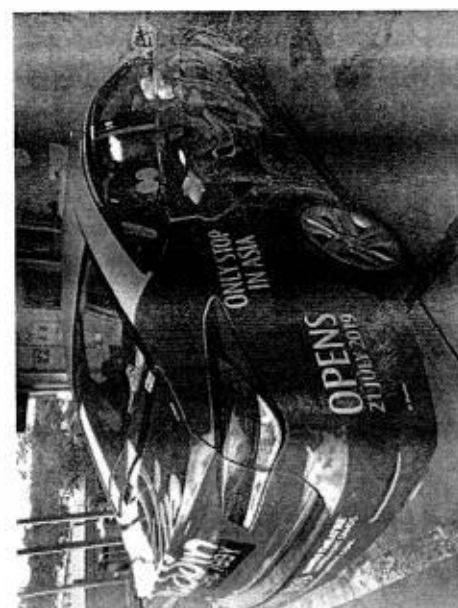
Rear 1/2

The U/C / Chassis frame / Body Structure affected due to collision.

THE VEHICLE SUSTAINED DAMAGES AT THE REAR N/S PORTION. DAMAGES SEE DETAILS.
--

Qty	Description of Parts	Condition	Estimate By Workshop (\$)	Our Adjusted (\$)
<b><u>REPLACEMENT OF PARTS</u></b>				
1	BOOT LID	SERVICEABLE	2,174.90	-
1	BOOT LID LOCK UPPER	SERVICEABLE	102.60	-
1	BOOT LID LOCK LOWER	SERVICEABLE	31.70	-
1	BOOT LID "H" EMBLEM	NOT NECESSARY	28.70	-
1	BOOT LID CRDI PLATE	NOT NECESSARY	27.90	-
1	BOOT LID LAMP (LH)	SERVICEABLE	565.60	-
1	REAR BUMPER	DEFORMED	553.00	553.00
10	REAR BUMPER CLIP	NECESSARY	22.00	22.00
1	REAR BUMPER REFLECTOR LAMP (LH)	GRAZED	30.60	30.60
1	TAIL LAMP (LH)	SERVICEABLE	697.80	-
1	REAR FENDER (LH)(NPA)	TO REPAIR SEE LABOUR	-	-
1	REAR BUMPER SIDE BRACKET (LH)	CRACKED	35.60	35.60
	LESS 20% DISCOUNT		-854.08	-128.24
			3,416.32	512.96
<b><u>SPECIAL NETT ITEMS</u></b>				
1	BOOT LID COMFORT LOGO & TEL NO STICKER (SN)	NOT NECESSARY	30.00	-
1	BOOT LID ADVERTISEMENT LOGO (SN)	NOT NECESSARY	100.00	-
1	REAR BUMPER RUBBER MAT (SN)	NECESSARY	50.00	50.00
1	REAR BUMPER ADVERTISEMENT LOGO (SN)	NECESSARY	50.00	50.00

2	REAR FENDER ADVERTISEMENT LOGO (LH/RH) @\$100.00 (SN)	NECESSARY	200.00	200.00
			430.00	300.00
<b><u>LABOUR</u></b>				
	PANEL BEATING.INCLUSIVE OF THE REPAIR OF REAR FENDER (LH).		400.00	300.00
	SPRAY PAINTING CHARGE.		600.00	400.00
	WIRING CHARGE.	NOT NECESSARY	50.00	-
	TUFF KOTE.	NOT NECESSARY	50.00	-

Qty	Description of Parts	Condition	Estimate By Workshop (\$)	Our Adjusted (\$)
	REMOVE/REFIX REVERSE SENSOR.	NOT NECESSARY	80.00	-
			1,180.00	700.00
GRAND TOTAL			5,026.32	1,512.96
RECOMMENDED COST OF LUMP SUM REPAIRS (TO ITS PRE-ACCIDENT CONDITION) (CONFIRMED)				1,200.00
