VEHICLE DAMAGE INSPECTION REPORT

Our File No: CC3/TMI19011097/K1SD3N2

Handling Insurer:	Tokio Marine Insurance Singapore Ltd	Policy No:	MK000203
Claimant Vehicle No :	SH8615G	Insured Vehicle No :	SLG9505Y
Date of Loss:	24/06/2019	Nature of Claim:	TP
		Claim No:	M1904692

Reg No:	SH8615G	Engine No:	D4FDFU503653
Make & Model:	HYUNDAI I40, 1.7 D CRDi (A)	Chassis No:	KMHLB41UMEU056092
Reg. Date:	10/07/2014 (Man. Year: 2014)	Odometer:	713283 km
Colour:	Blue		
Engine Capacity:	1685 cc		
Market Value/New Car Price:	N/A		
Sum Insured (S\$):	Market Value/New Car Price

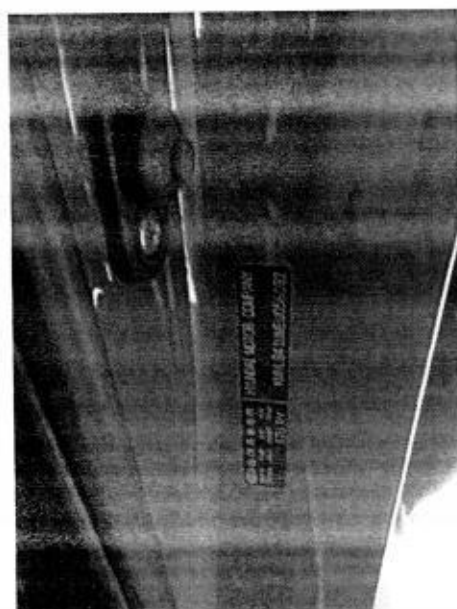
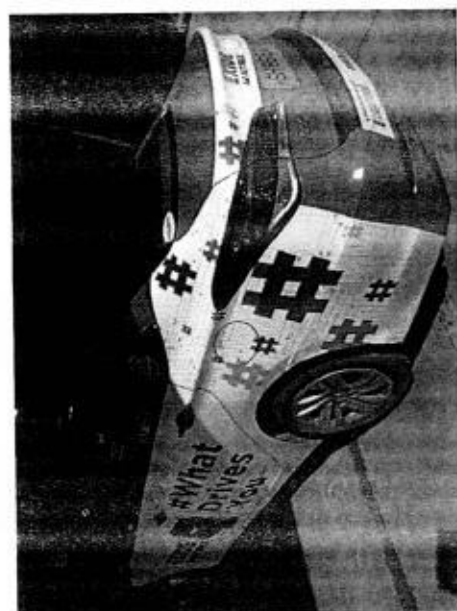
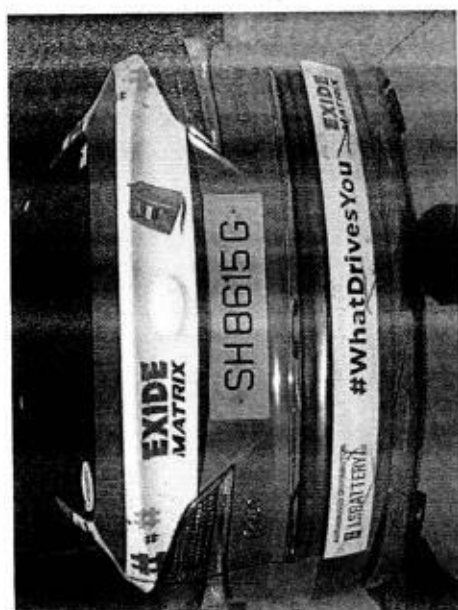
Remark: The veh had commenced its
repair at the time of inspection.

The U/C / Chassis frame / Body Structure affected due to collision.

No.	Qty	Part No.	Particulars	Condition	Repairer's	Amount
1	1		*REAR BUMPER	Deformed	553.00 FL	*553.00 FL
2	10		*REAR BUMPER CLIPS	Necessary	22.00 FL	*22.00 FL
3	1		*REAR BUMPER UNDER COVER	Cut	228.00 FL	*228.00 FL
4	1		*REAR BUMPER RUBBER MAT	Necessary	50.00 F	*50.00 FS
5	1		*REAR BUMPER ADVERTISEMENT LOGO	Necessary	50.00 F	*50.00 FS
6	1		*REAR FENDER ADVERTISEMENT LOGO RH	Necessary	100.00 F	*100.00 FS
7	1		*REAR FENDER ADVERTISEMENT LOGO LH	Necessary	100.00 F	*100.00 FS
					Sub Total (\$\$)	1,103.00 1,103.00
					- List Item Discount on L Items 20.00/20.00% (\$\$)	160.60 160.60
					Total Parts (\$\$)	942.40 942.40

No	Particulars	Lab.Type	Repairer's	Amount
<u>Labour Items</u>				
1	PANEL BEATING	New	400.00	200.00
2	SPRAY PAINTING CHARGE	New	300.00	200.00
3	WIRING CHARGE	New	30.00	0.00
4	REMOVE/REFIX REVEVRSE SENSOR	New	80.00	30.00
Gross Labour Cost (\$\$)			810.00	430.00
