NTUC INCOME INSURANCE CO-OPERATIVE LTD Ref: NS/INC19011155/K1qd3n2

1. Policy Particulars :- THIRD PARTY CLAIM

4. Description of Damages

ADJUSTMENT ON REPAIR COST FOR VEHICLE NO. SHC 982E

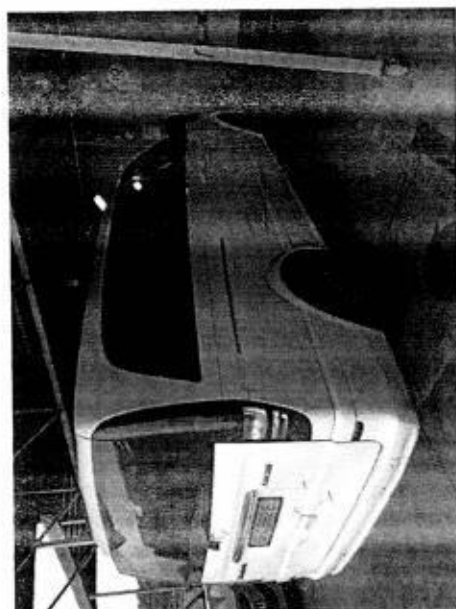
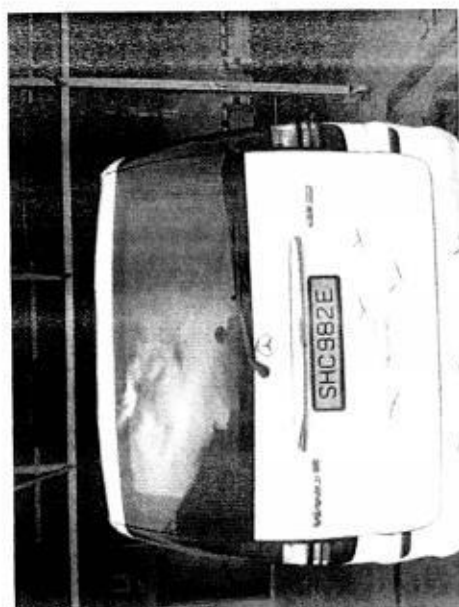
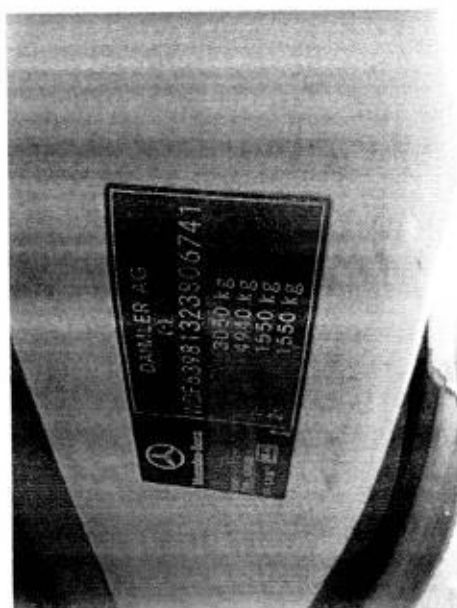
The U/C / Chassis frame / Body Structure affected due to collision.

THE VEHICLE SUSTAINED DAMAGES AT THE REAR PORTION. DAMAGES SEE DETAILS.
--

Qty	Description of Parts	Condition	Estimate By Workshop (\$)	Our Adjusted (\$)
<u>REPLACEMENT OF PARTS</u>				
1	REAR BUMPER	TO REPAIR SEE LABOUR	1,372.00	-
1	BUMPER L/H SIDE, RR	SERVICEABLE	473.60	-
1	BUMPER R/H SIDE, RR	SERVICEABLE	473.60	-
1	CROSSMEMBER REAR	SERVICEABLE	462.48	-
2	CROSSMEMBER STAY REAR	SERVICEABLE	141.14	-
1	TAIL GATE ASSY	BUCKLED	3,951.98	3,951.98
1	TAIL GATE TRIM COVER	SERVICEABLE	320.00	-
1	TAIL GATE WEATHERSTRIP	SERVICEABLE	166.63	-
1	TAIL GATE MERCEDES STAR LOGO	NECESSARY	45.46	45.46
1	TAIL GATE "2.2" LOGO	NECESSARY	78.00	78.00
1	TAIL GATE "CDI" LOGO	NECESSARY	78.00	78.00
1	TAIL GATE VIA NO LOGO	NECESSARY	78.00	78.00
1	TAIL GATE STEP GARNISH	SERVICEABLE	161.45	-
	LESS 20% DISCOUNT		-1,560.47	-846.29
			6,241.87	3,385.15
<u>SPECIAL NETT ITEMS</u>				
1	REVERSE SENSOR (SN)	SERVICEABLE	288.00	-
1	TAIL GATE "MAXICAB" LOGO (SN)	NOT NECESSARY	30.00	-

318.00	-
<u>LABOUR</u>				
	PANEL BEATING. INCLUSIVE OF THE REPAIR OF REAR BUMPER.		750.00	200.00
	SPRAY PAINTING CHARGE.		600.00	400.00
	WIRING CHARGE.		50.00	20.00
	TUFF KOTE.		50.00	20.00
	REMOVE / REFIX REVERSE SENSOR.	NOT NECESSARY	120.00	-
			1,570.00	640.00
GRAND TOTAL			8,129.87	4,025.15

RECOMMENDED COST OF LUMP SUM REPAIRS (TO ITS PRE-ACCIDENT CONDITION) (CONFIRMED)			3,200.00
--	--	--	----------
