Report No: 0279-19-SHM

Vehicle No. SLB6685G

ACCIDENT VEHICLE SURVEY REPORT

VEHICLE DAMAGE INSPECTION REPORT

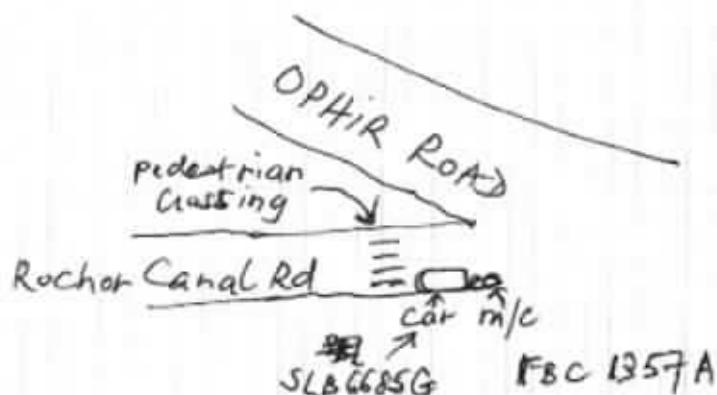
SKETCH PLAN

While turning into ~~the~~ Minor Road Rochor Canal just before Zebra Crossing I stop my vehicle to allow an elderly man to cross. M/c suddenly hit from behind with heavy force. No injury on both sides.

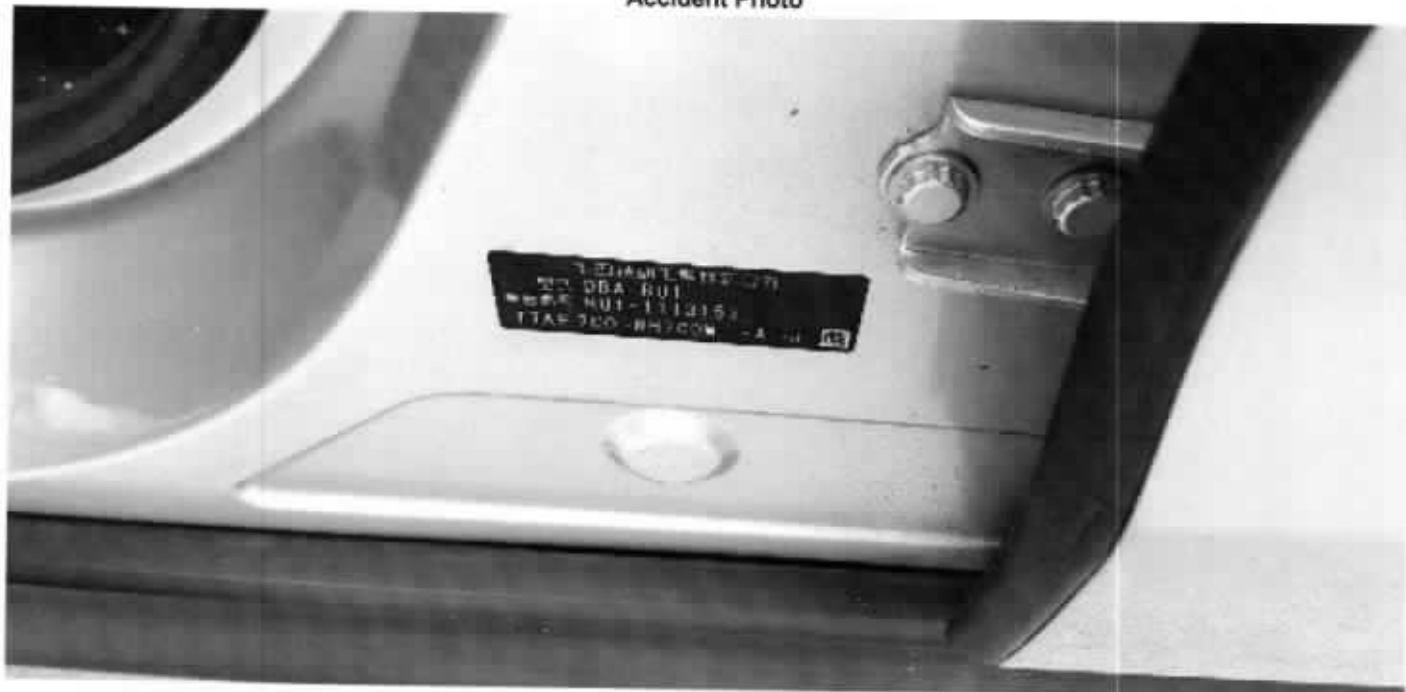
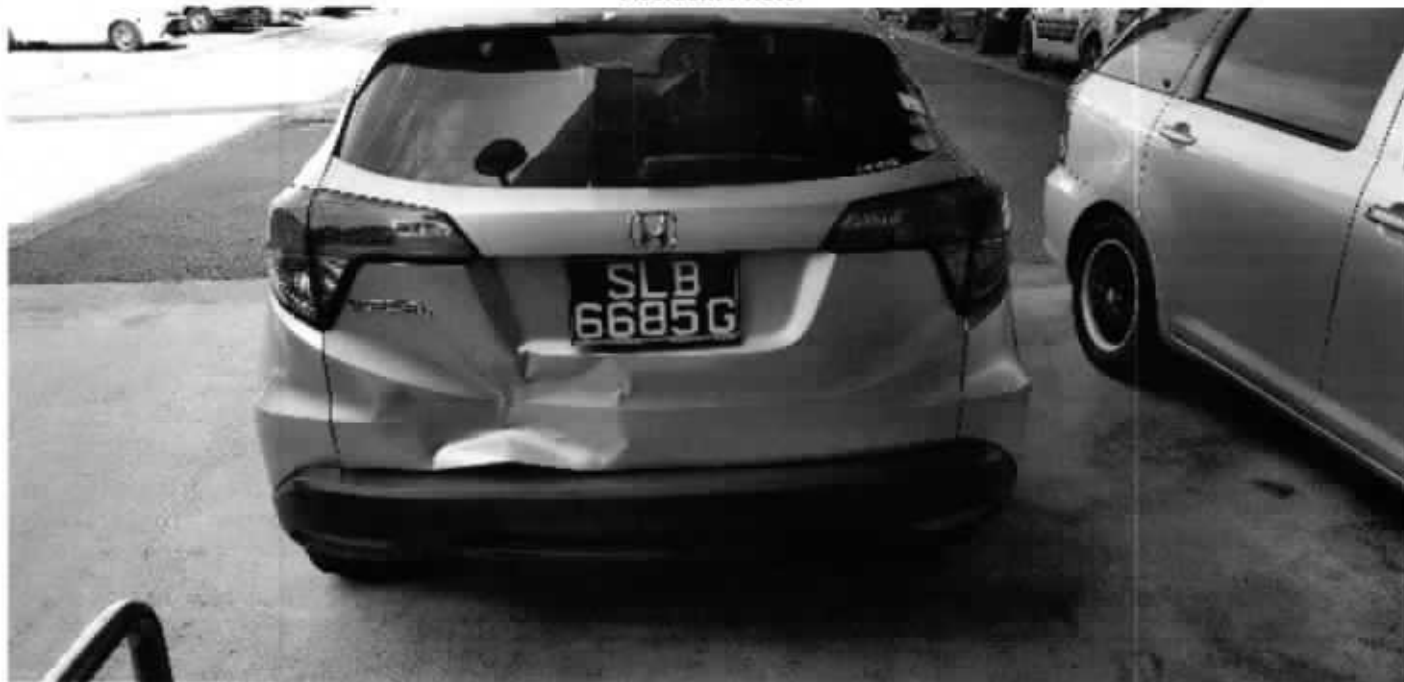
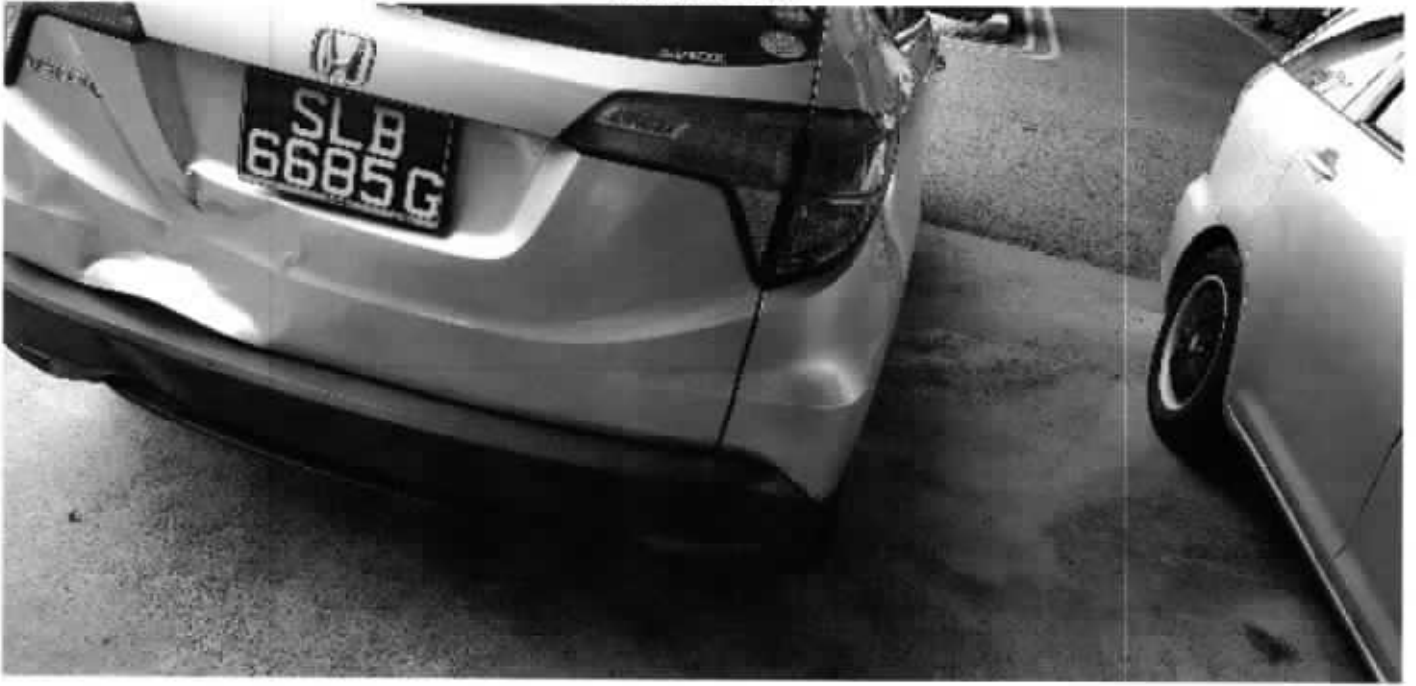
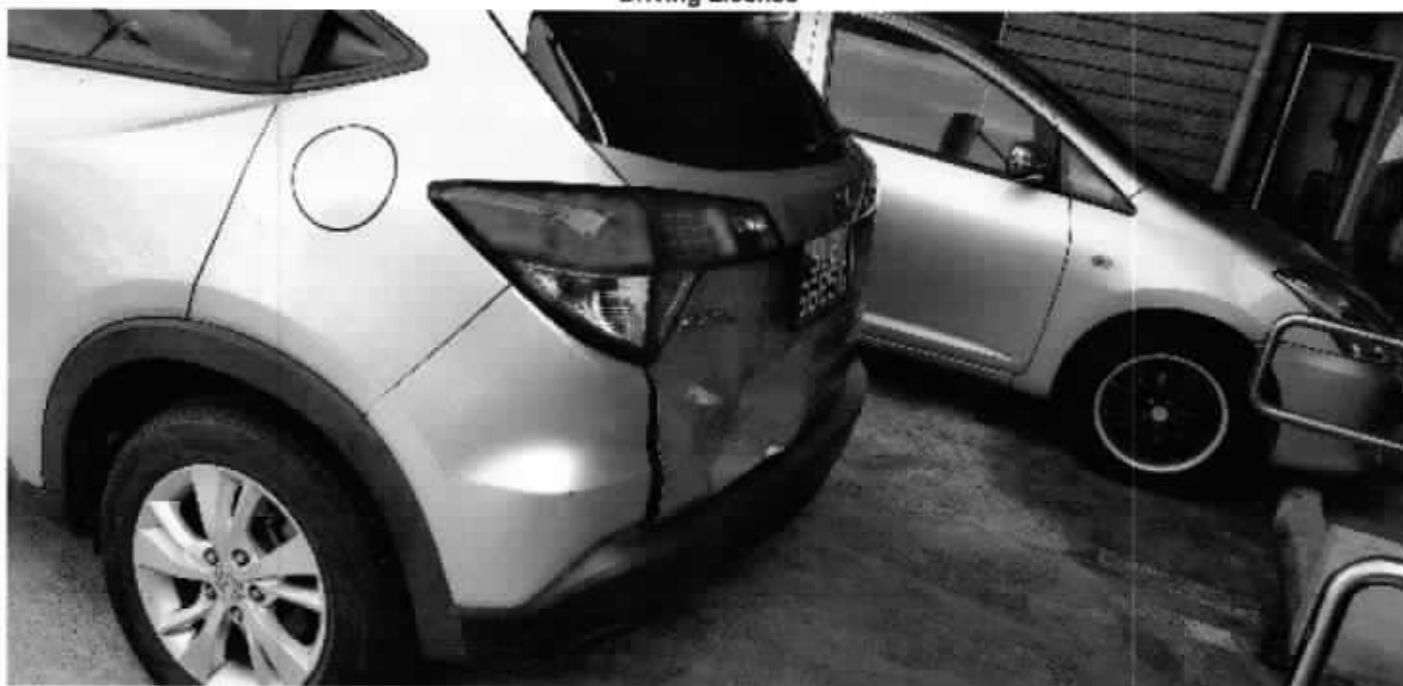
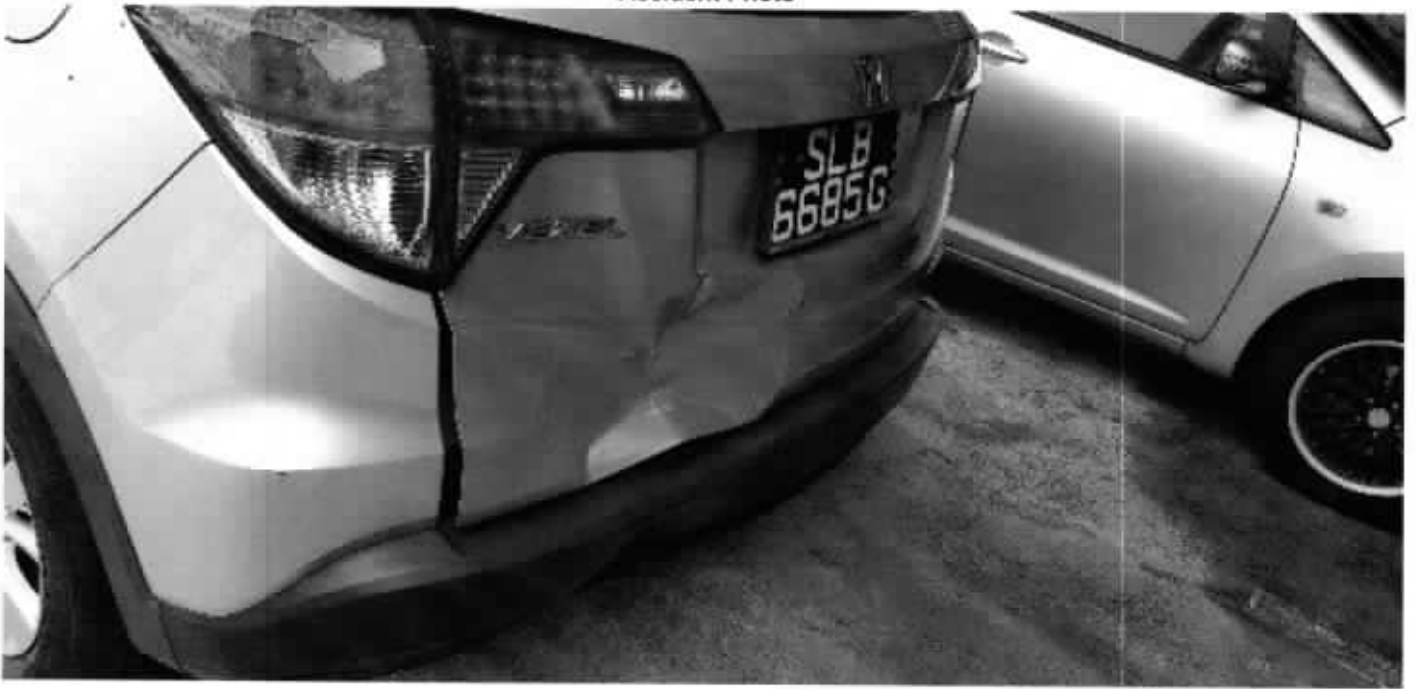
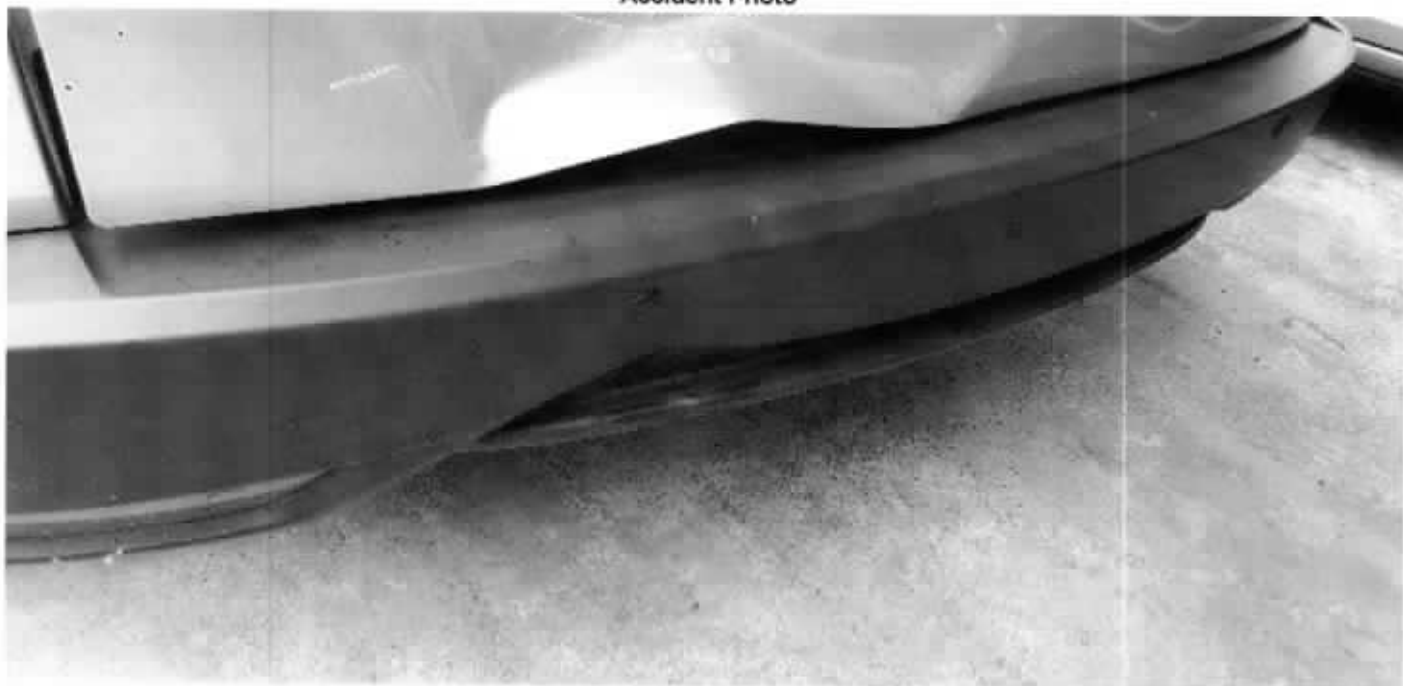
Accident Photo

The UIC / Chassis frame / Body Structure affected due to collision.

Impact on the rear portion.
Please see details as described in the Annex for parts and labour.

1. To straighten and panel beating rear fender RH/LH, rear boot floor panel and rear frame members. To cut and weld rear end panel. To remove and refit above parts.	1,600.00	1,250.00	600
2. To putty, re-spray painting and polish affected areas.	1,500.00	1,320.00	600
3. To check and rectify wiring system.	80.00	50.00	30
4. To remove and refit rear windscreen.	150.00	120.00	100
5. To rust proof affected areas.	120.00	60.00	1390
Labour total	3,450.00	2,800.00	
Parts & Labour total	11,091.50	8,535.20

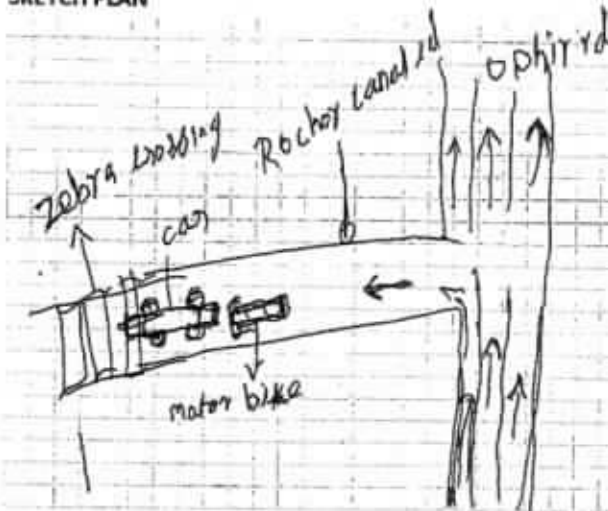
SKETCH PLAN

on Saturday 11th May night time 7.50pm I am traveling in ophir rd in front of me a car also traveling he also take left in Rocher canal rd i am also been left zebra crossing suddenly people run way that time in front of me car to put brake i also put brake to stop but can't control so i hit the car back side door. no injuries happened i am alright. The other party car num [SLB 6685G] my vehicle num [FBI 1357A]
