Insured Veh.	SLR 3922H	Veh. Inspected	SHC 8187G
Policy No.	5094510232-01	Coverage (\$)	0.00
Claim No.	MT/1050908-003	Excess (\$)	0.00
Assign From		Assign Date	26/06/2019

4. Description of Damages

THE VEHICLE SUSTAINED DAMAGES AT THE REAR O/S PORTION. DAMAGES SEE DETAILS.
--

ADJUSTMENT ON REPAIR COST FOR VEHICLE NO. SHC 8187G

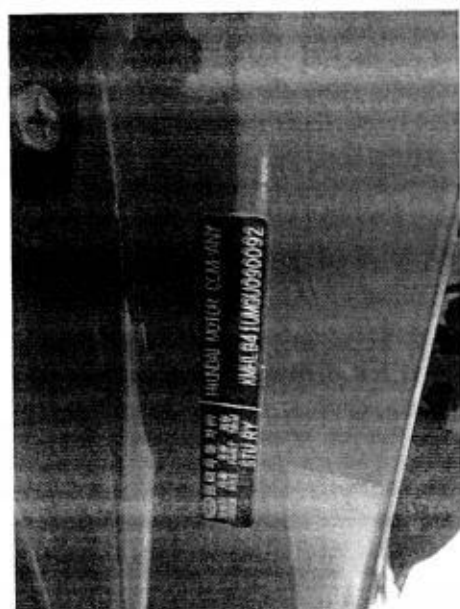
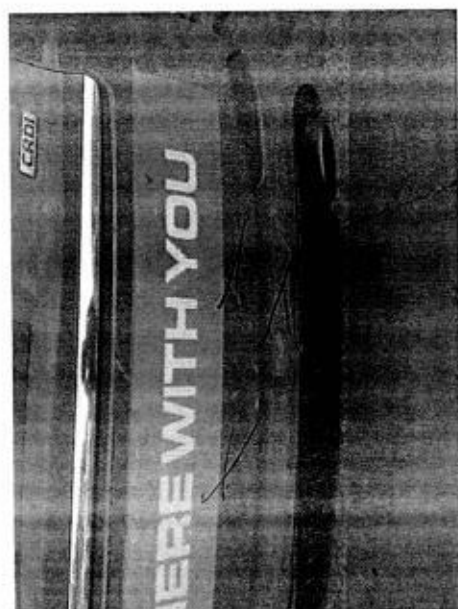
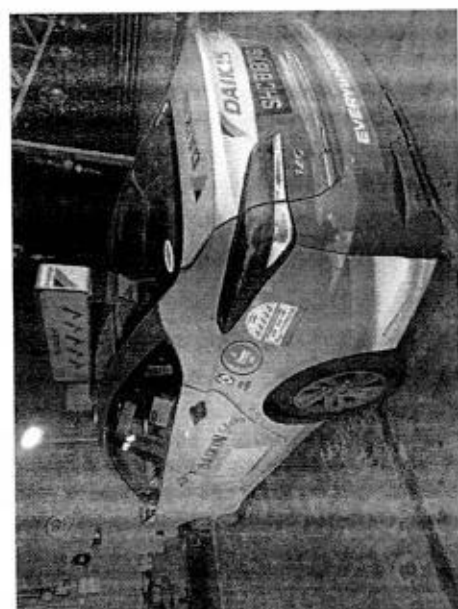
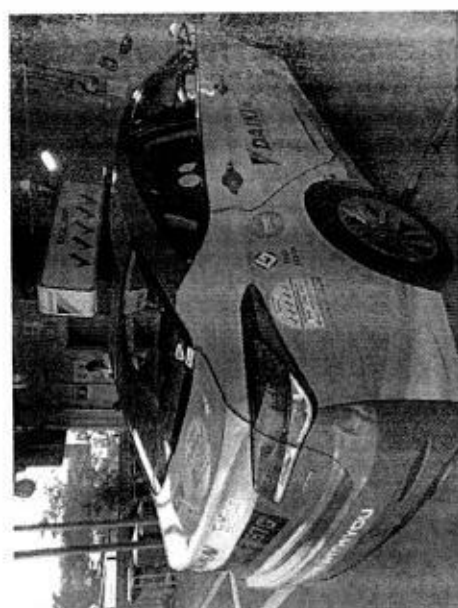
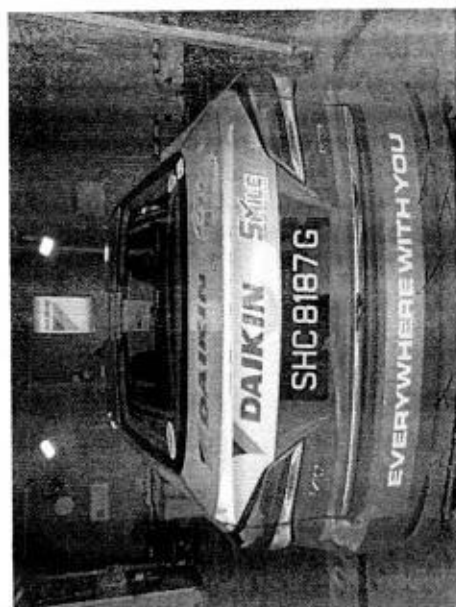
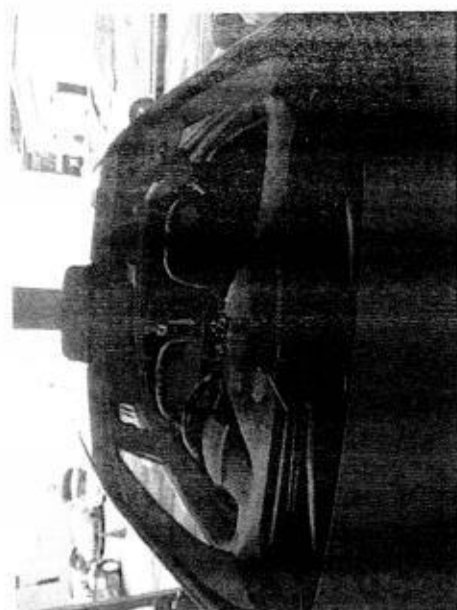
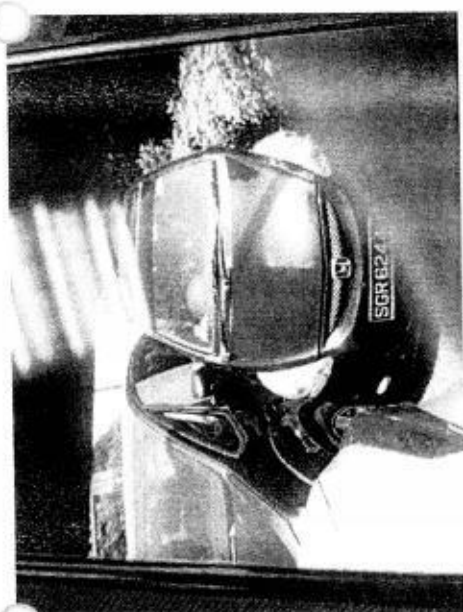
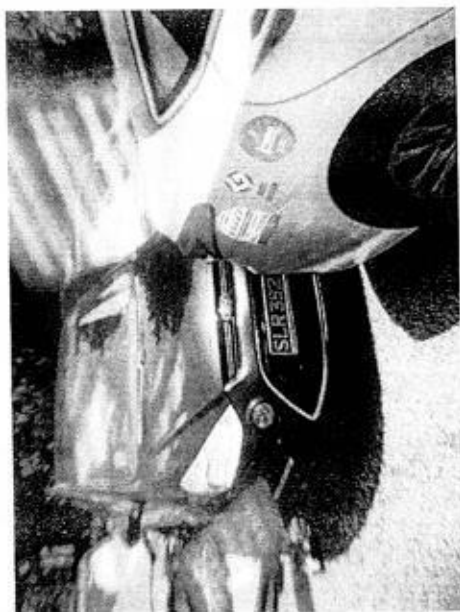
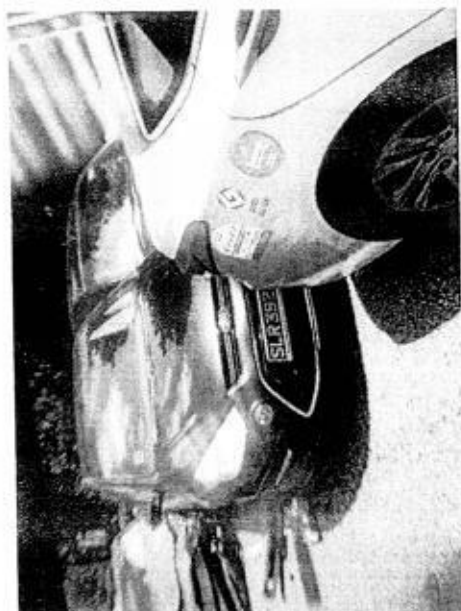
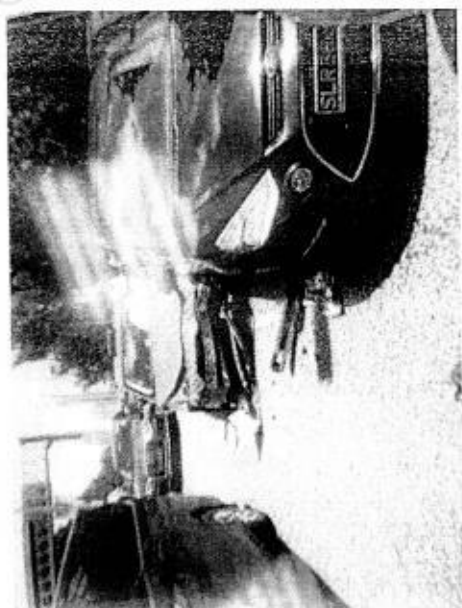
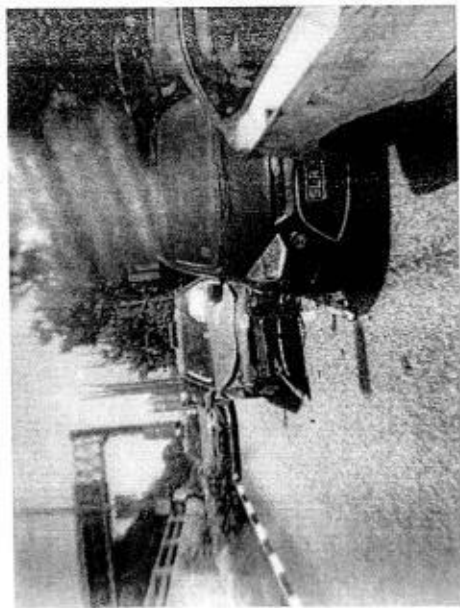
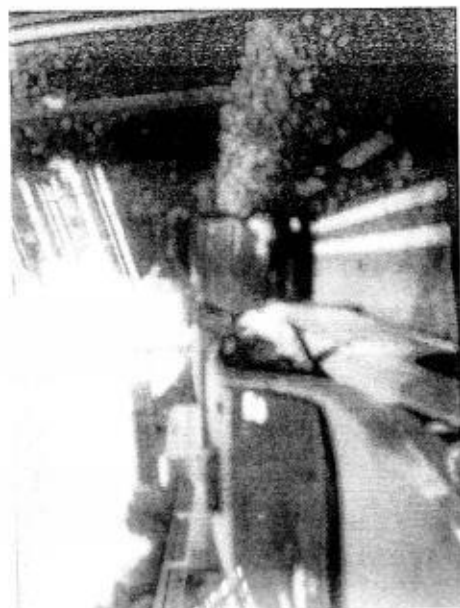
Qty	Description of Parts	Condition	Estimate By Workshop (\$)	Our Adjusted (\$)
REPLACEMENT OF PARTS				
1	REAR BUMPER	DEFORMED	553.00	553.00
10	REAR BUMPER CLIP	NECESSARY	22.00	22.00
2	REAR BUMPER BRACKET @\$35.60	SERVICEABLE	71.20	-
1	REAR BUMPER UNDER COVER	CUT	228.00	228.00
	LESS 20% DISCOUNT		-174.84	-160.60
			699.36	642.40
SPECIAL NETT ITEMS				
1	REAR BUMPER ADVERTISEMENT LOGO (SN)	NECESSARY	50.00	50.00
2	REAR FENDER ADVERTISEMENT LOGO (LH/RH) @\$100.00 (SN)	NECESSARY	200.00	200.00
			250.00	250.00
LABOUR				
	PANEL BEATING.		400.00	200.00
	SPRAY PAINTING CHARGE.		300.00	200.00
	WIRING CHARGE.	NOT NECESSARY	30.00	-
	REMOVE/REFIX REVERSE SENSOR.	NOT NECESSARY	80.00	-
			810.00	400.00
GRAND TOTAL			1,759.36	1,292.40

RECOMMENDED COST OF LUMP SUM REPAIRS (TO ITS PRE-ACCIDENT CONDITION) (CONFIRMED)			1,000.00
---	--	--	-----------------
