Re : **THIRD PARTY CLAIM**

VEHICLE INSPECTION REPORT

ADJUSTMENT ON REPAIR COST FOR VEHICLE NO. GZ 9001T

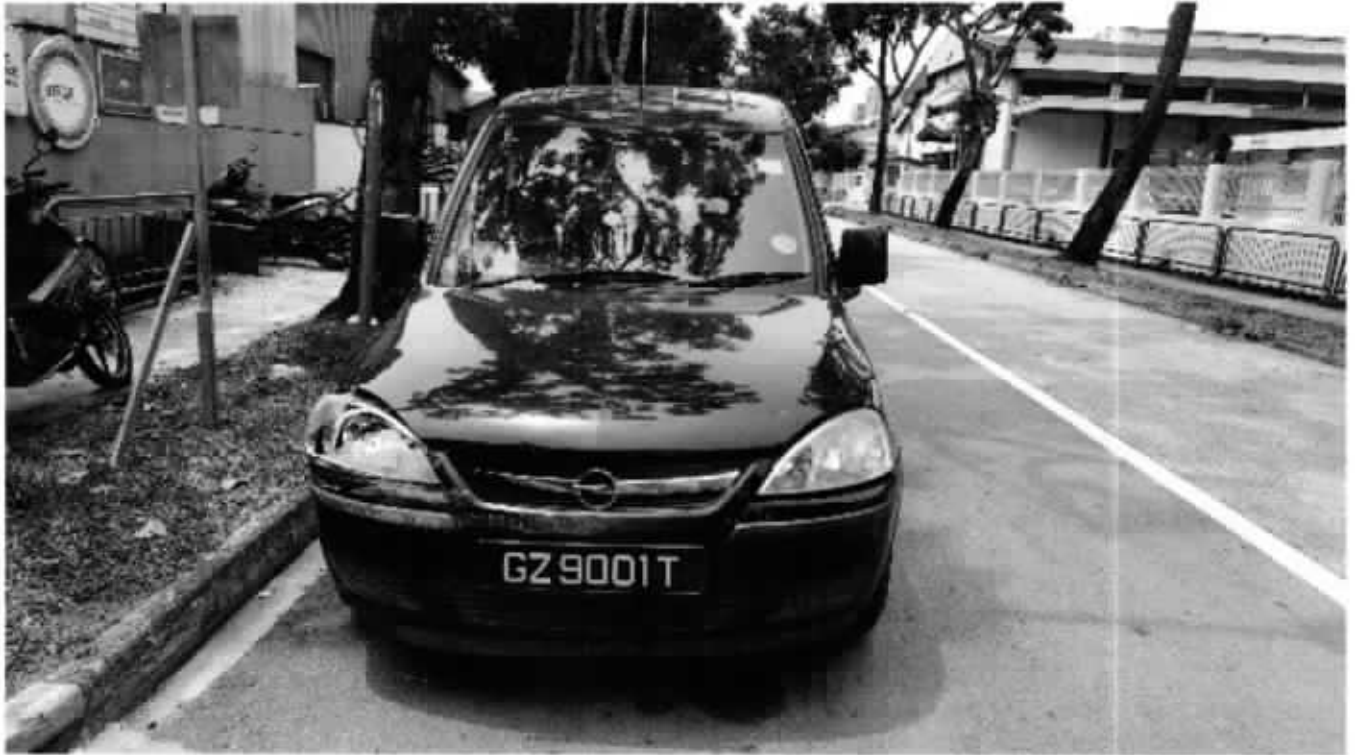
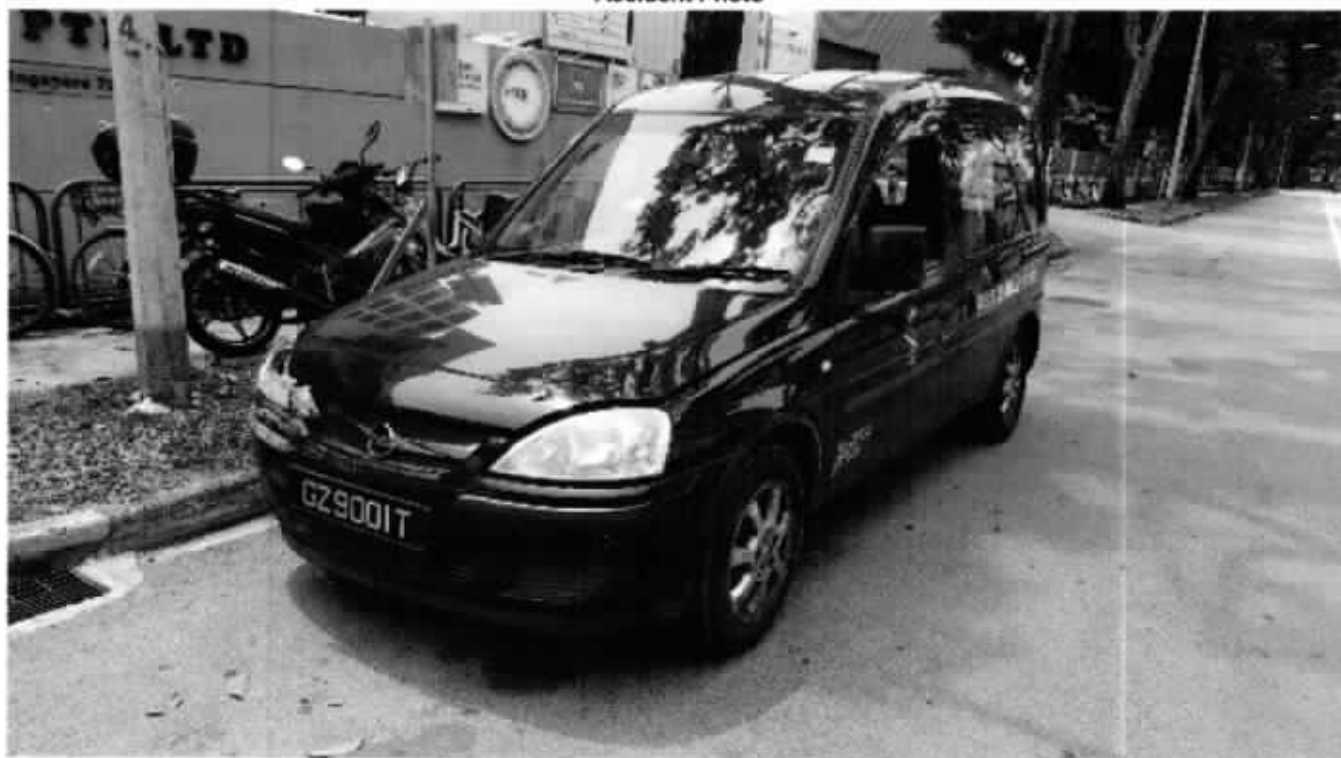
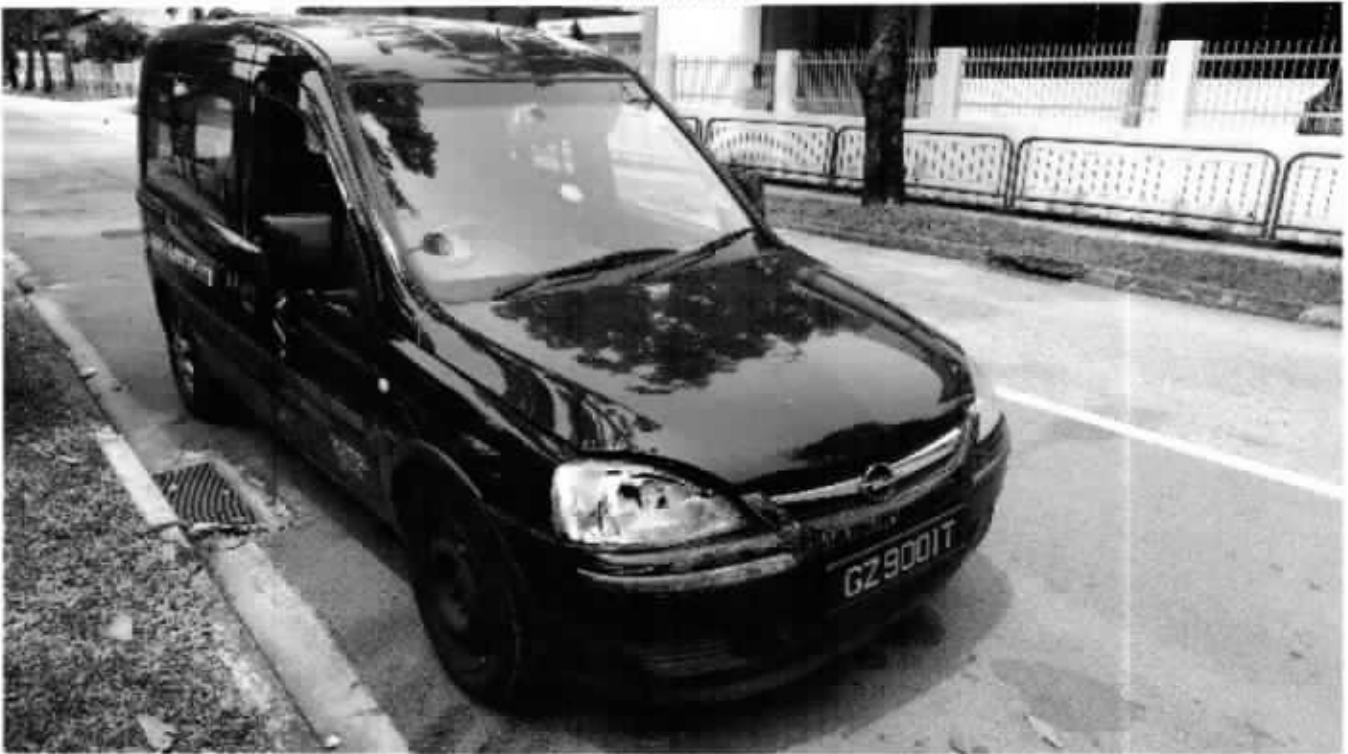
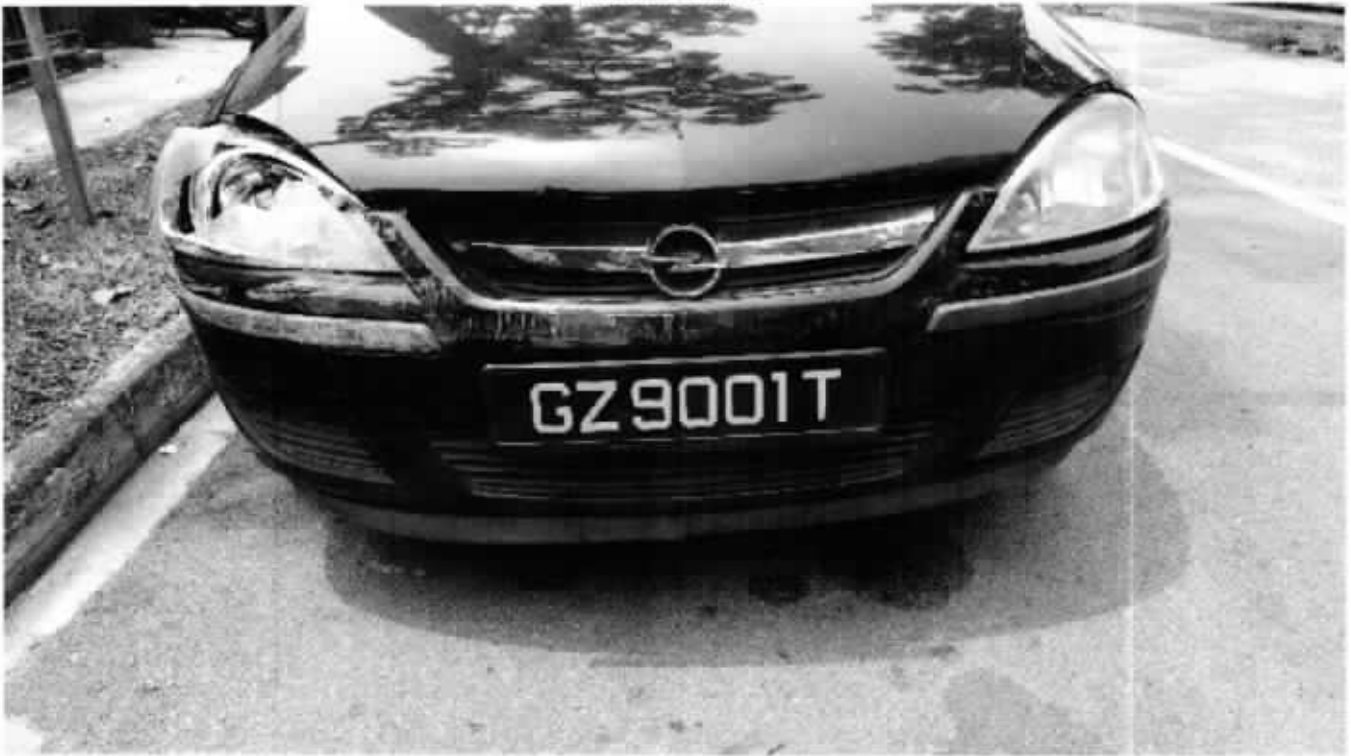
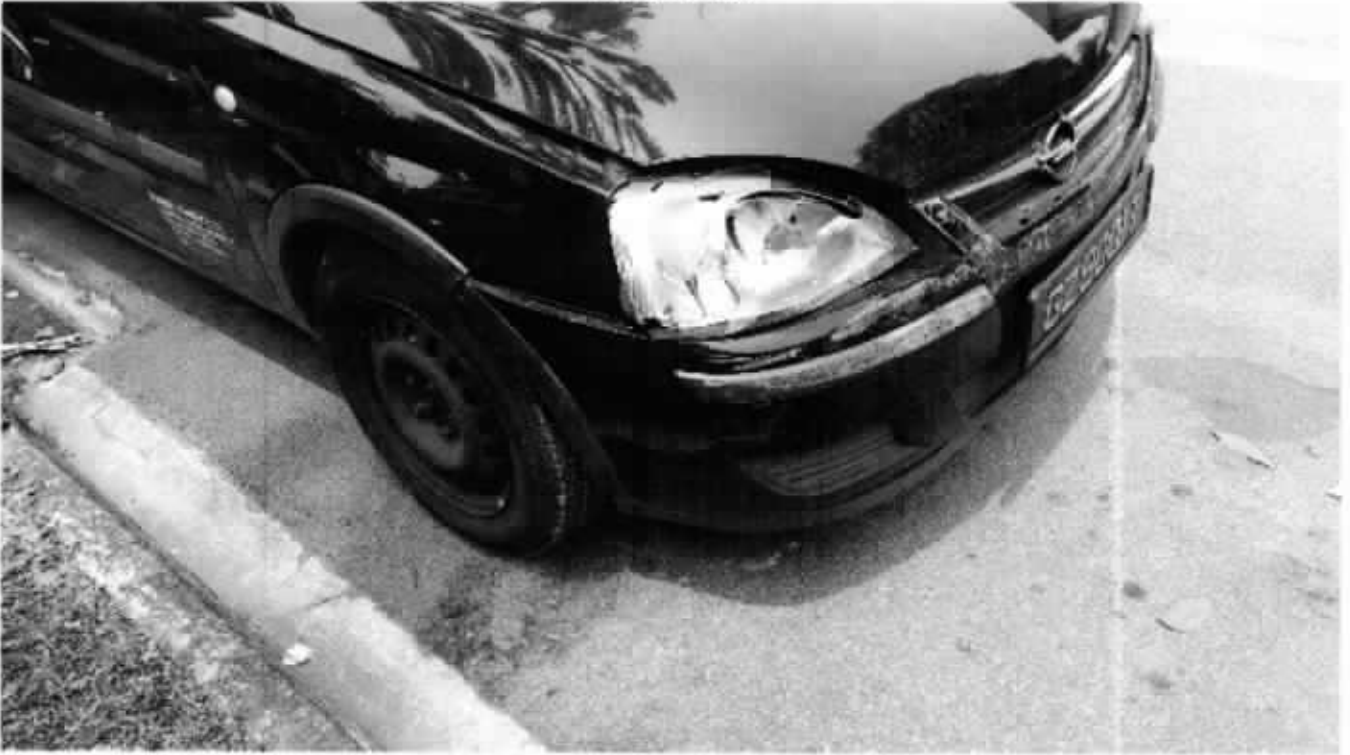
Accident Photo

The vehicle sustained an impact on the front portion.

The front support panel, bumper assy, fenders, bonnet, radiator, aircon condenser were dented/distorted.
