To Inspect Vehicle No: SLQ 2M Insured: SLB 6166 M

The U/C / Chassis frame / Body Structure affected due to collision.

## ESTIMATE FOR SLQ2M

## VEHICLE DAMAGE INSPECTION REPORT

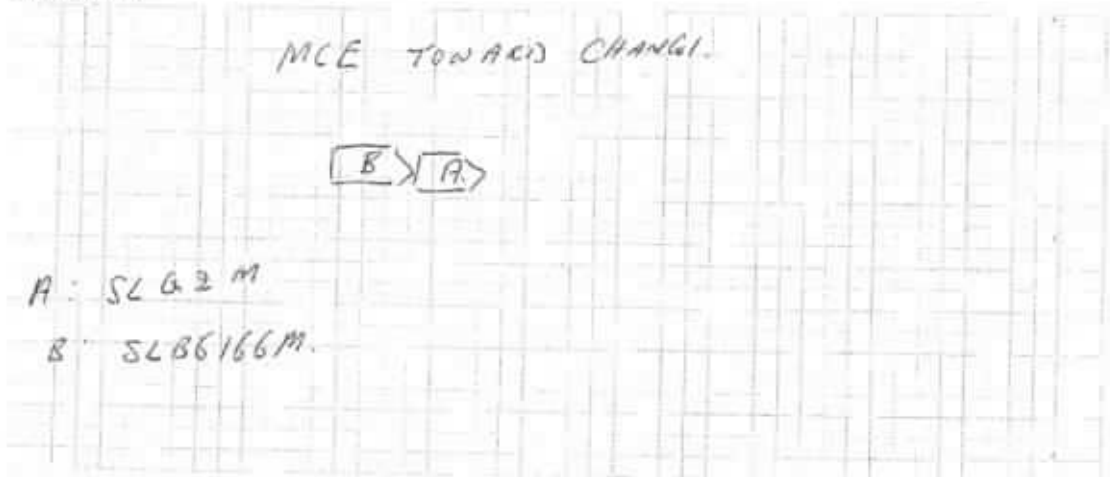
## SKETCH PLAN

I was travelling on Lane 1 along MCE toward Changi. I applied emergency brake when a car cut in to my lane and jammed brake.

Suddenly vehicle No SLB 6166 M travelling behind me collided on to the rear of my vehicle
