1. Policy Particulars :- THIRD PARTY CLAIM

4. Description of Damages

THE VEHICLE SUSTAINED DAMAGES AT THE REAR PORTION. DAMAGES SEE DETAILS.
--

ADJUSTMENT ON REPAIR COST FOR VEHICLE NO. SHC 3728D

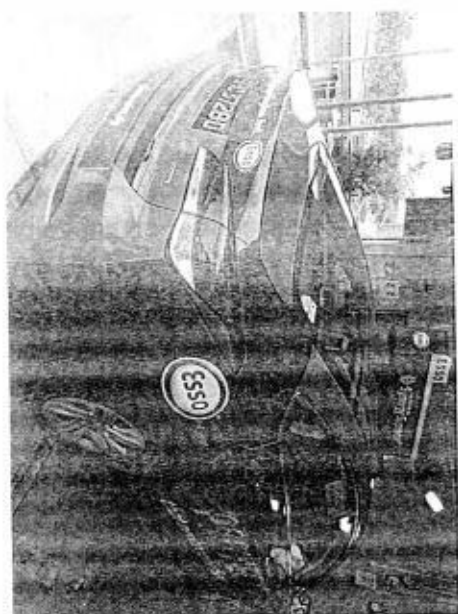
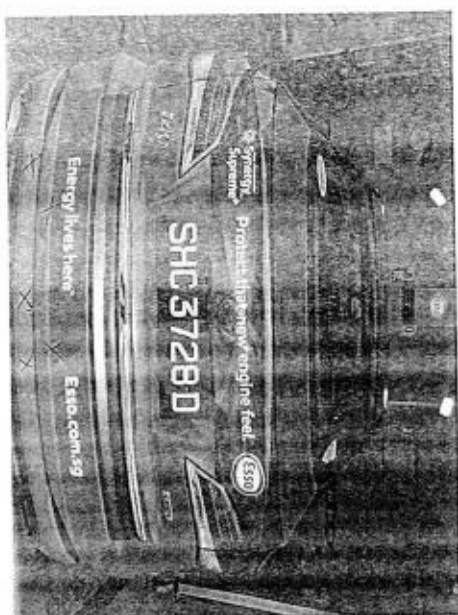
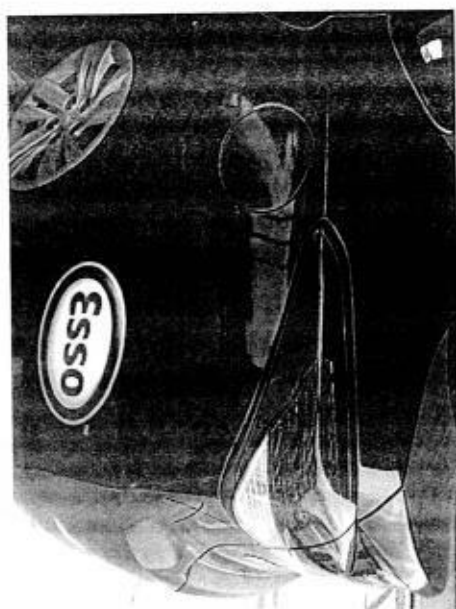
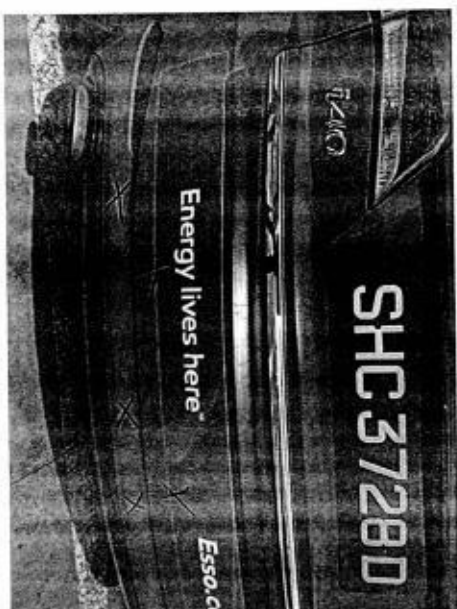
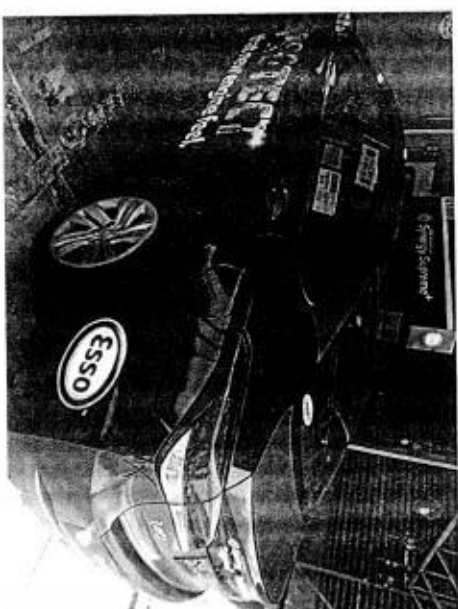
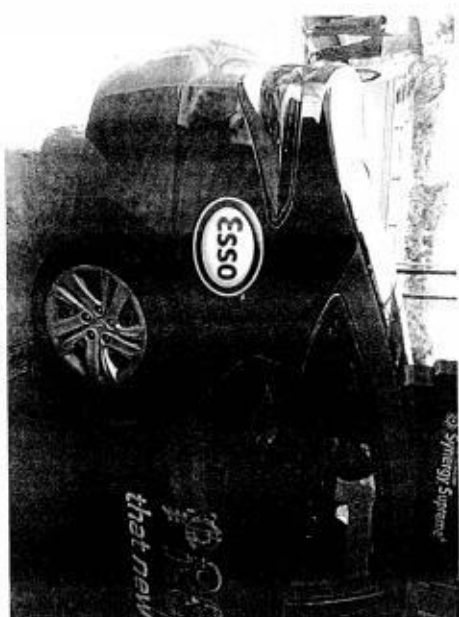
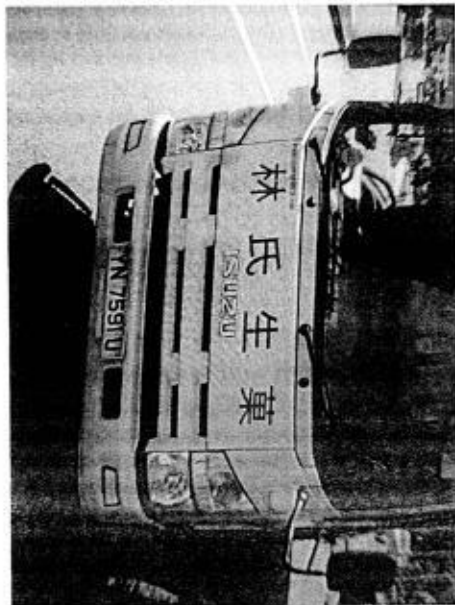
Photos

Qty	Description of Parts	Condition	Estimate By Workshop (\$)	Our Adjusted (\$)
REPLACEMENT OF PARTS				
1	REAR BUMPER	DEFORMED	553.00	553.00
10	REAR BUMPER CLIP	NECESSARY	22.00	22.00
1	REAR BUMPER UNDER COVER	SERVICEABLE	228.00	-
	LESS 20% DISCOUNT		-160.60	-115.00
			642.40	460.00
SPECIAL NETT ITEMS				
1	REAR BUMPER RUBBER MAT (SN)	NECESSARY	50.00	50.00
1	REAR BUMPER ADVERTISEMENT LOGO (SN)	NECESSARY	50.00	50.00
2	REAR FENDER ADVERTISEMENT LOGO (LH/RH) @\$100.00 (SN)	NECESSARY	200.00	200.00
			300.00	300.00
LABOUR				
	PANEL BEATING.	NOT NECESSARY	400.00	200.00
	SPRAY PAINTING CHARGE.		300.00	200.00
	WIRING CHARGE.		30.00	-
	REMOVE/REFIX REVERSE SENSOR.		80.00	30.00
			810.00	430.00
GRAND TOTAL			1,752.40	1,190.00
RECOMMENDED COST OF LUMP SUM REPAIRS (TO ITS PRE-ACCIDENT CONDITION) (CONFIRMED)				950.00
