OD/TP Re-inspection / Evaluation

To Inspect Vehicle No: FT4846Z

ADJUSTMENT ON REPAIR COST FOR VEHICLE NO. FT 4846Z

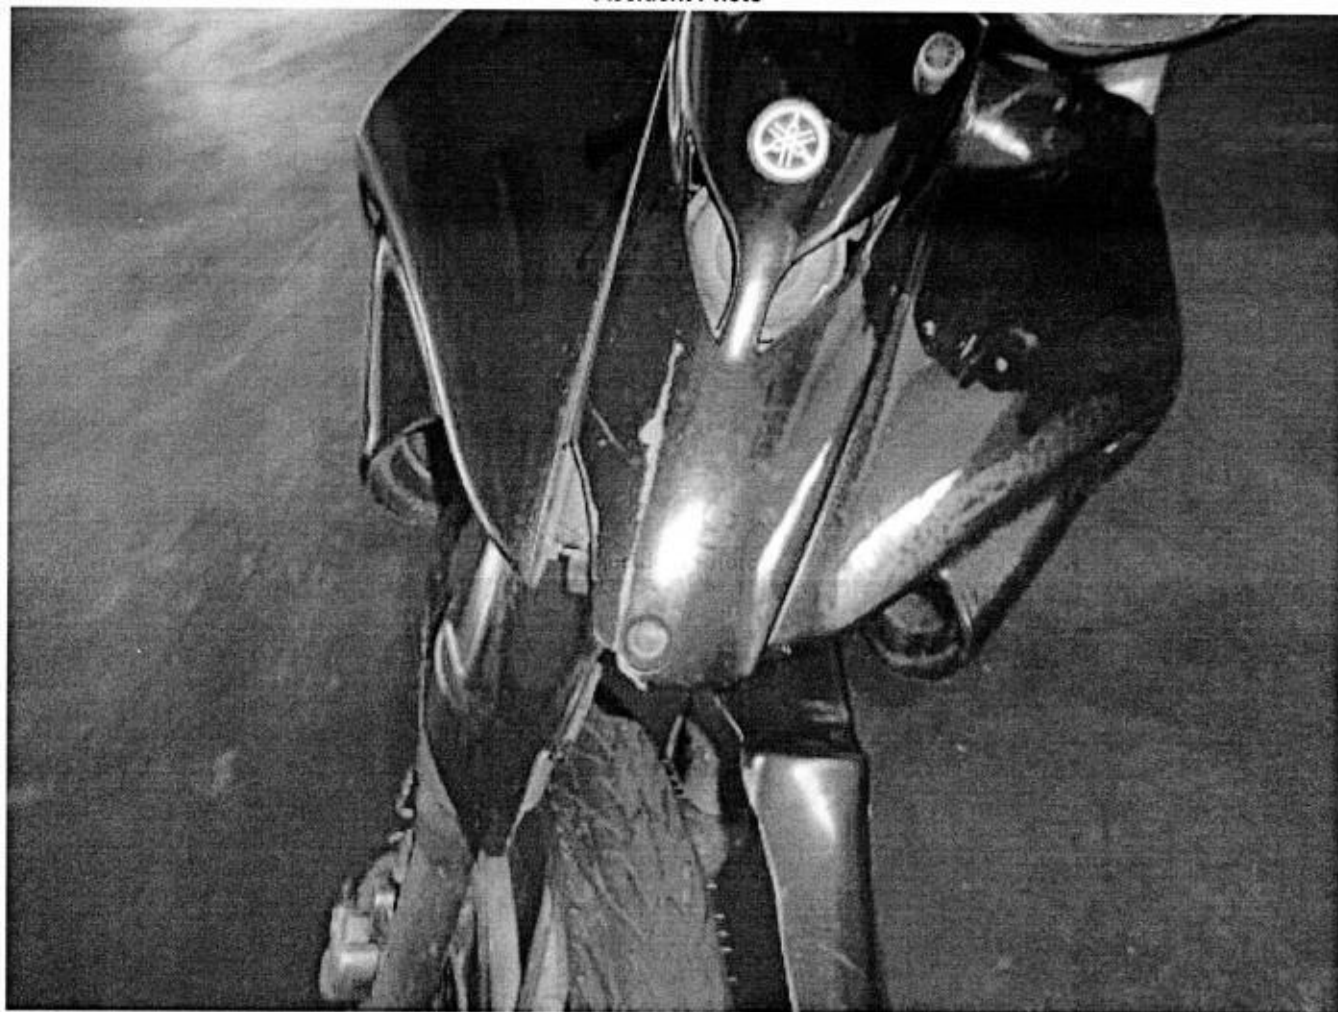
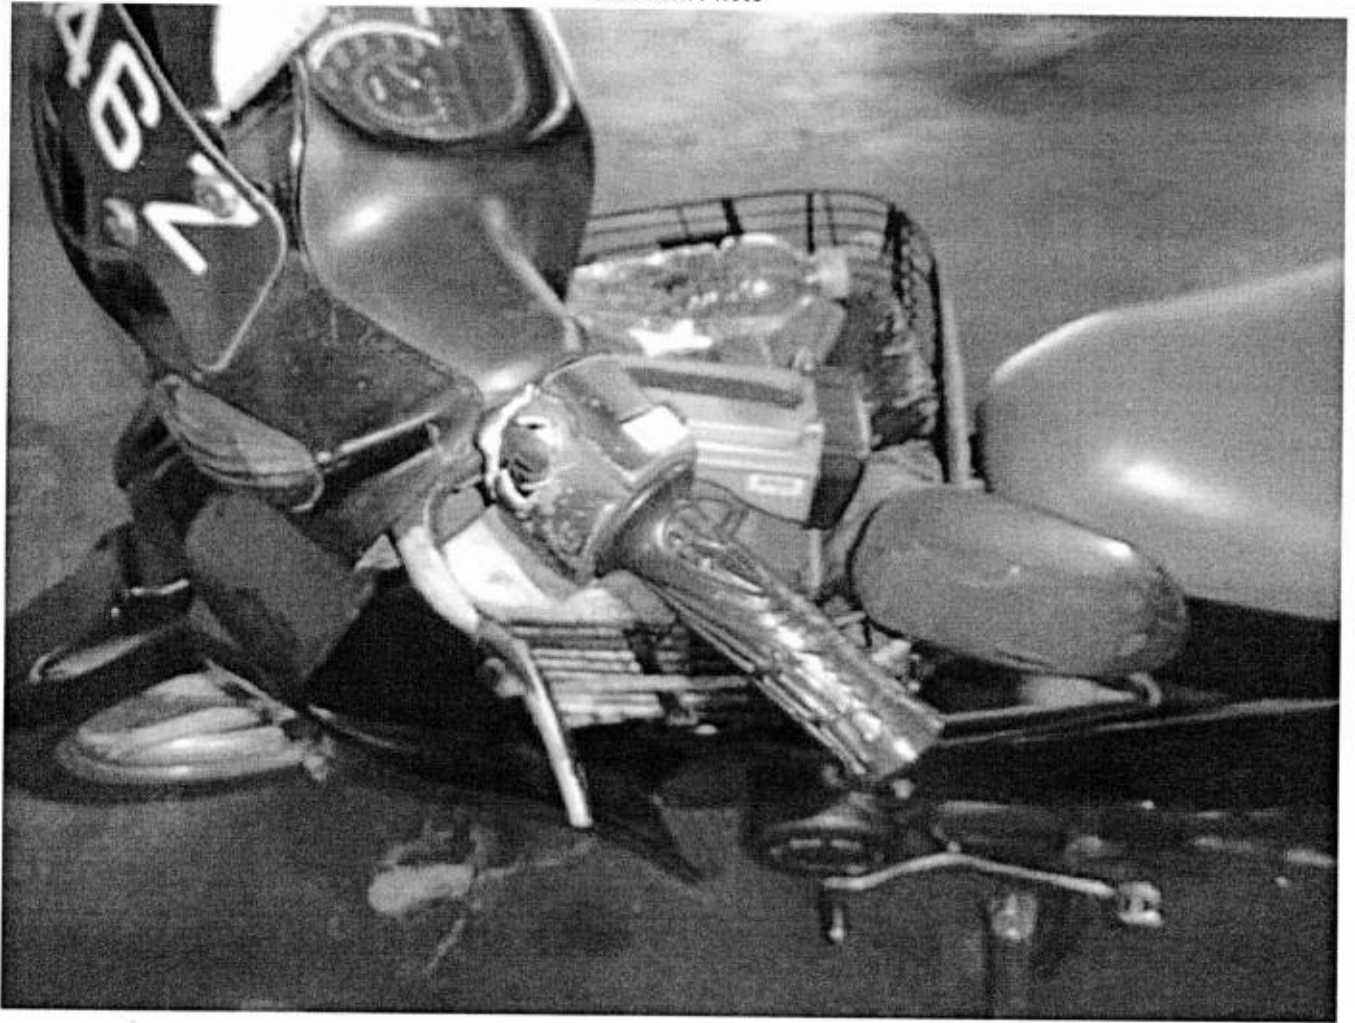
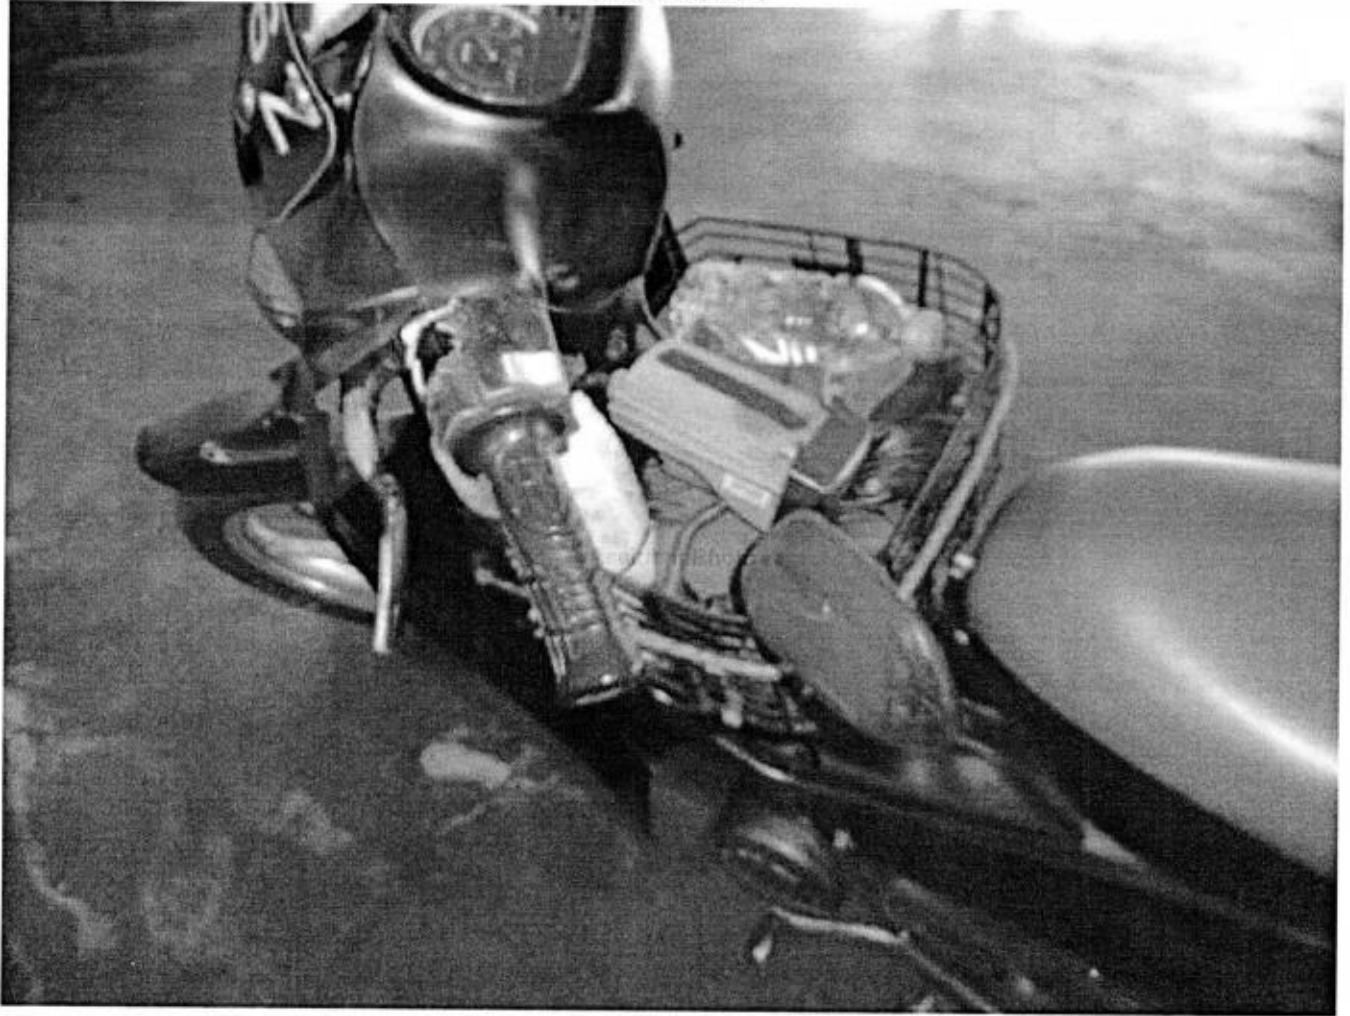
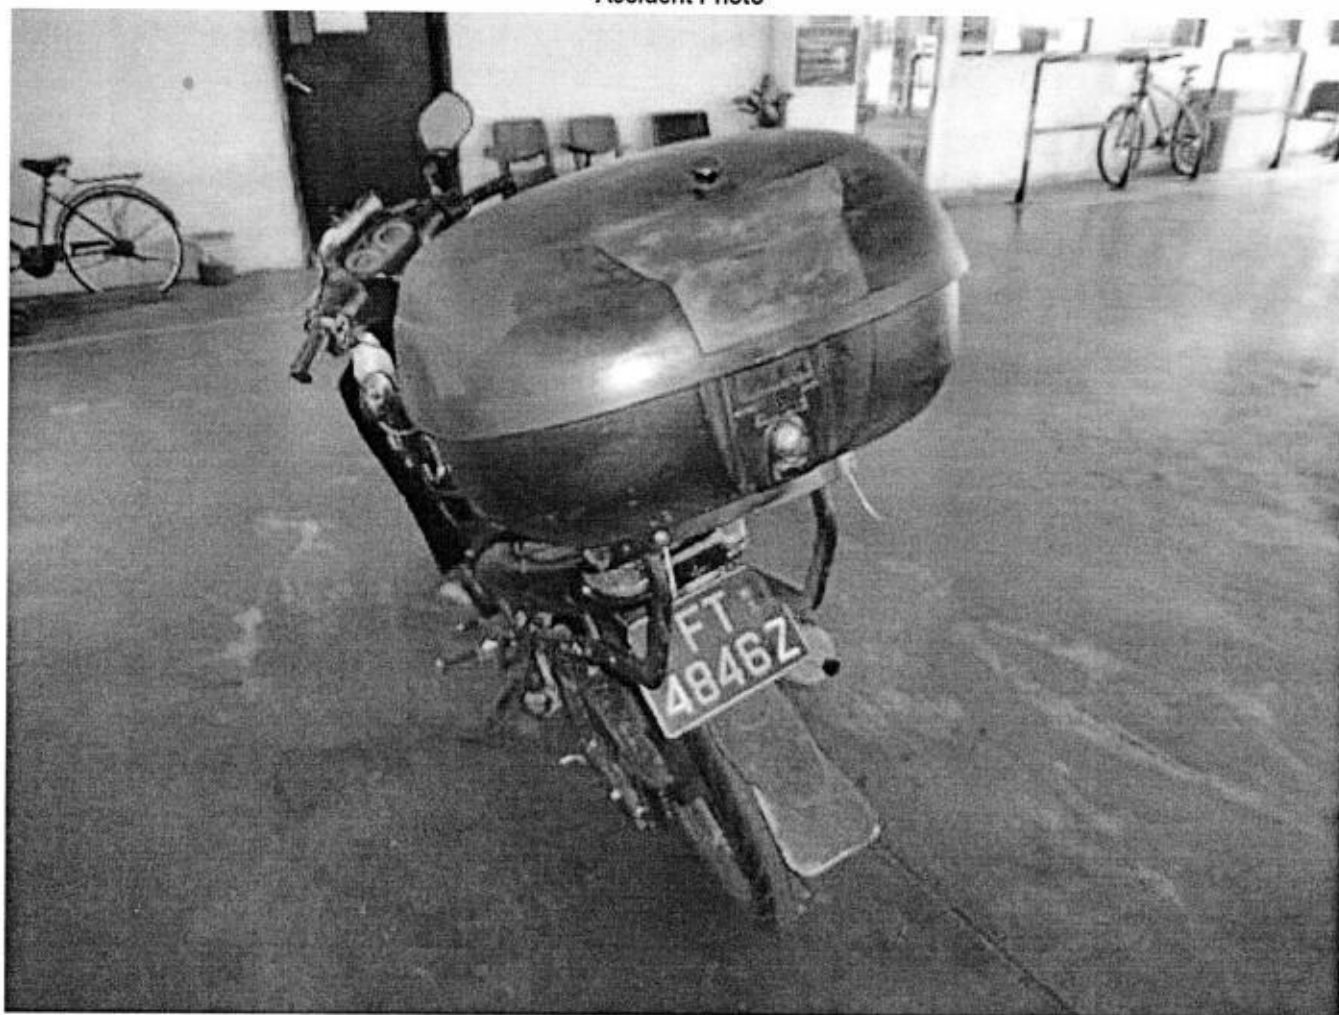
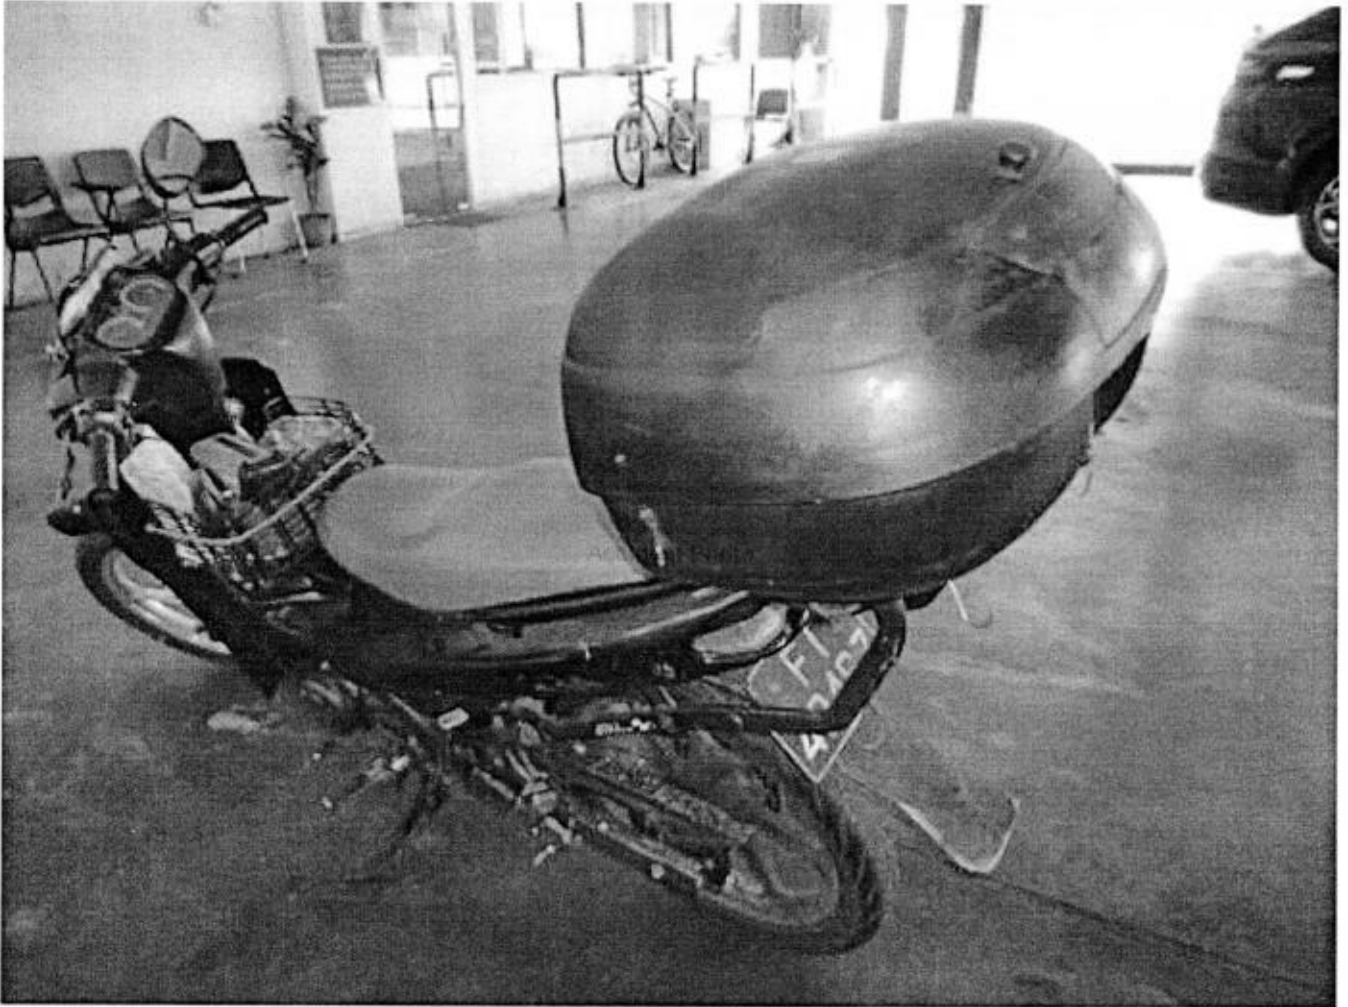
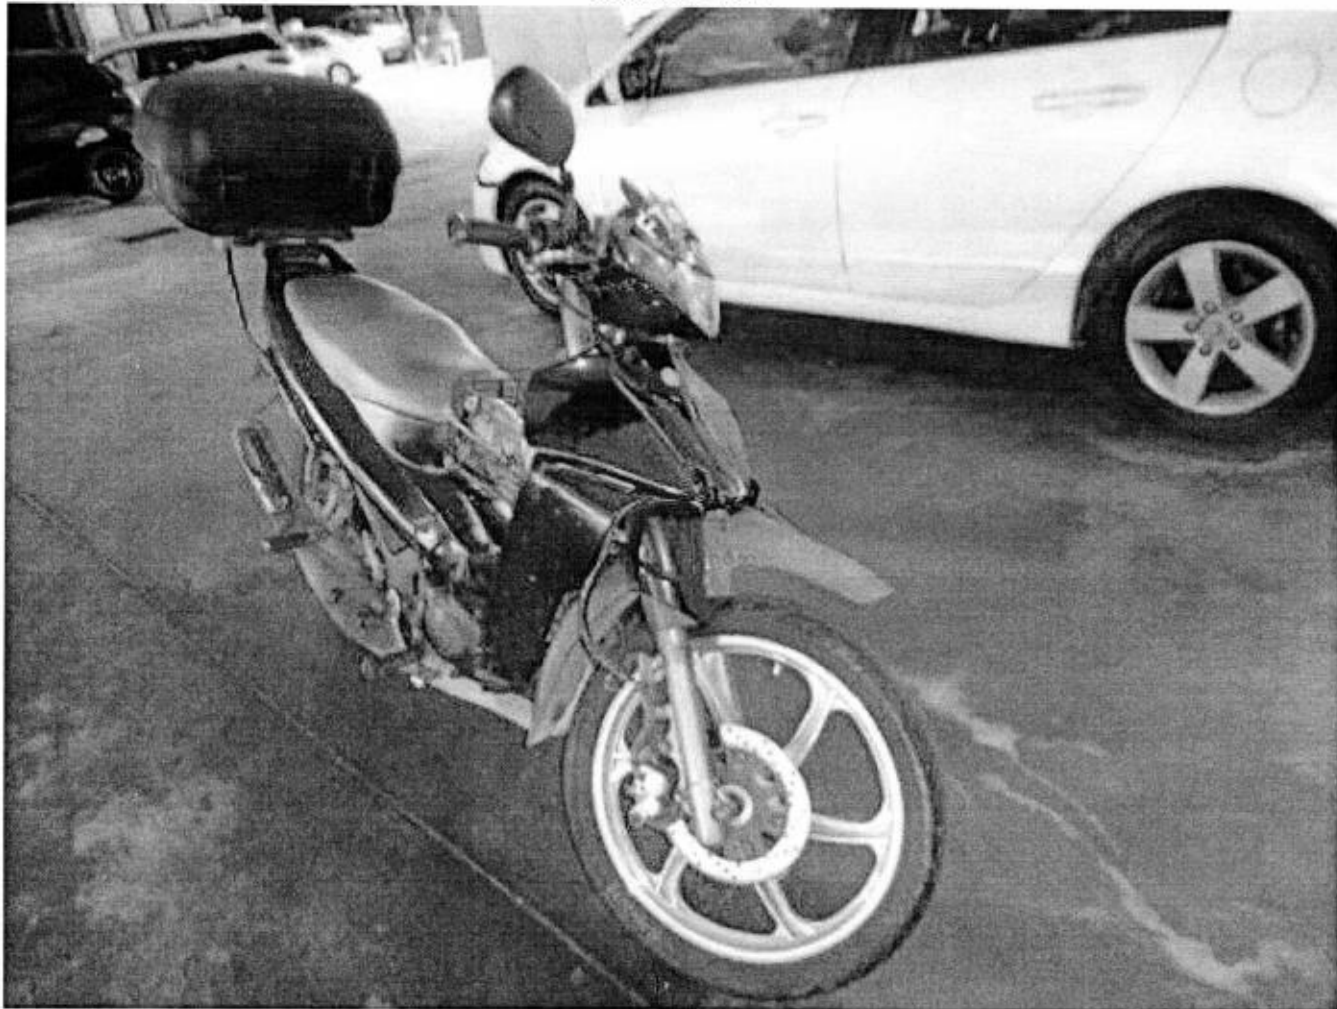
The motorcycle's side mirror is broken and the mudguard is broken too.

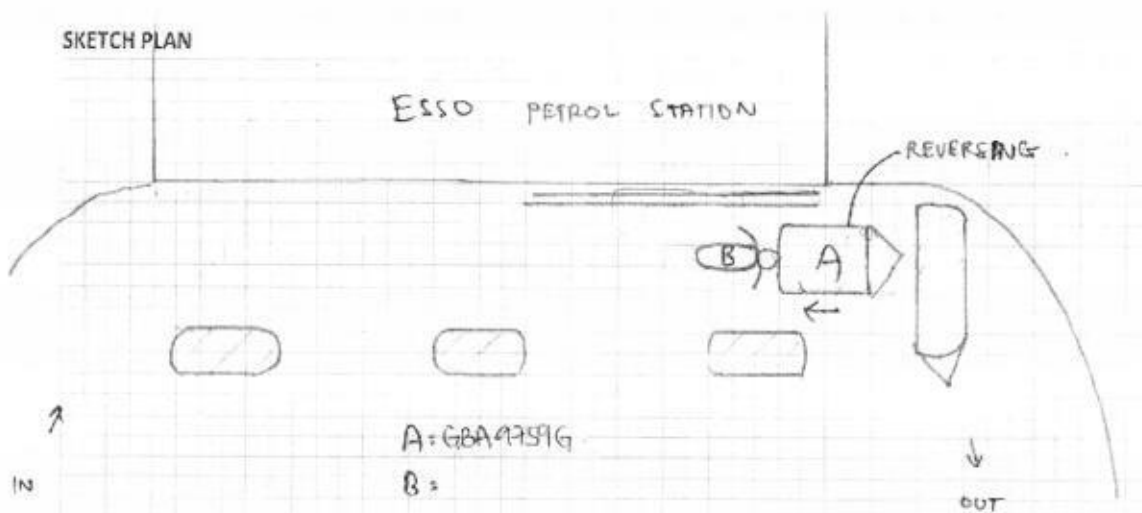
I am a driver from Gardenia Road. I parked my Lorry ~~and~~ to unloading the bread at ESSO Petrol station at Bukit Batok. And I ~~had~~ 'touch' the motorcycle behind me when I reverse to get out there accidentally.

There is a car in front of me. And the motorcycle ~~is~~ is parked on double ~~the~~ yellow line behind of my Lorry.

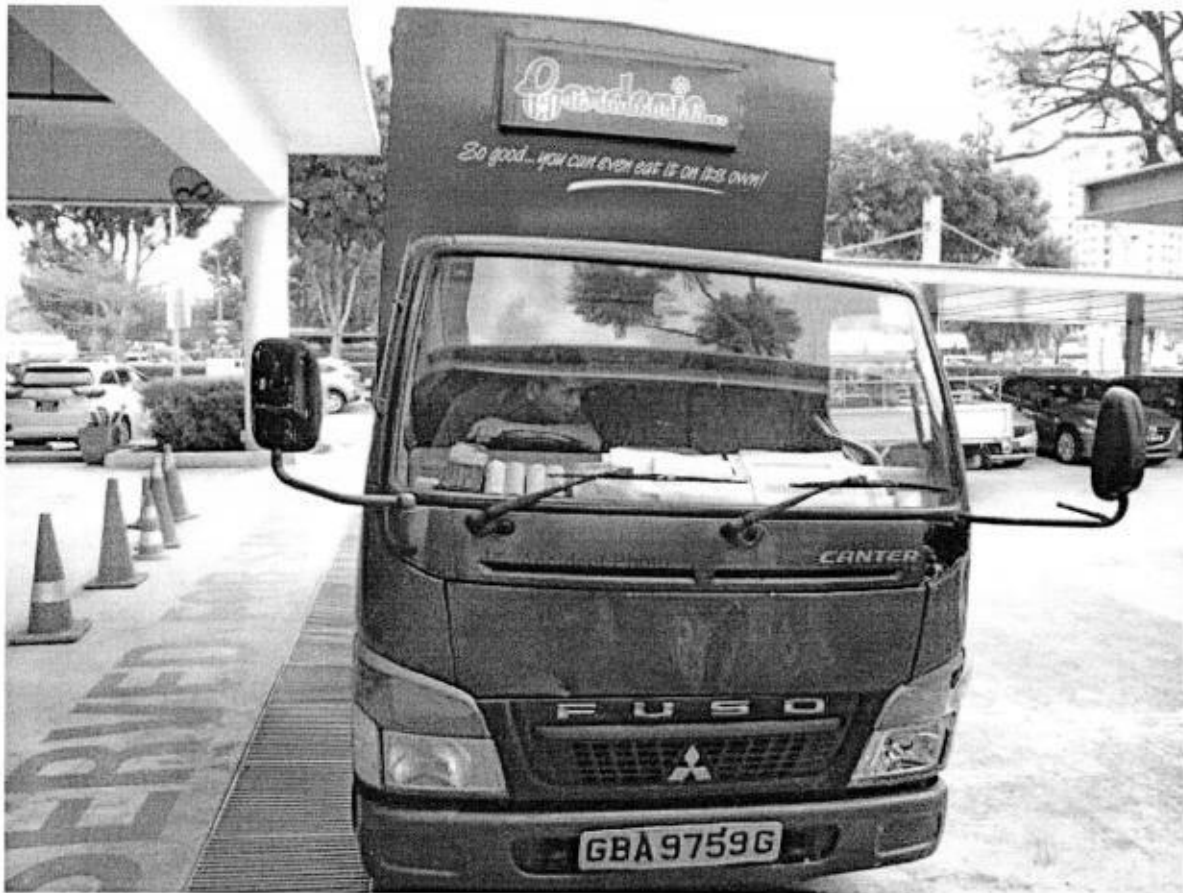
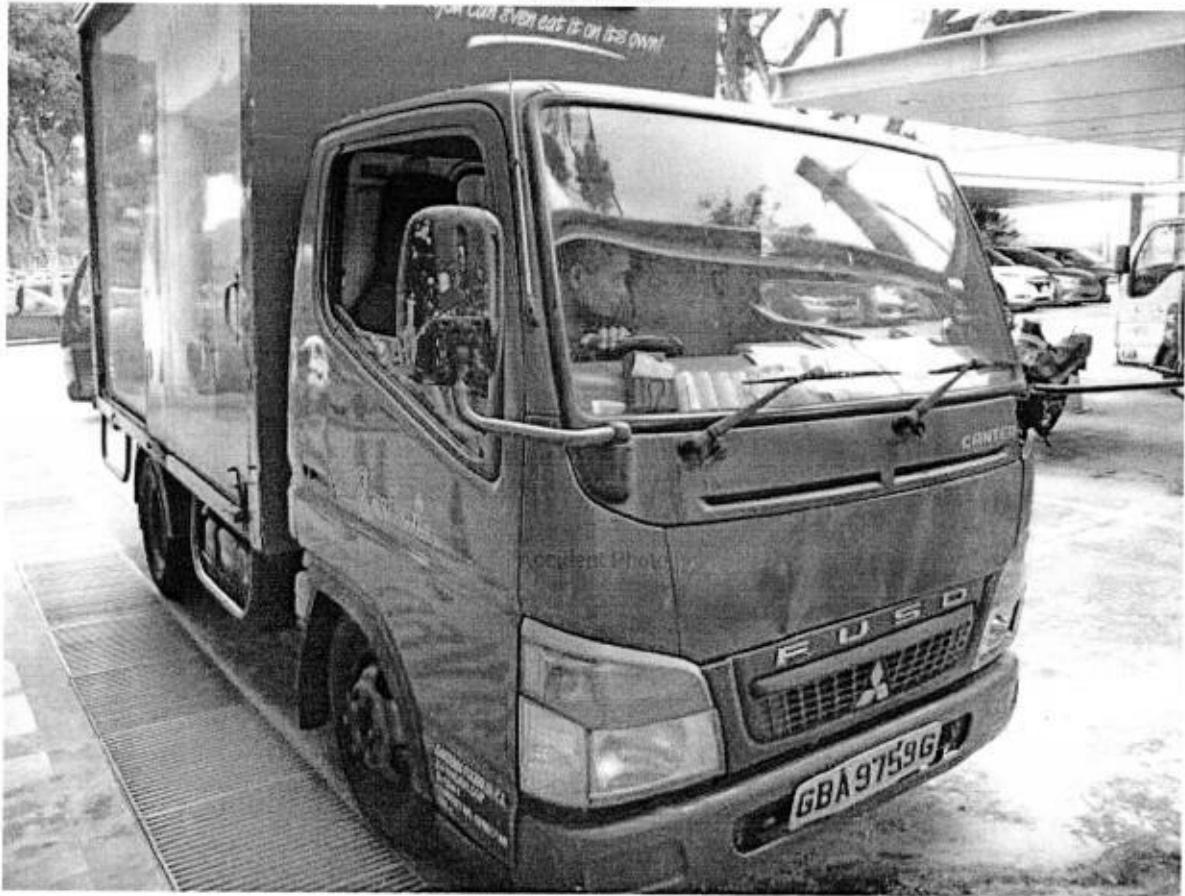
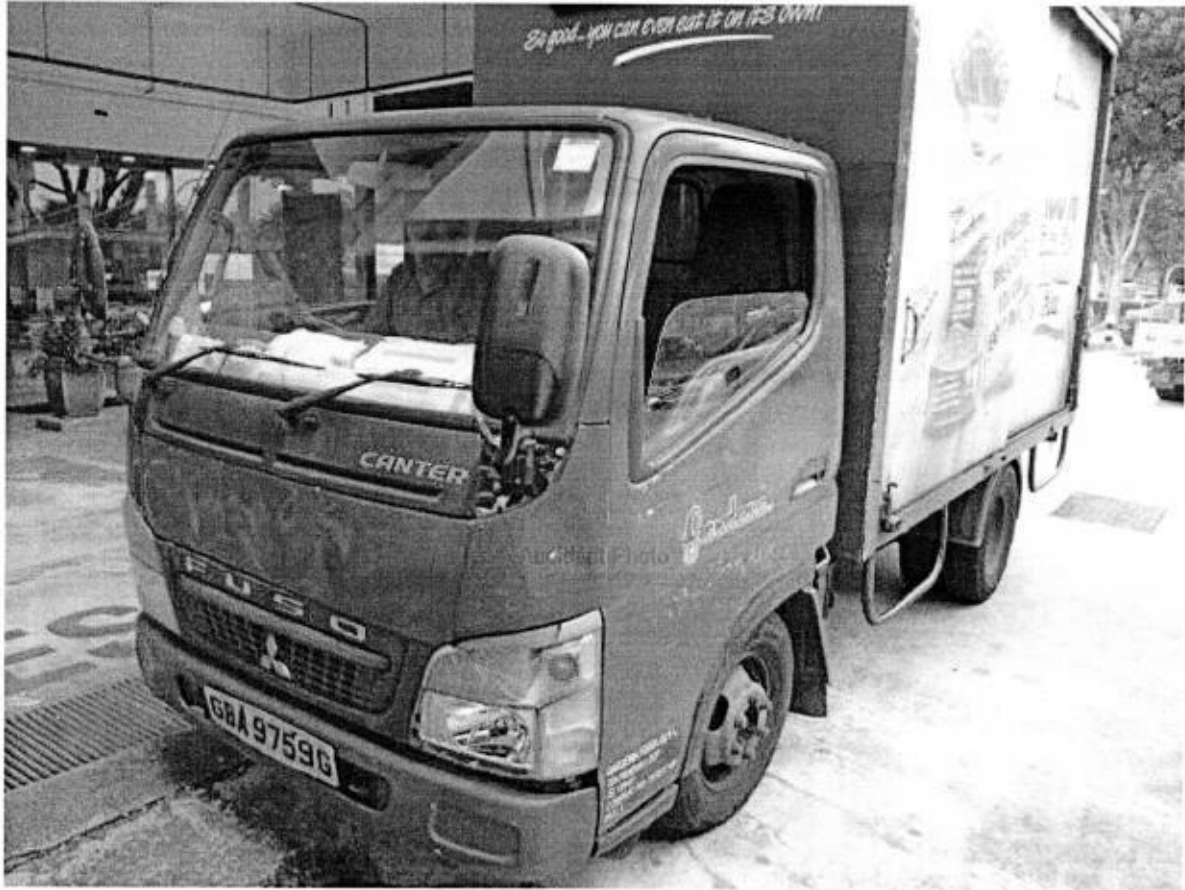
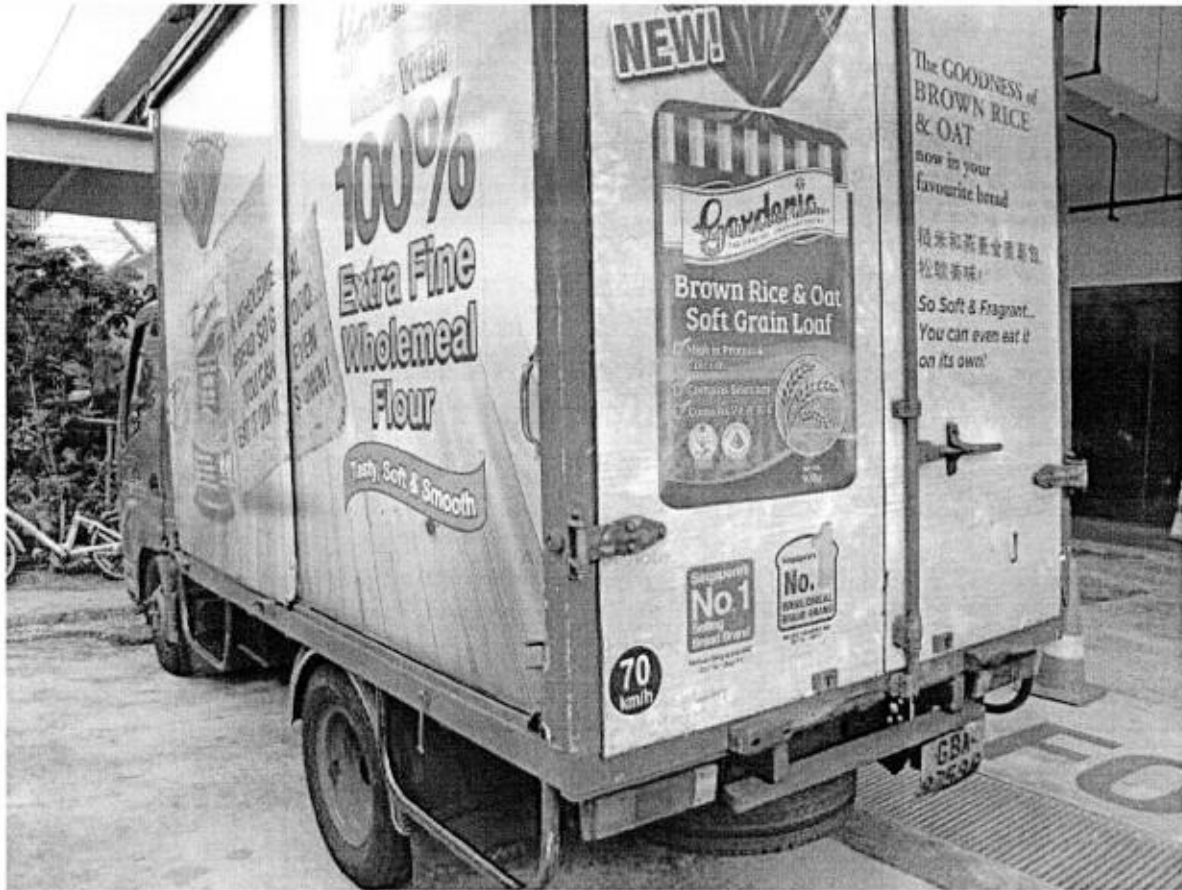
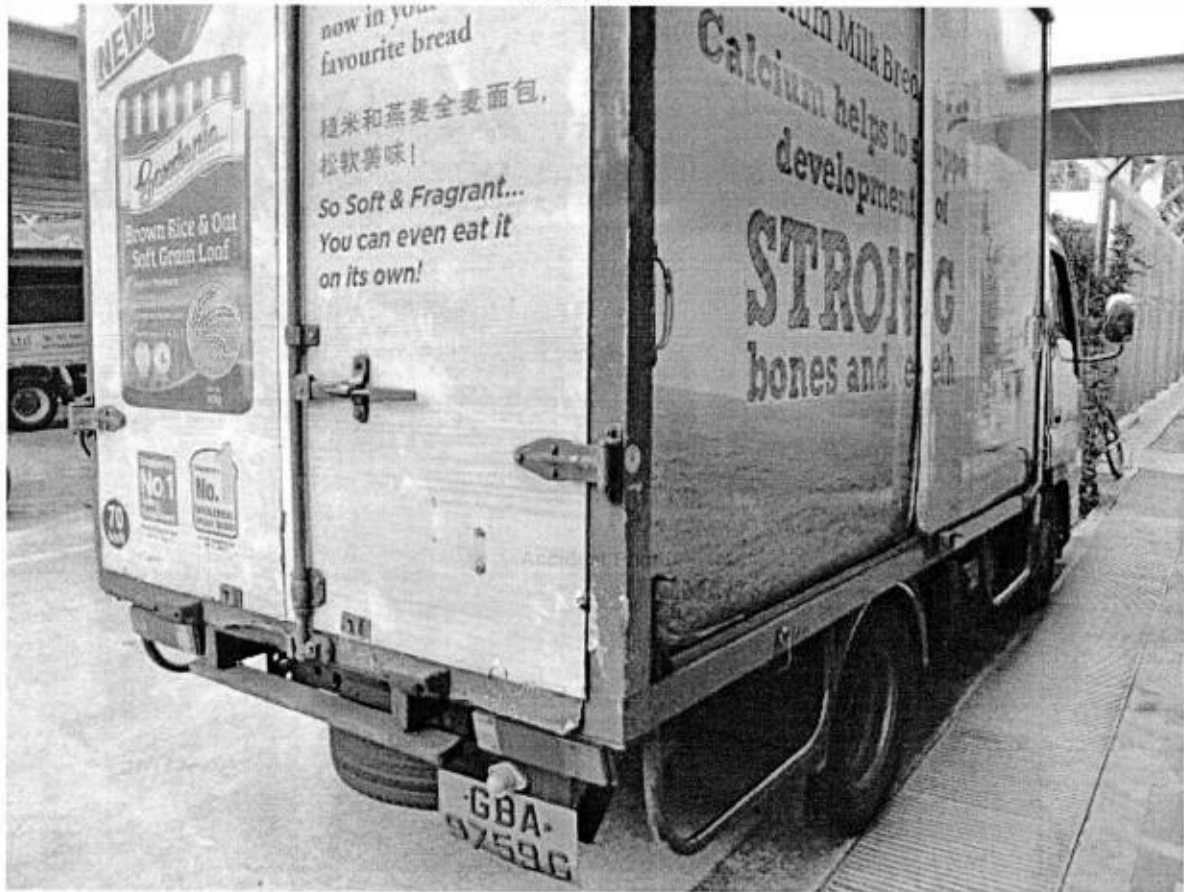
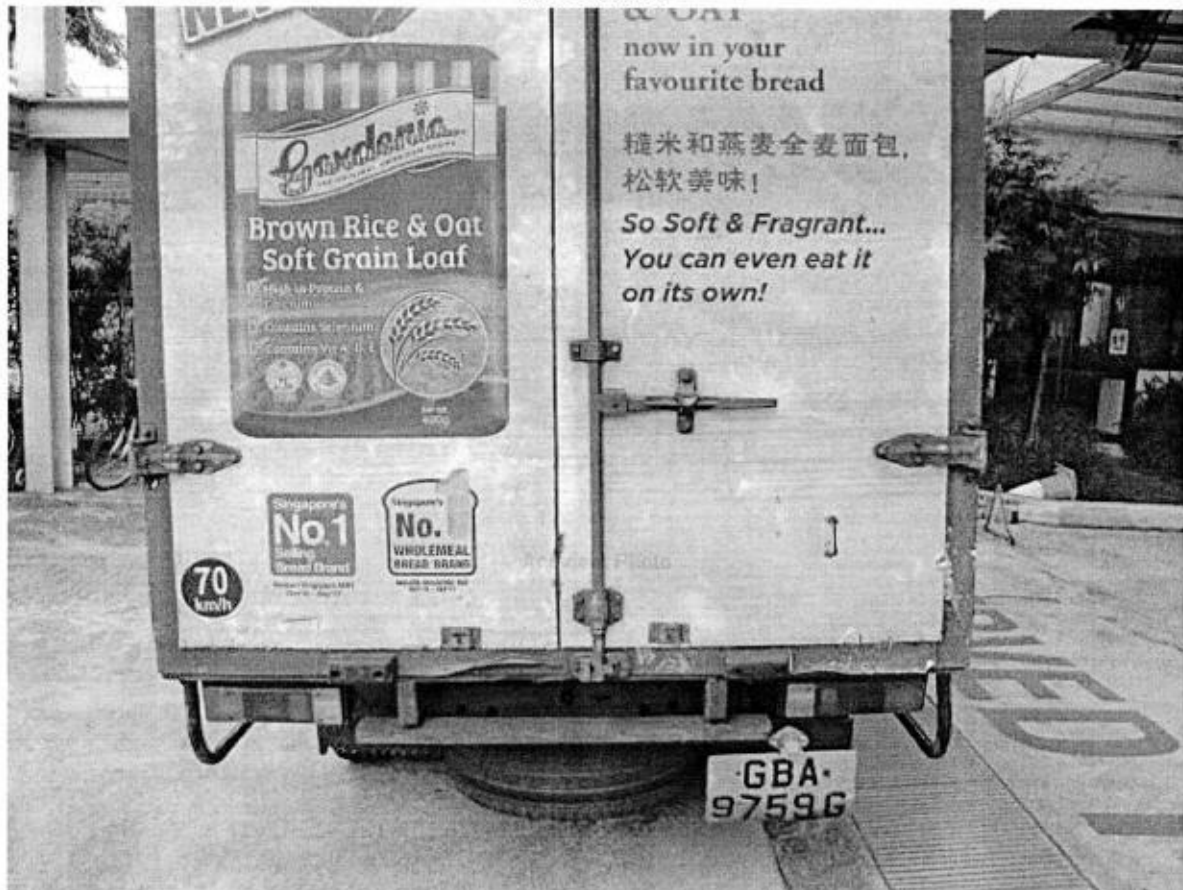
At the time of inspection, we noted that the vehicle has sustained an impact damages on the ALL portion(s). For more detail of the damages, please see photograph attached.

4. Estimated normal period of repair : 09 working days to complete
5. In accordance to your instruction, we have Not Authorised repair to the vehicle and the survey done on a "Without Prejudice" basis. We hope that this report will be of assistance to you in dealing with the matter.
6. Should you discover any discrepancy in the report, please kindly notify us within 1 week, or the report will be treated as correct.
